Hydrological restoration

**Summary of experience
with restoration of wetlands,
springs and streams in the Šumava region**

Project "LIFE for MIRES"

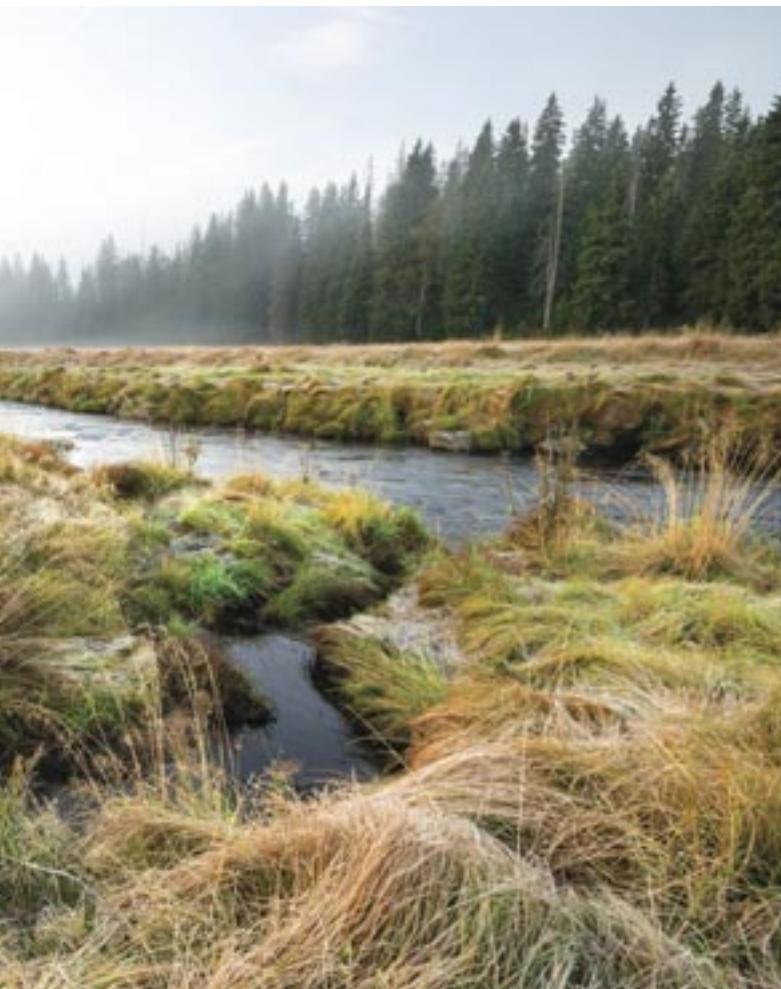
Fig. 1: The mouth of the small restored stream into the Roklanský brook stream stream at the Rybarny I location. Before the revitalization, the stream had the form of a deep straight channel, September 2022 (I. Bufková)

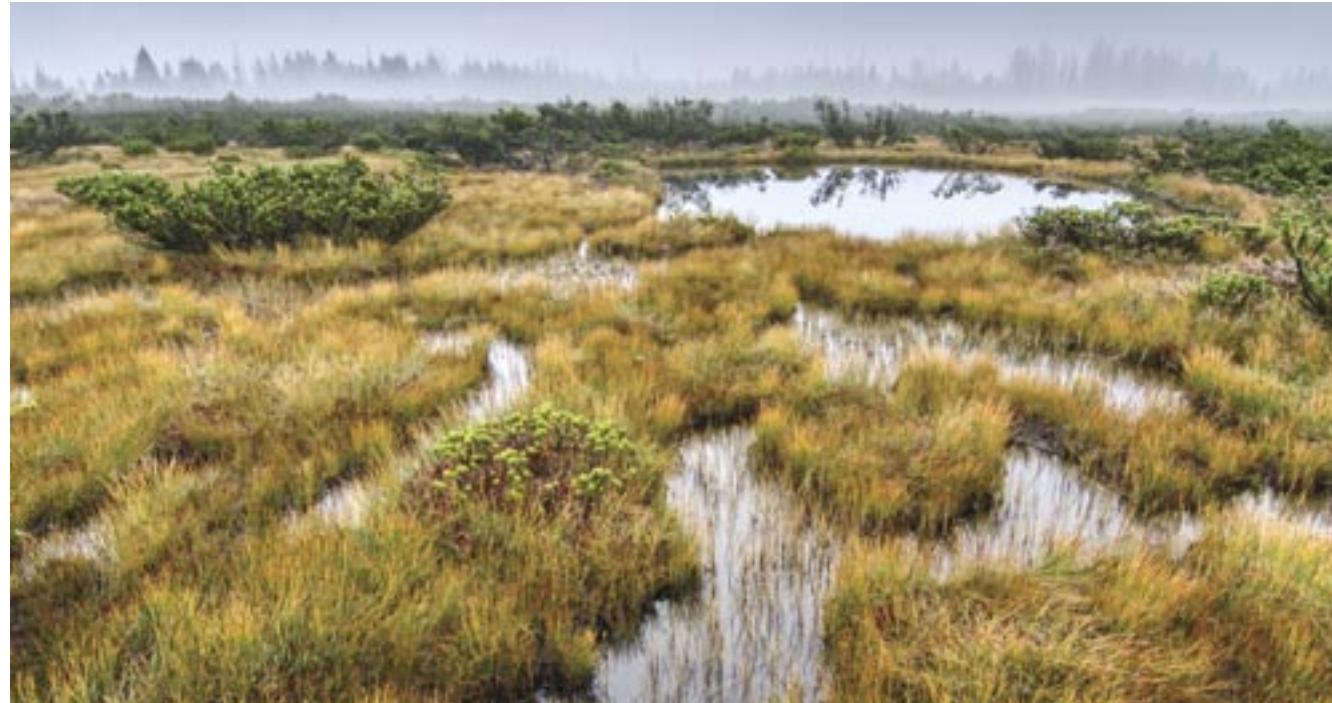
Fig. 5: View of the high raised bog Rokytecká slat in the area of the Šumava plains, September 2021 (P. Semerád)

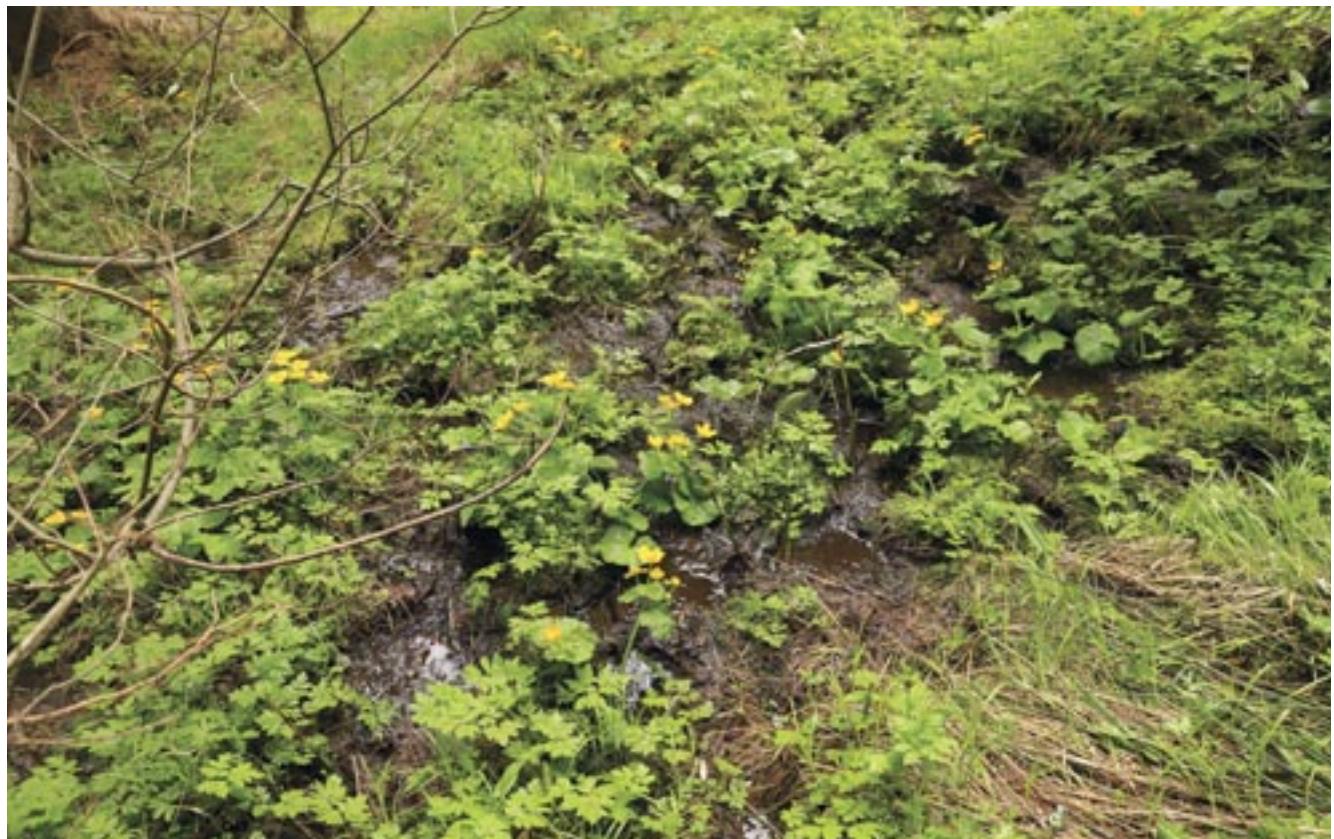
Fig. 9: Helocrene-type slope spring in the undergrowth of willow carr near Přední Výtoň, May 2023 (I. Bufková)

The Šumava region as a spring area is characterised by a rich abundance of springs. Most of them have the form of a helocrene, i.e. a spring wetland (Fig. 9). In this type of spring, the water is upwelling to the surface over a larger area, giving the spring the character of a wetland. The water flows out of it in multiple small streams. Typical rheocrene springs, i.e. springs from which the stream flows directly without being impeded, are also found in the area, although to a lesser extent. Natural limnocrene, in which a well is formed above the water outlet and a stream flows out of it, has rarely been formed in the Šumava region.

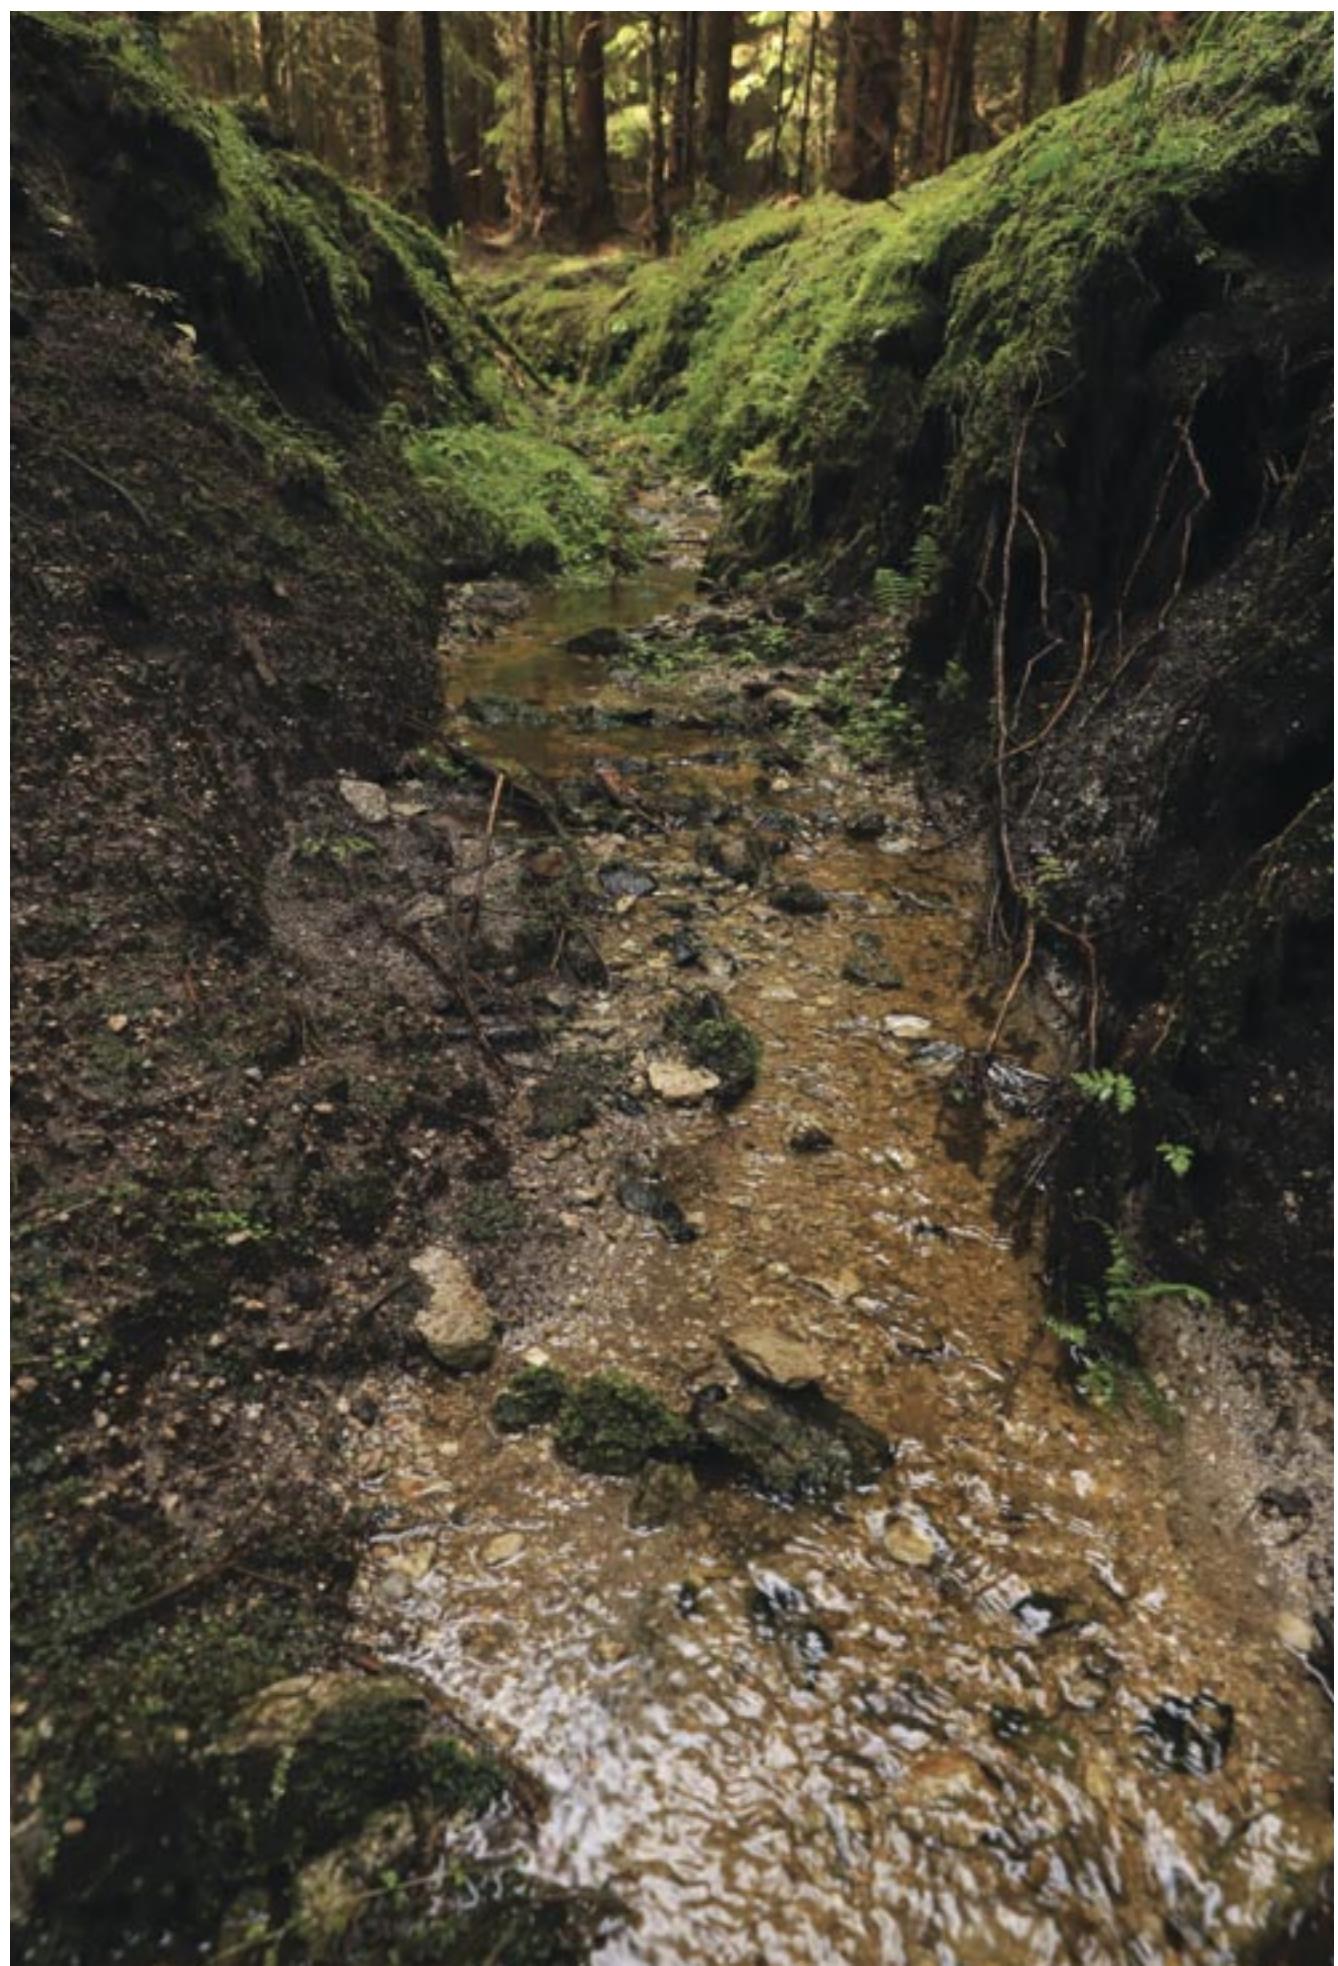
Fig. 15: A deep drainage channel in a stand of former spruce mire at the Devítka site, October 2020 (I. Bufková)

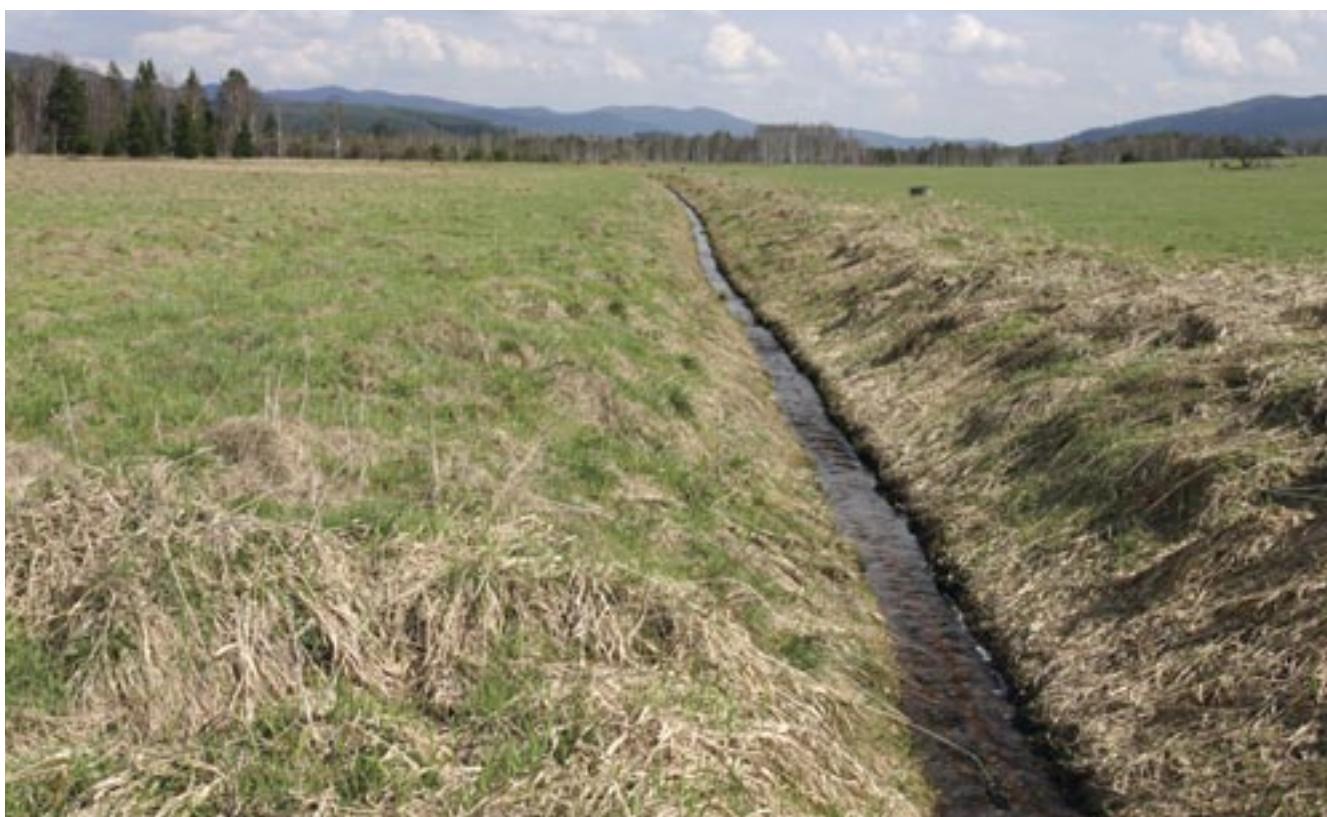
Fig. 16: Straightened and altered stream in the Teplá Vltava river floodplain near Malý luh, April 2006 (I. Bufková)

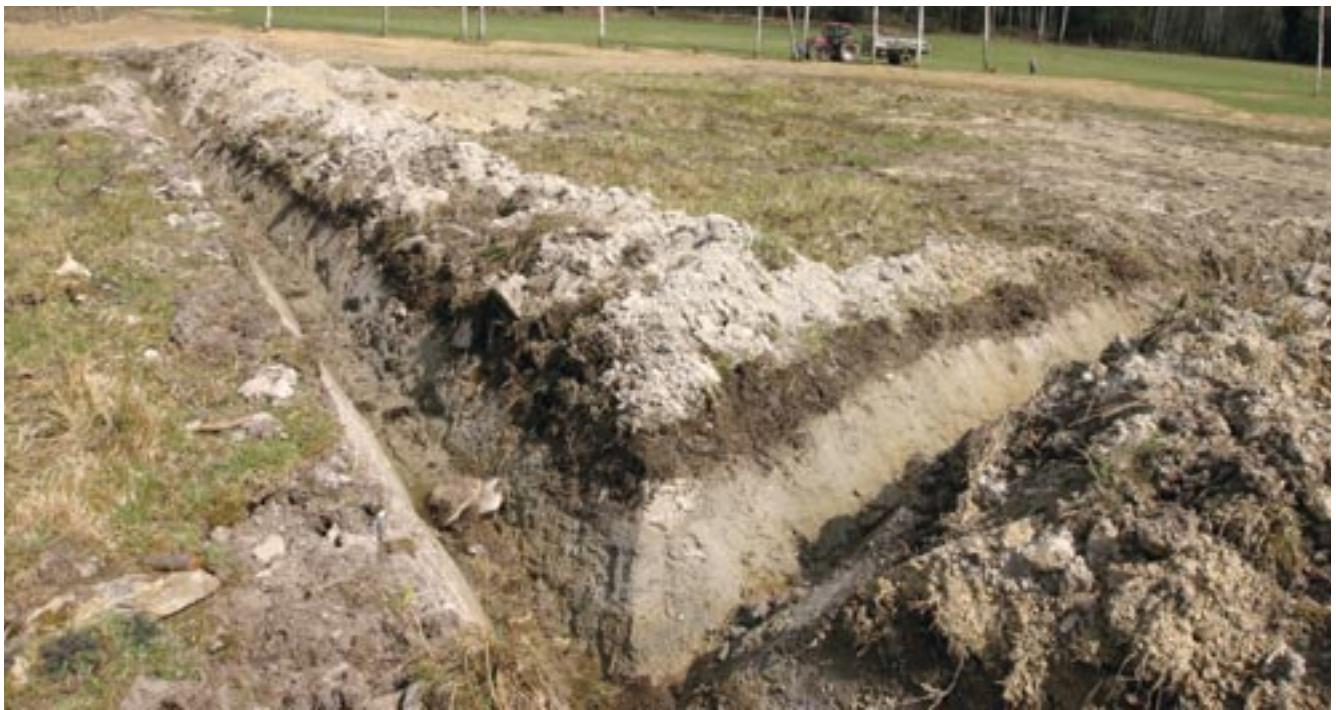
Fig. 18: Drained spring and fens near village Červená u Kašperských Hor, April 2015 (I. Bufková)

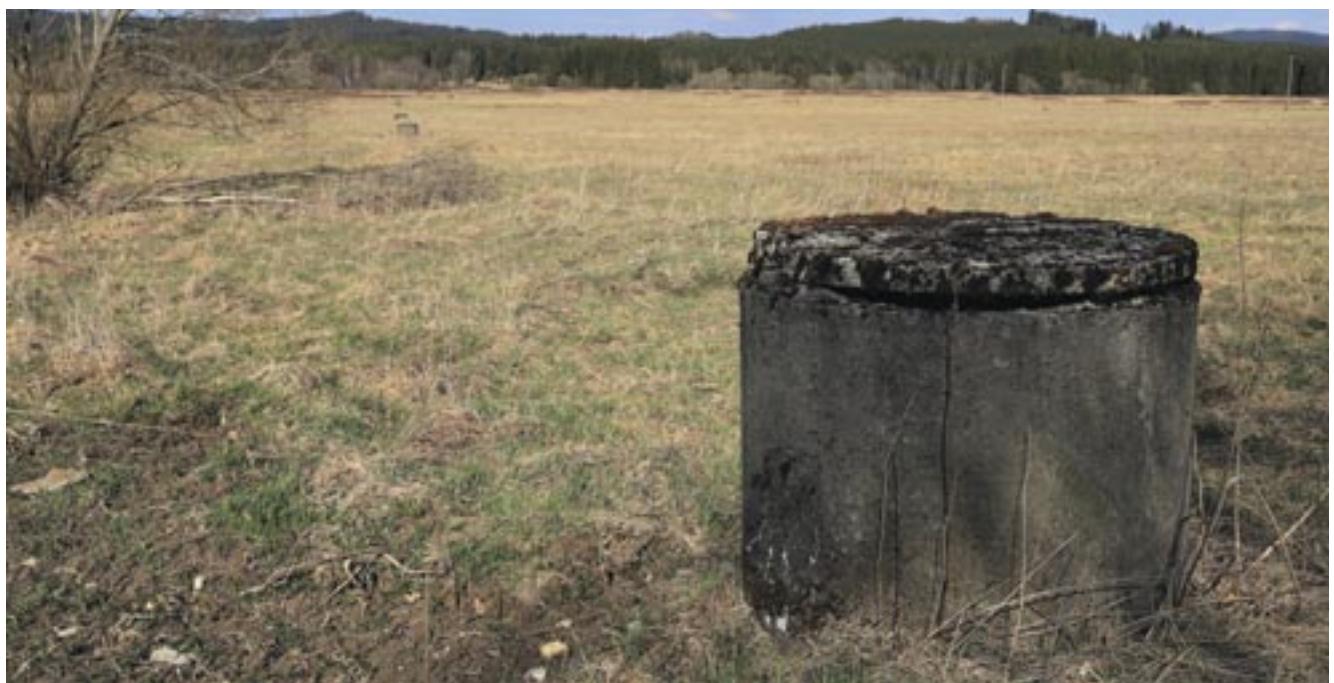
Fig. 19: Wet meadows intensively drained by a piped drainage system near settlement Dobrá, April 2020 (I. Bufková)

The second significant wave of drainage took place in the framework of intensification in agriculture and forestry in the 1970s and 1980s. Drainage systems from this time were not so widespread, but they were very vigorous and thoroughly built. Piped drainages were also built to a large extent (Fig. 19), especially in lower positions on agricultural land. Intensive drainage of grasslands (Fig. 16) was often carried out as part of so-called compensatory reclamations as a substitute for high-quality soil on new built-up areas inland. But it was a bad decision, because it did not lead to a significant improvement in production on nutrient poor mountain soils, but it unnecessarily destroyed naturally valuable territories and damaged the hydrology in spring areas.

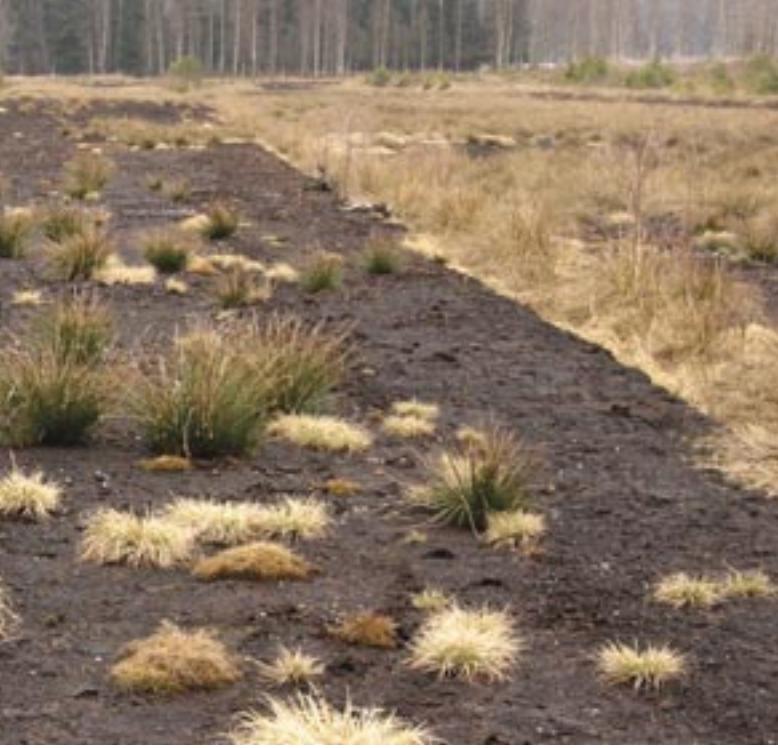
Fig.20: Industrially mined peat bog Vlčí Jámy before restoration, March 2016 (I. Bufková)

In industrial peat mining, peat was most often extracted by milling, where peat bogs were repeatedly milled using a small layer technique. Prior to milling, the peat bogs were first drained by surface and in some places by piped drainage channels (see Vlčí Jámy p. 178). The woody debris was then removed from the surface layer, the layer was milled and subsequently collected by bulky excavators (Horn, 2009). Milling was carried out over large areas and usually the majority of the raised bog was removed in this way. The prescribed layer of residual peat (minimum 60 cm) was not left on any mire industrially mined in the Sumava region. In some parts, the peat was even stripped down to the mineral subsoil. A basic prerequisite for industrial mining was, of course, thorough drainage. This method is the most destructive way of mining and leads to permanent damage or even the disappearance of the raised bog. The potential for spontaneous regeneration is minimal.

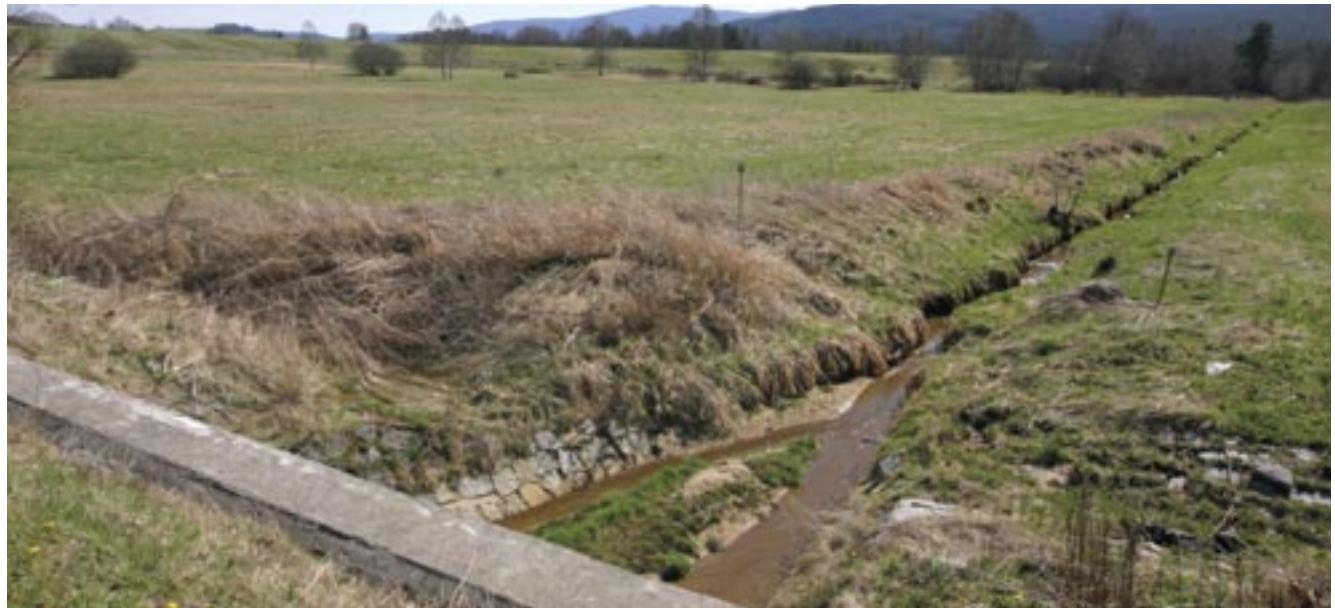
Fig. 23: Straightened and modified Korunáč stream in the Šumava foothills, April 2014 (I. Bufková)

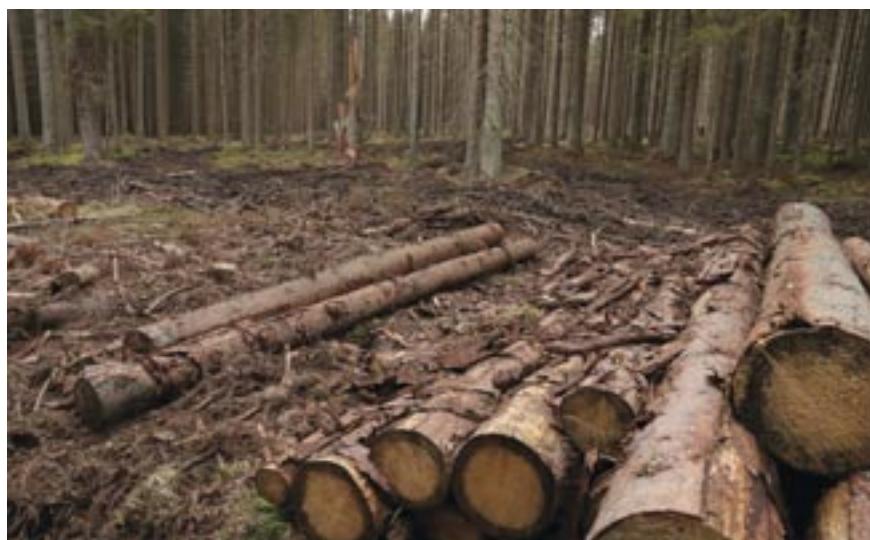
Fig. 24: Soil surface and peat-forming vegetation in a bog forest damaged by heavy machinery, near settlement of Černý Kříž, October 2021 (I. Bufková)

Even today, despite relatively good territorial protection, there is local damage to forest wetlands and mires (especially springs, spruce mires and waterlogged spruce forests) by too intensive forestry interventions. This is mainly due to the use of too heavy machinery (harvesters) and inappropriate technologies in the asanation of windbreaks, trees infested with bark beetle, educational interventions and deliberate logging, including timber transport from the site (Fig. 24).

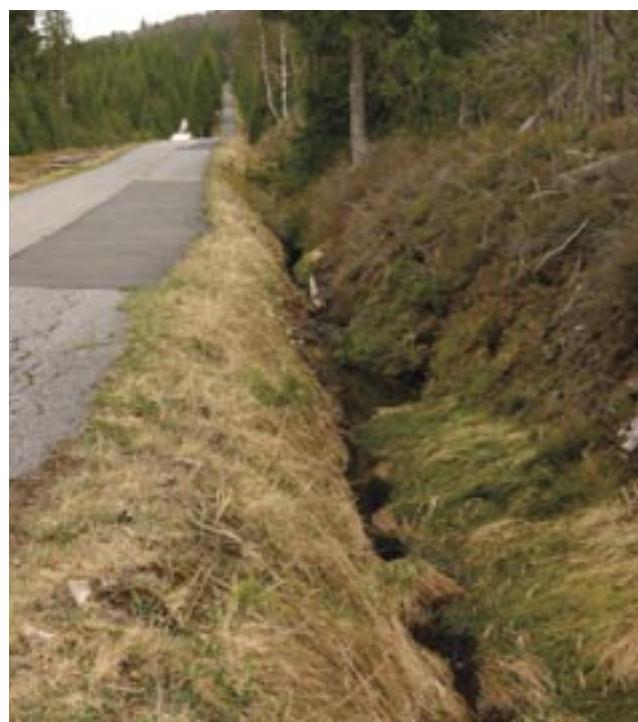
Fig. 26: Drainage of forest roads represents a big load for wetlands and mires, forest road in the area of Modravské slatě, April 2018 (I. Bufková)

Roads are a fairly inconspicuous but significant intervention in the water regime. And they can affect relatively large wetland areas in their vicinity. Drainage ditches are being built along the roads to protect the roadbed from water damage, but also to effectively speed up water runoff from the landscape and limit its infiltration into the soil profile

(Fig. 26). In particular, roads crossing wetlands tend to be associated with deep linear drainage along the road body, which also drains the surrounding wetlands and destabilises the water regime. The road network thus acts in conjunction with the surface drainage of the sites. The more sloping the terrain the stronger the effect.

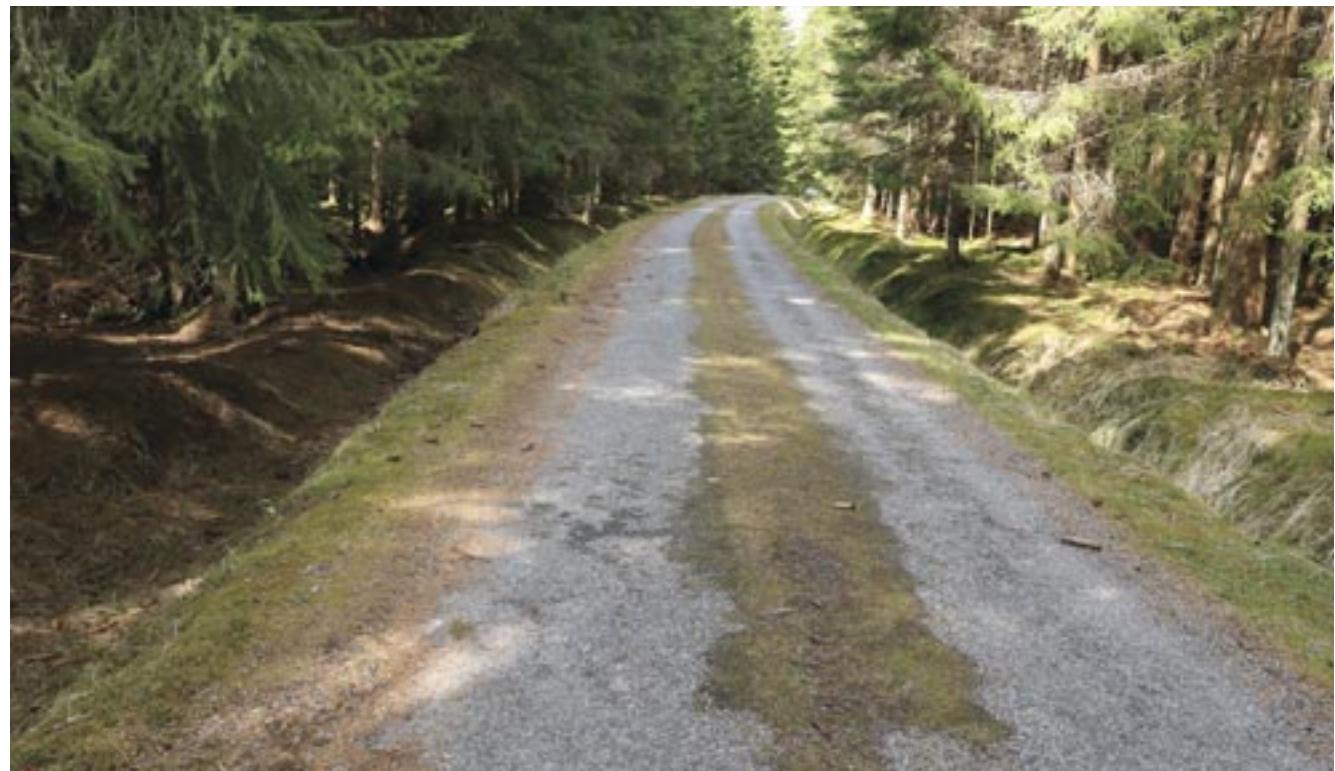
Fig. 27: A paved forest road with deep ditches crosses forest wetlands at the Devítky site in Stožecko, May 2021 (I. Bufková)

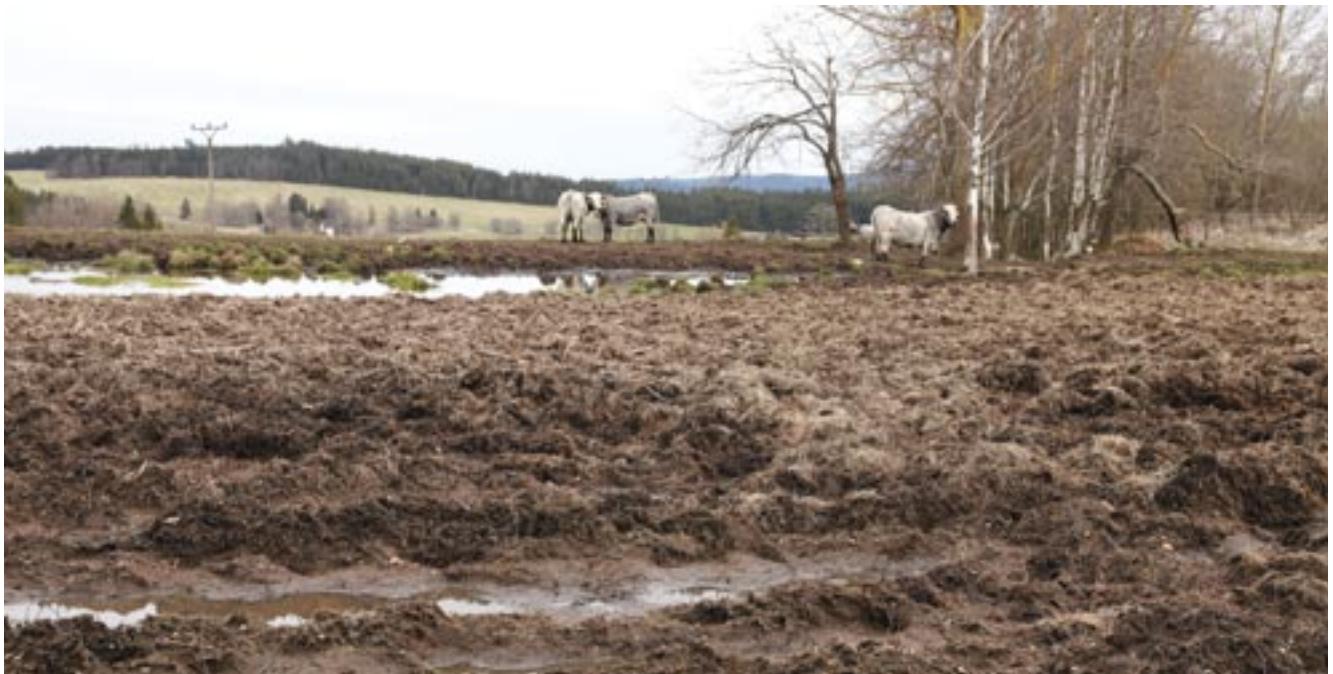
Fig. 28: Cattle wintering grounds on waterlogged areas in the vicinity of Nové Hutě settlement, April 2024 (I. Bufková)

Nowadays, on the other hand, the main problem is represented by large intensively grazed areas, which often operate all year round and include large proportion of wetlands (Fig. 28, 29). Point sources of eutrophication such as inappropriately located wintering sites for cattle, manure dumps or the unsuitable location of some farms cause significant problems as well.

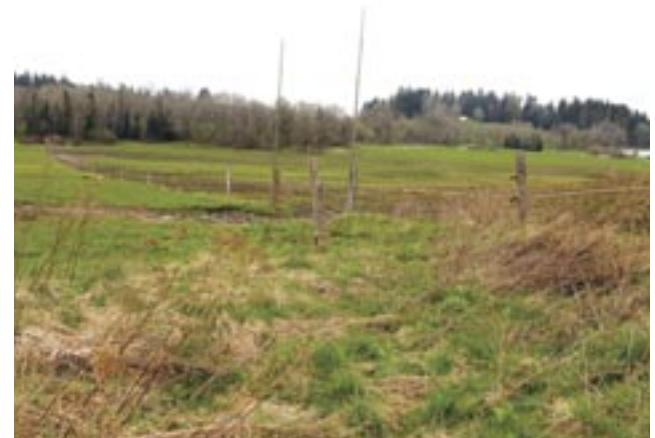
Fig. 29: Too intensive grazing in drained wetlands, Zadní Zvonková settlement near Přední Výtoň, May 2023 (I. Bufková)

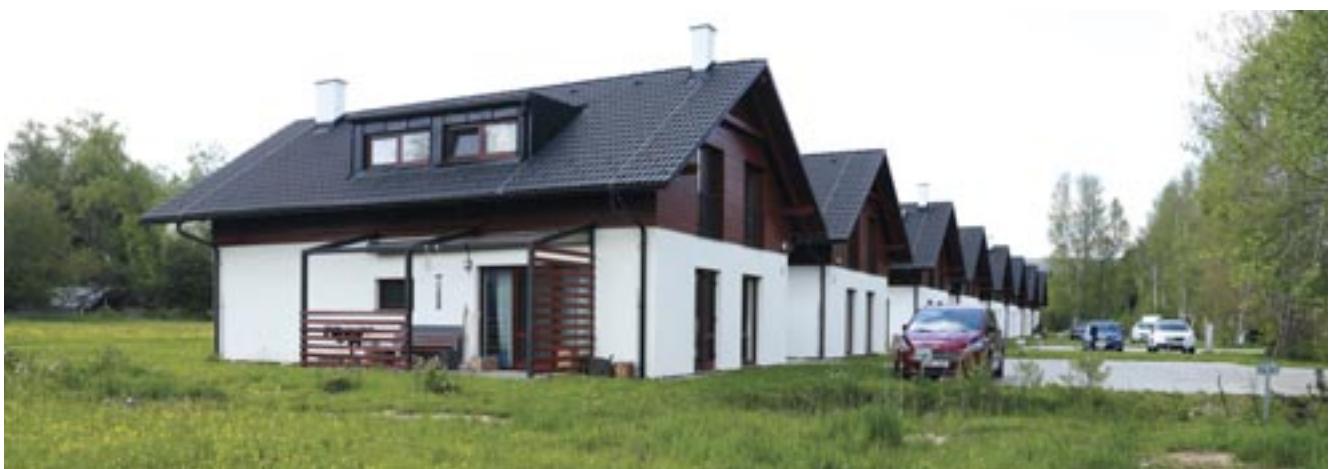
Fig. 30: New buildings on wet alluvial meadows near village of Nová Pec, May 2024 (I. Bufková)

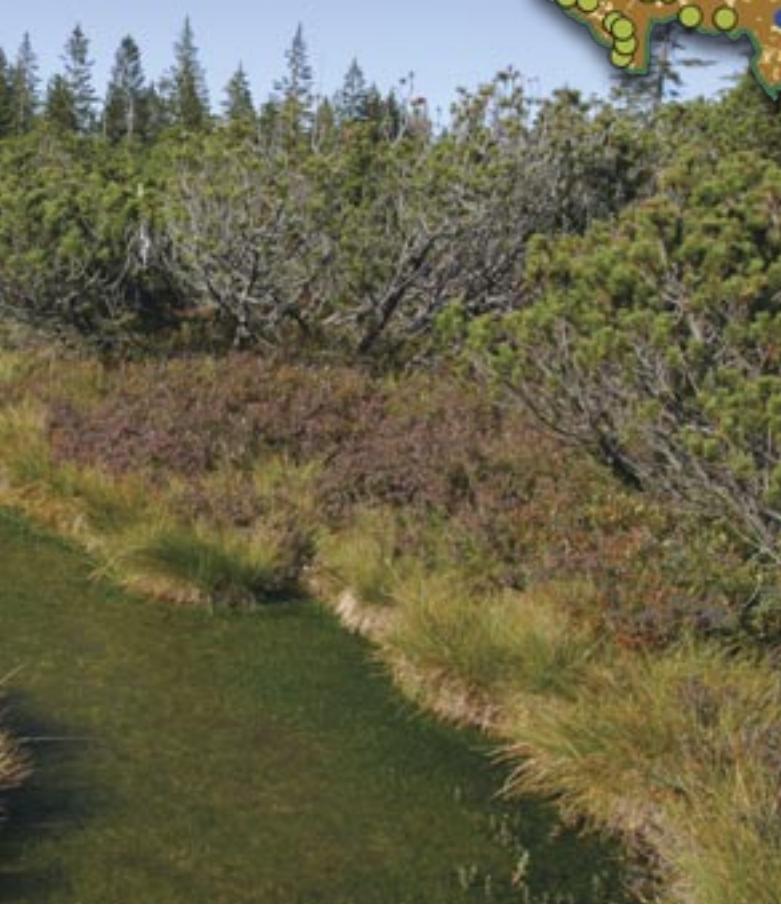
Fig. 32: The first restored site Kamerální slat' peat bog 13 years after implementation, September 2012 (I. Bufková)

The first site where the drainage channels were officially removed was the Kamerální slatě bog in 1999 (Fig. 32). This pilot project initiated the first phase of restoration, which took place between 1999 and 2008. During this period, restoration of drained mires was mainly carried out. Restoration measures were part of the forestry management and were implemented in cooperation with the forest administrations of the Šumava National Park. The distinct projects were financed from the national park budget earmarked for forestry activities.

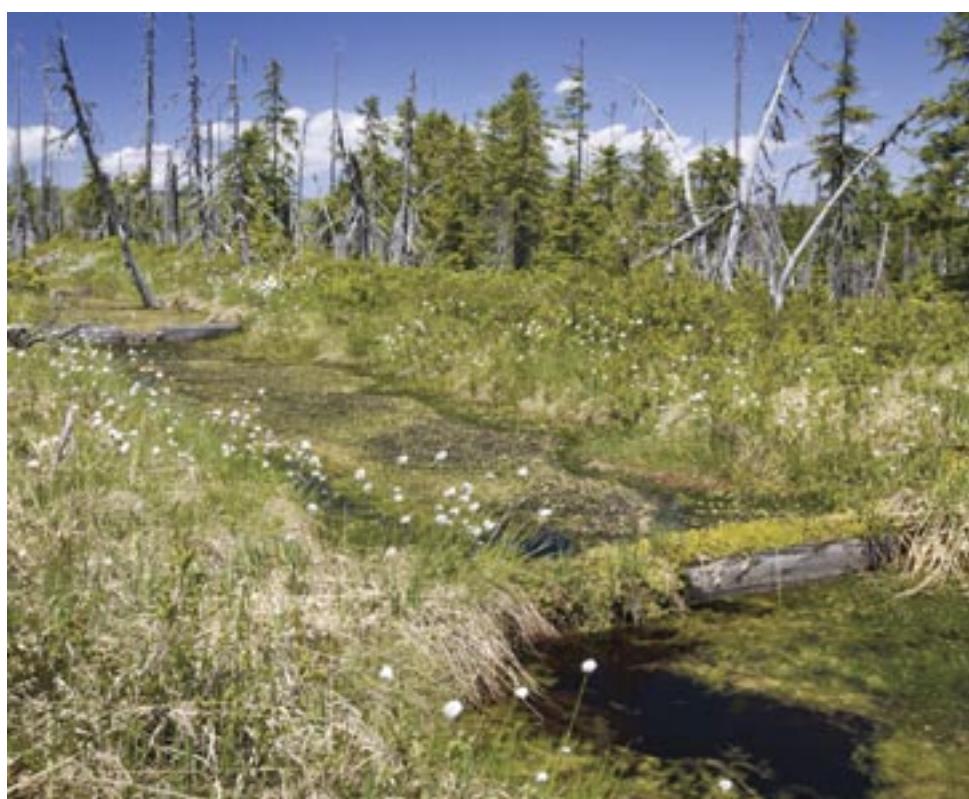
Fig. 34: The first stage of hydrological restoration in Šumava was mainly focused on the removal of drainage ditches in valuable peatland habitats. The picture shows the Schachtenfilz peat bog 14 years after restoration, May 2022 (P. Semerád)

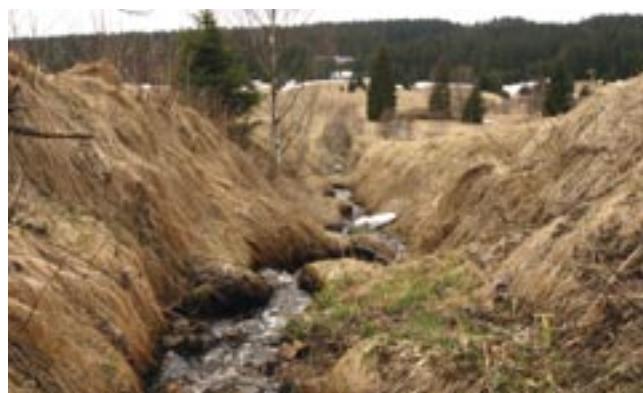
Fig. 38: A straightened small stream below Hadí vrch hill, deeply incised due to gully erosion, April 2012 (I. Bufková)

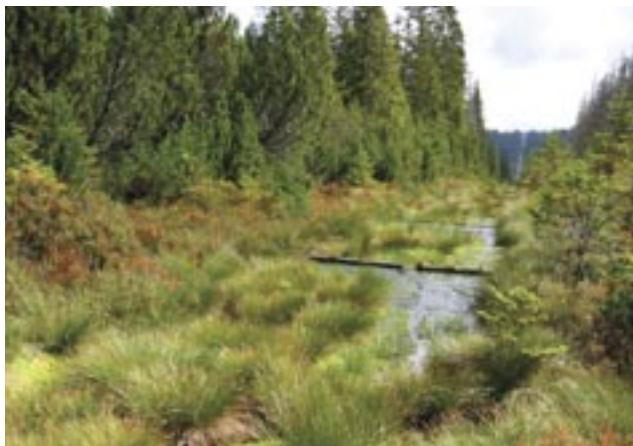
Fig. 39: The blocking of drainage ditches on slopes must be perfect, otherwise the flow of water will easily return up into them. A view of the dammed and infilled drainage channel 10 years after restoration, which is already almost disappearing under the carpet of bog mosses (*Sphagnum*) and hare's-tail cottongrass (*Eriophorum vaginatum*), September 2014 (I. Bufková)

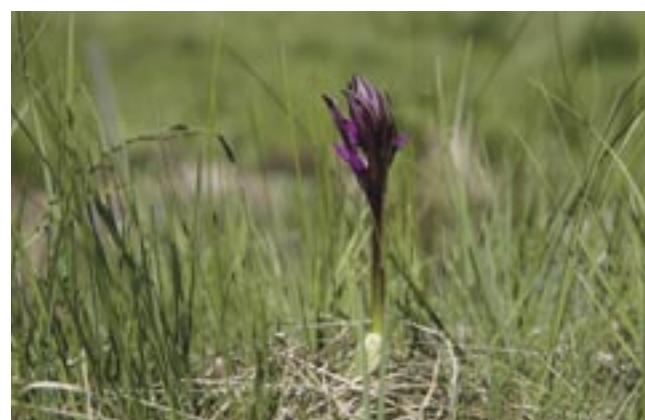
Fig. 40: The removal of the ditch withdrawing water from a valuable transitional mire with the occurrence of rare subspecies of endangered orchid *Dactylorhiza majalis* sp. *turcosa*, common butterwort (*Pinguicula vulgaris*) and common lousewort (*Pedicularis sylvatica*) on the site Rybární I adjacent to the village of Modrava, had to be done very carefully, June 2022 (I. Bufková)

In the diverse landscape mosaic of preserved and destroyed parts of the landscape, restoration measures must be carried out very gently in the field, taking into account the existing natural values (Fig. 40). During the restoration, we simply cannot destroy the last islands of preserved nature left in the landscape. This results in a set of limitations that must be taken into account.

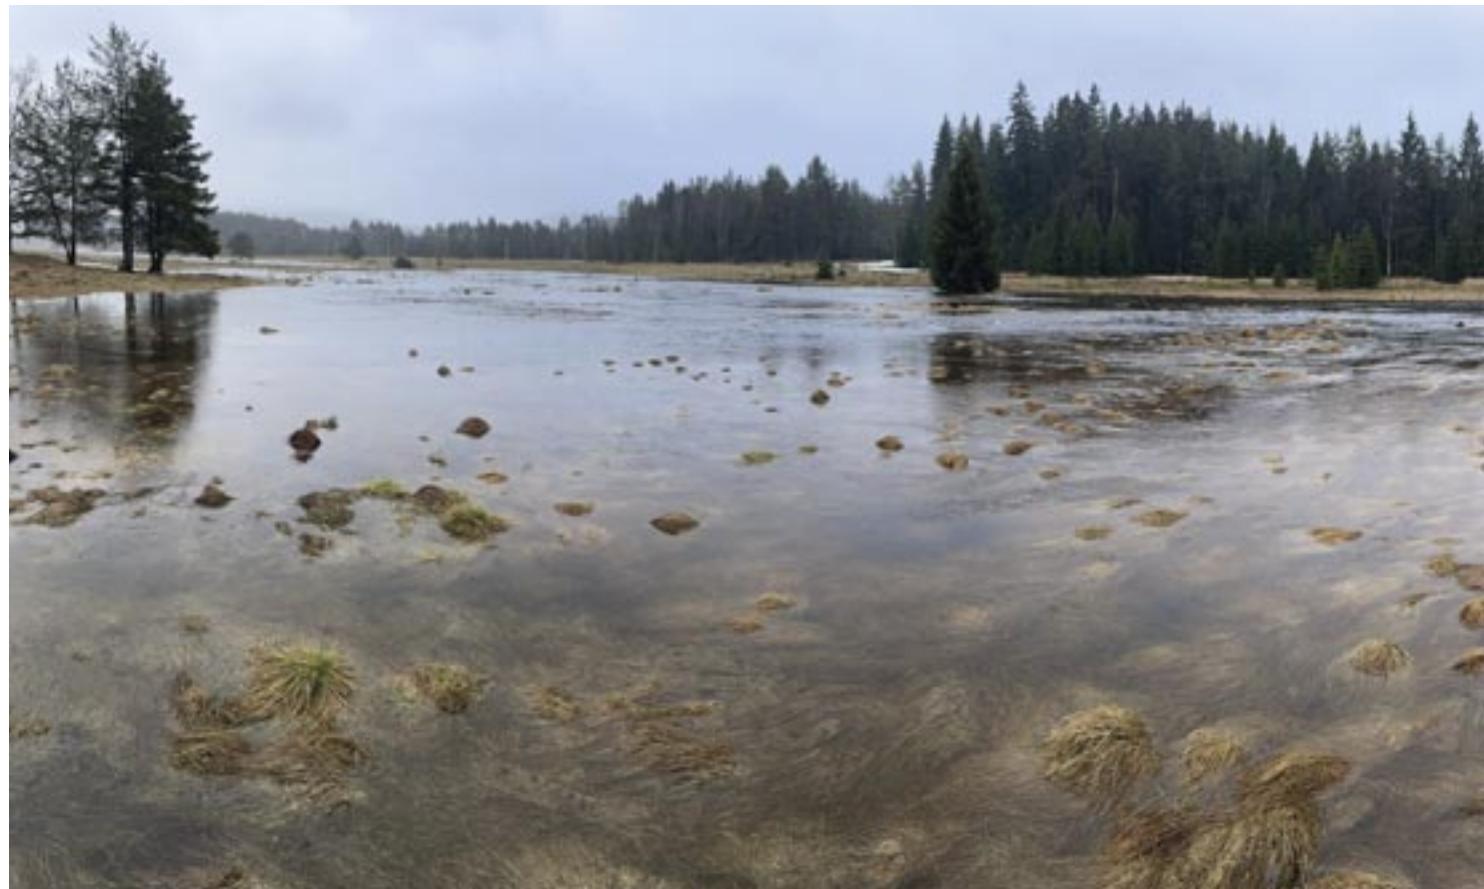
Fig. 42: Water spilling into the stream floodplain in the vicinity of the restored section of the Častá stream at the Stráženská slat site during high flows in January 2024 (L. Linhart)

Re-established connectivity between important features such as wetlands, springs and watercourses is one of the important sub-objectives of most projects. It is closely related to the holistic approach to implemented restorations (see the concept of micro-catchments p. 45). Thanks to this, the restoration of streams and their floodplains, springs and adjacent wetlands is usually solved within the framework of a joint project (Fig. 42).

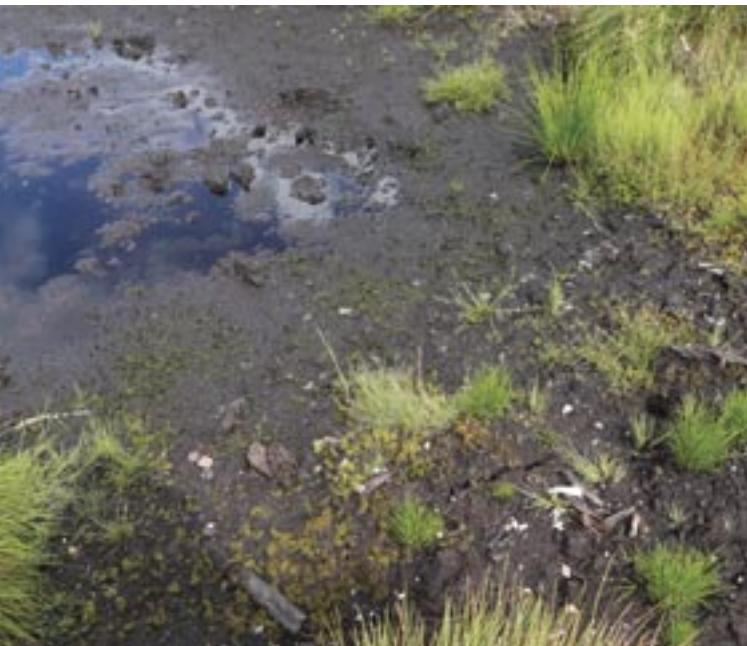
Fig. 44: New establishing peat-forming vegetation with a significant representation of species typical for minerotrophic mires (*Sphagnum flexuosum* or *Carex canescens*) at the Vlčí Jámy site, July 2023 (I. Buřková)

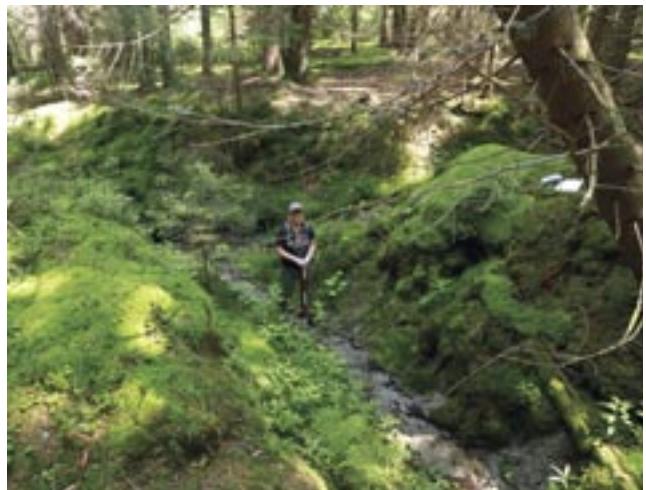
Fig 43: A straightened stream and deep drainage channels cross bog spruce forests in the Najmanka Nature Reserve in Šumava. Sunk of the water table and stream erosion on the slope are so strong that a spontaneous return to the natural state is virtually impossible. Restoration of the water regime is necessary in such cases. The picture shows the situation in June 2024 (I. Buřková)

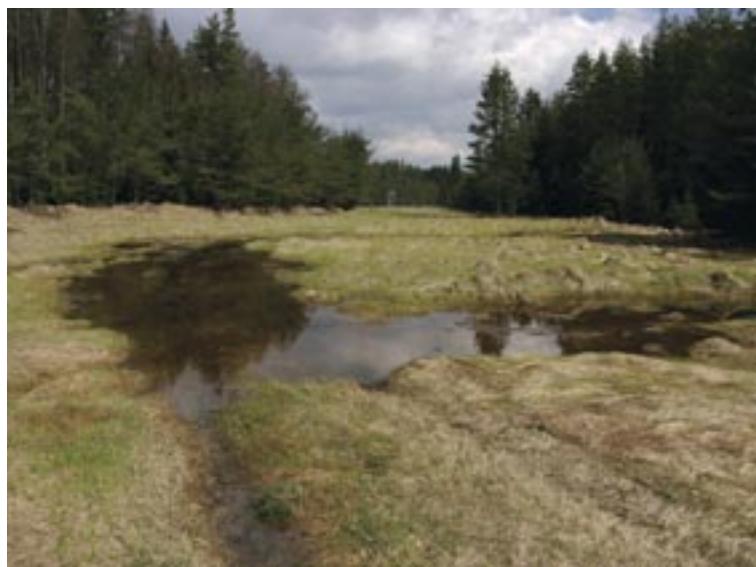
Fig. 49: High water levels during the spring thaw often reveal the original natural routes of water courses. The original riverbed of Hučina stream during the spring flood in April 2006 (I. Bufková)

It is very useful to carry out part of the field surveys in the spring during higher water levels, as water often remembers its paths (Fig. 49). Thanks to this, some segments of the original watercourse beds as well as parts of former surface runoff routes including their possible recent barriers are easily identifiable.

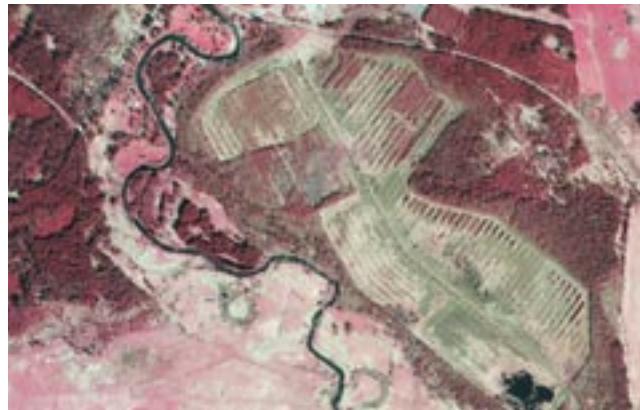
Fig. 52: Aerial images taken in the infrared spectrum were a useful in tracing the routes of drainage channels and original stream beds before the introduction of lidar images.

- Aerial orthophotos in different time periods, including black-and-white archival images from the 1950s (former Military Institute in Dobruška, now available web portals); images in the infrared spectrum are also of great informative value (Fig. 52).

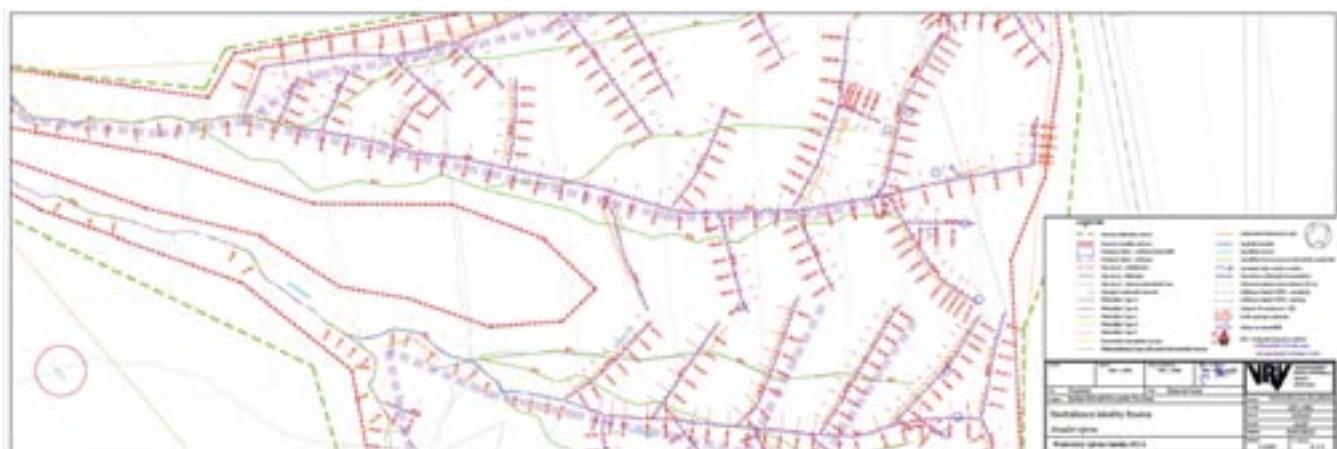
Fig. 53: Example of a detailed map demonstrating the proposed measures, including the number of installed dams along drainage channels, restored stream beds and access roads for excavator, project site of Rovina, June 2019 (VRV a. s. Prague)

All access and transport routes for machinery must be very thoughtfully determined with regard to site-specific conditions and must always be clearly specified in the project documentation, including map drawings of the routes (Fig. 53). The routes for the machinery must consider not only the bearing capacity of the terrain, but also the presence of valuable species and communities or other natural values on the site that could be damaged by the machinery.

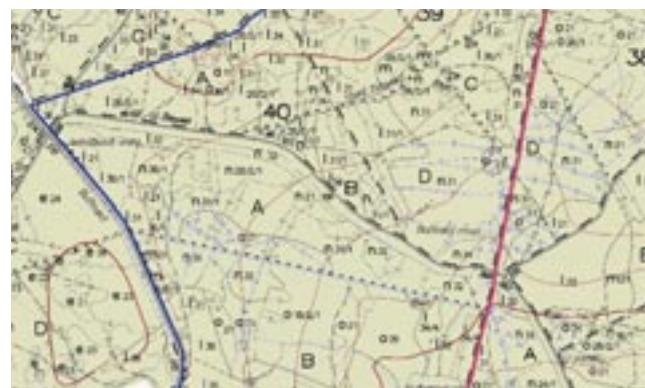
Fig. 51: Forest maps are among an important source of information.

- Former VÚMOP plans and documentation for water structures and peat deposits intended for mining
- Detailed forest vegetation maps
- Cadastral and historical maps (Fig. 51)
