Hydrological restoration

**Summary of experience
with restoration of wetlands,
springs and streams in the Šumava region**

Project "LIFE for MIRES"

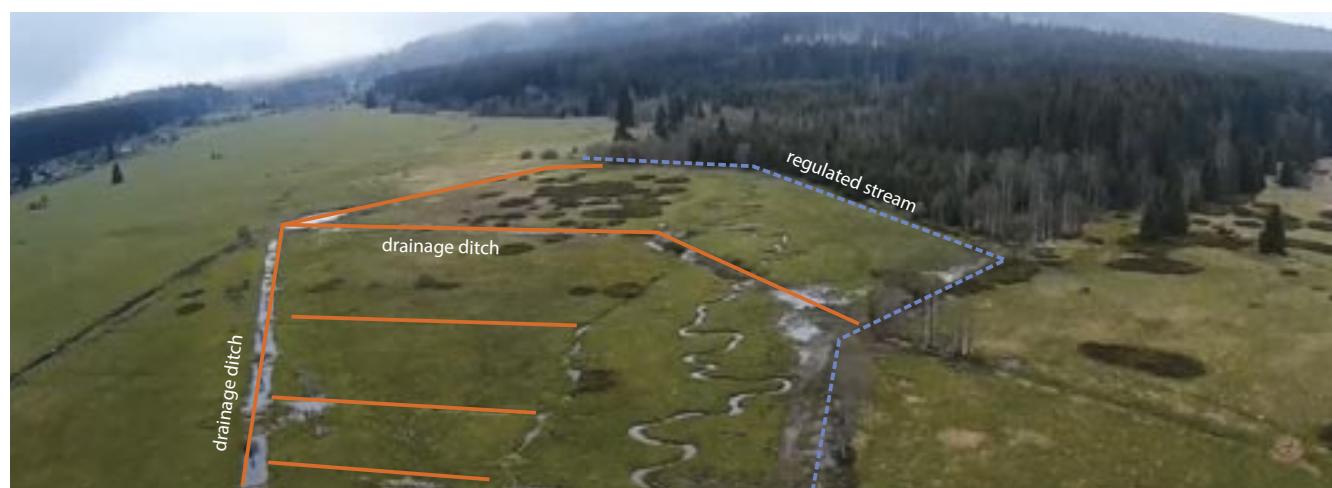
Fig. 56: Example of drainage channels and watercourses in the Žlebský brook catchment from a bird's eye view (Dobrá, 2014)

In upper parts of the catchments is a frequently asked question (Fig. 56). This is because there is often a situation where watercourses are immediately transferred from the spring into a network of surface drainage channels. Capillary flows redirected in this way tend to have very small flow rates and can, especially during higher water levels, be easily confused with the flow collected in classic drainage ditches simply by seepage from the soil profile or by the overflow of surface runoff into the ditch line.

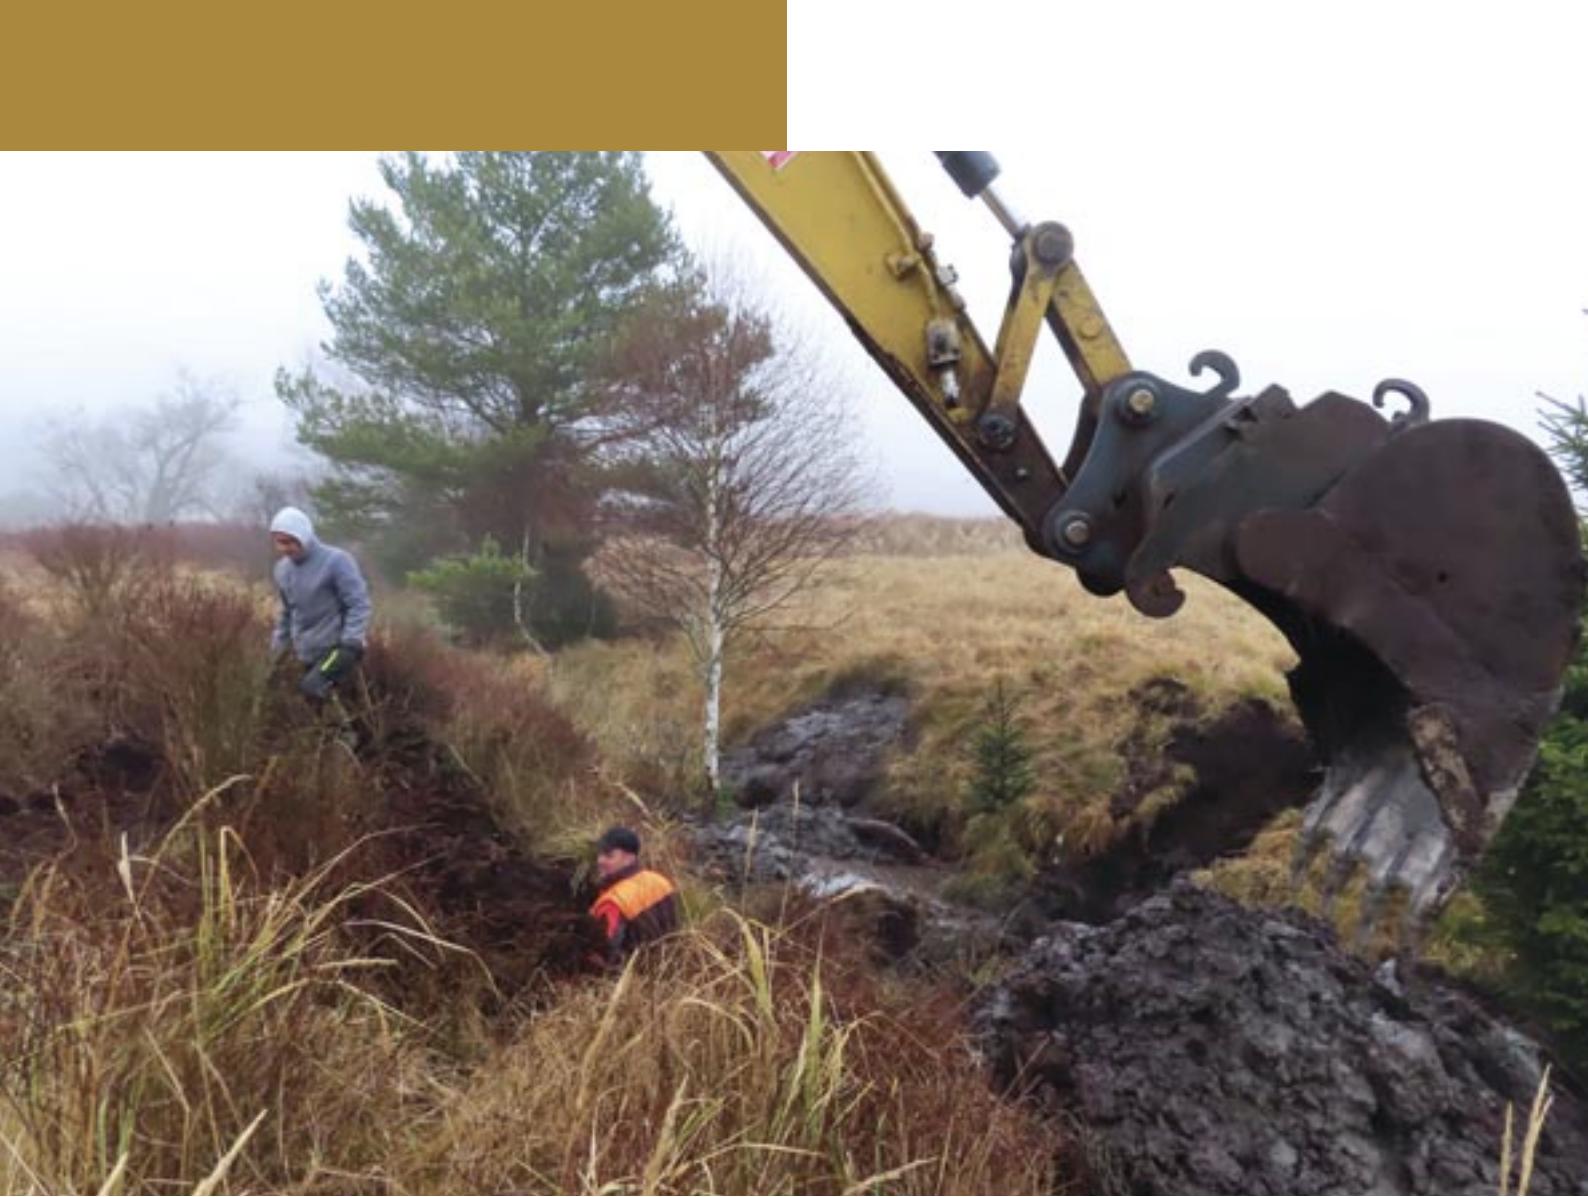
Fig. 57: Work on blocking large drainage channels crossing alluvial wetlands and peatlands at the Dobrovodská luka location, November 2021 (E. Václavíková)

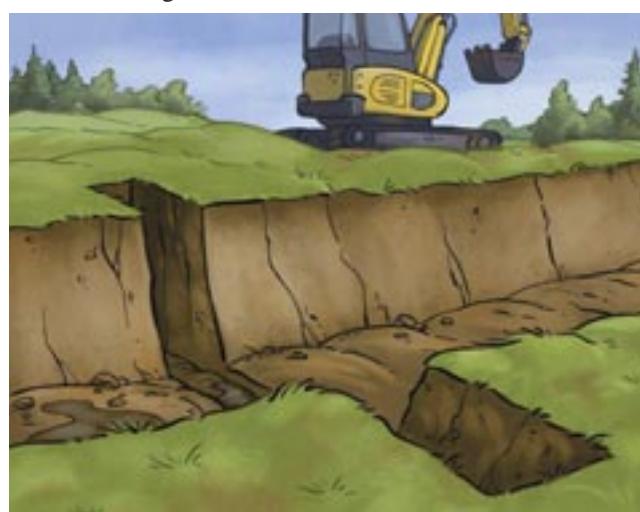
Fig. 58: Excavated cut for instalation of the dam made of plank dam

When installing dams, care must be taken to ensure that they are impermeable and sufficiently overhang the bottom and bank areas of the channel. To anchor the plank dams, sufficiently large notches should be dug in the banks and bottom of the ditch (Fig. 58). The parameters of these overhangs and the method of anchoring are given on page 62. It is advisable to respect them, otherwise there is a risk of erosion and subsequent scouring of the dams on sloping terrain.

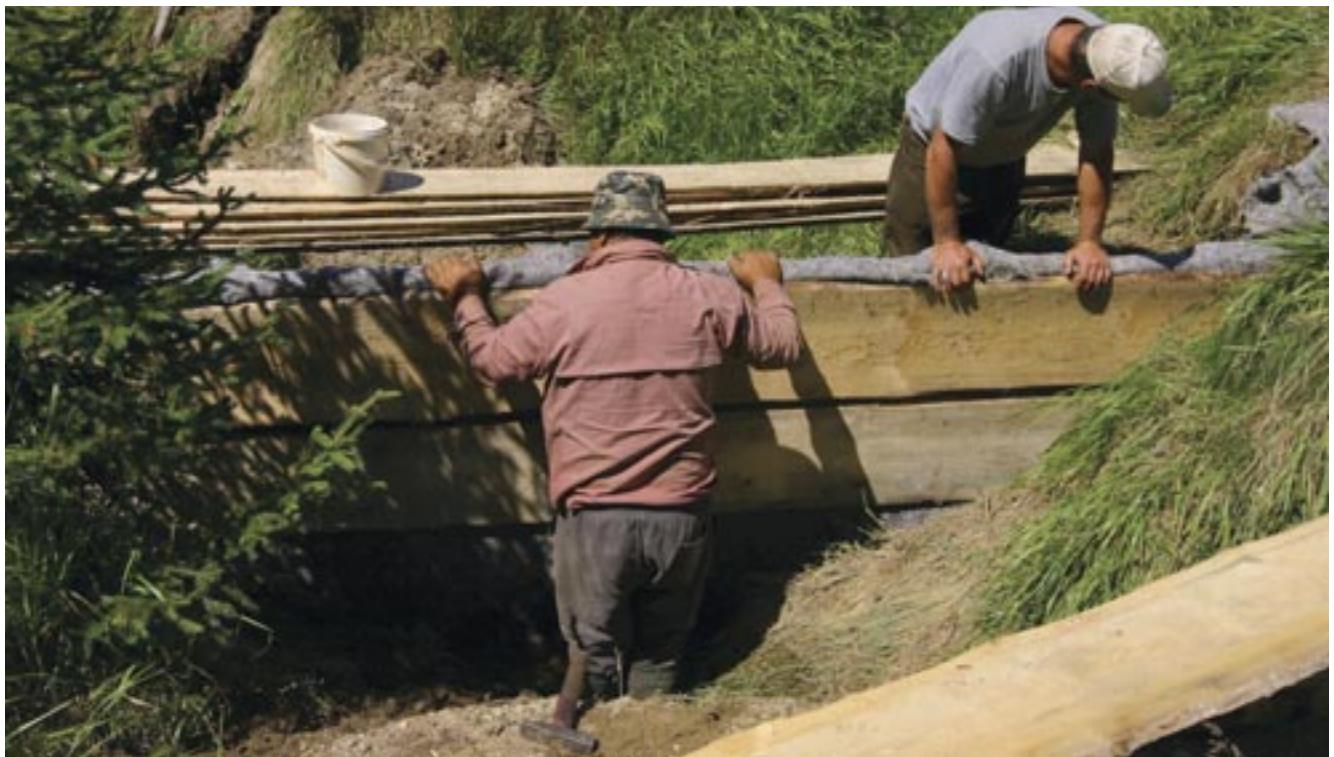
Fig. 60: The construction of a board dam in a prepared cut at the Rybárny – Javorí location, July 2008 (I. Bufková)

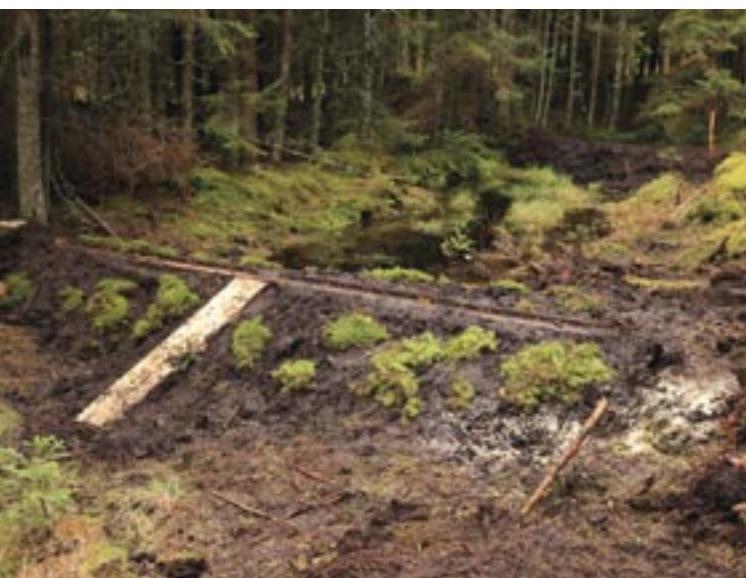
Fig. 61: A well-installed dam with an overflow in case of outflow during high water levels. Proper backfilling on the front air side of the partition and insufficient backfilling on the upper (water) side, Devítká location near village of Stožec, November 2020 (I. Bufková)

Dams made of horizontally installed planks are the most commonly used type in Šumava. They are ideal for blocking channels in non-peat wetlands on sloping terrain. Also on mires bogs wherever the furrows are excavated down to the mineral bedrock or where there is insufficient peat (less than 50 cm) in the channel bed. They are therefore the main type of transverse channel blockage on minerotrophic mires such as spruce mires (Fig. 61) and fens .

The width of the backfill should be at least 1 m on both sides of the dam (in the crown) (Fig. 61). In ditches with a depth of up to 0.8 m and with slight slopes, the backfill can be reduced to a width of approx. 0.5 m in the crown on both sides of the dam; in large channels, on the other hand, it is advisable to increase the width of the backfill to several metres.

It is also desirable to cover the backfill with sods, “plates” or stripes of local vegetation that can be easily obtained from the bottom of drainage channels, from the surface of bank embankments or from the surrounding area (Fig. 61). Areas for sod removal in the vicinity of the channel should be marked in advance and should not encroach on valuable parts of the wetland. The retrieval of removed sod and vegetation for dam backfill and channel fill has its own rules, which are outlined in Chapter 4.1.3. Acquired dry-loving herbaceous vegetation should preferably be placed at the top of the dam and backfill while wet-loving vegetation should be placed more at the bottom and near the channel bed (unless the rest of the channel is completely backfilled with soil). Overlaying the backfill with vegetation significantly increases its stability and thus the durability of the cascade of dams. It also accelerates the overall process of terrestrialisation and the disappearance of the drainage channel line as a preferential water route.

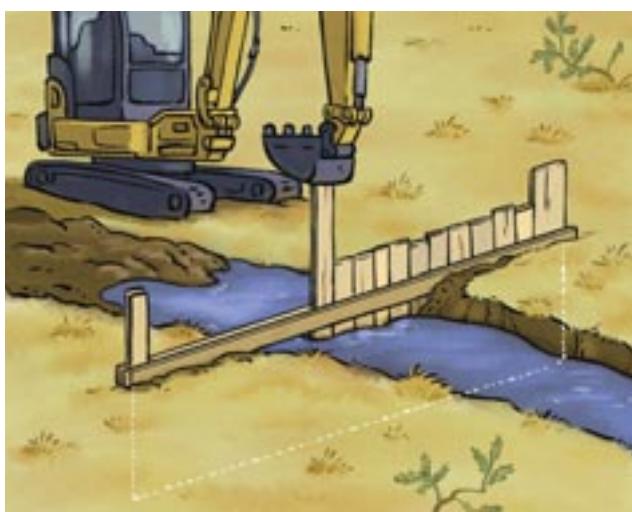
Fig. 63: Installation of a dam from vertical planks with help of technique

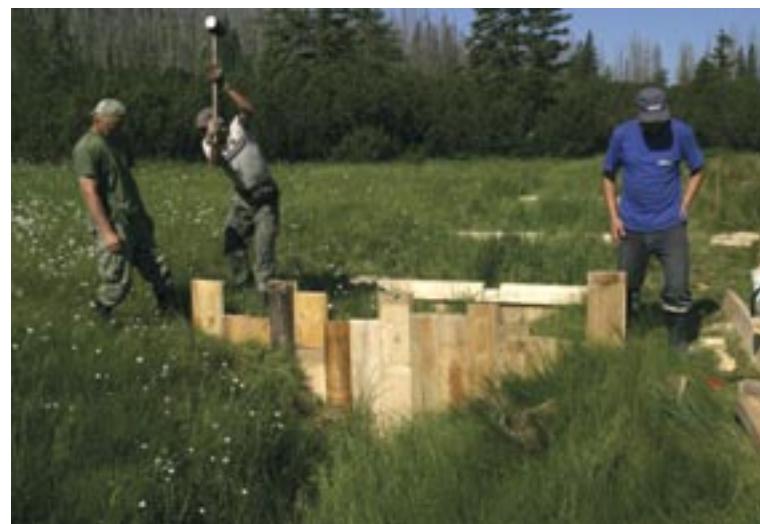
Fig. 62: Manual installation of a dam from vertical planks at the Blatenská slat' location, July 2006 (I. Bufková)

The dams are installed by hammering the individual timbers vertically into the bottom of the furrow (Fig. 62). It is advisable to place the guide timber/plank first, and then hammer the timbers from the centre of the channel towards the banks. It is advisable to use machinery (excavator) when hammering, but it can also be done by hand. The planks are joined together at the same time during the hammering process. Afterwards, the clamps are attached and the planks are cut to the required height from above.

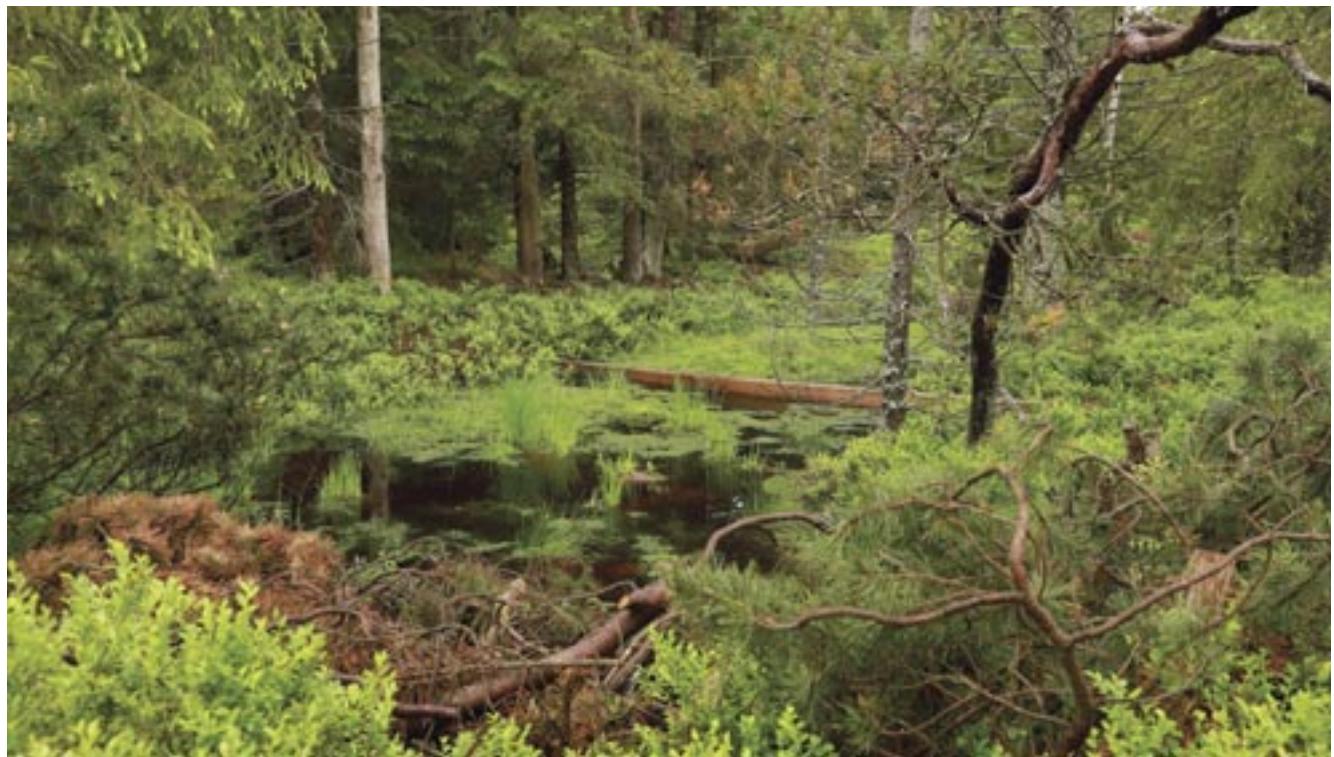
Fig. 64: A properly installed and functioning dam assembled from vertical planks on raised bog in the Multerberg locality, June 2024 (I. Bufková)

of accumulated water from the ditch into the wetland or mire area. Where the topography allows water to overflow away from the channel into the wetland area (on one of the banks or both), the top edge of the dam wall may project above the ground. This is particularly evident if the ditch follows a contour line and the slope is inclined perpendicular to the channel. In this situation, the dam on the lower bank need not be sunken and its edge can be left above ground level – but always assuming that water overflows down the slope away from the ditch. If, however, there is a risk of water outflow just along the lateral wall of the dam projecting above the ground surface, the edge of such a dam must be sunk in the bank (Fig. 64). The height of the dam in such a situation is determined by the lower of the banks.

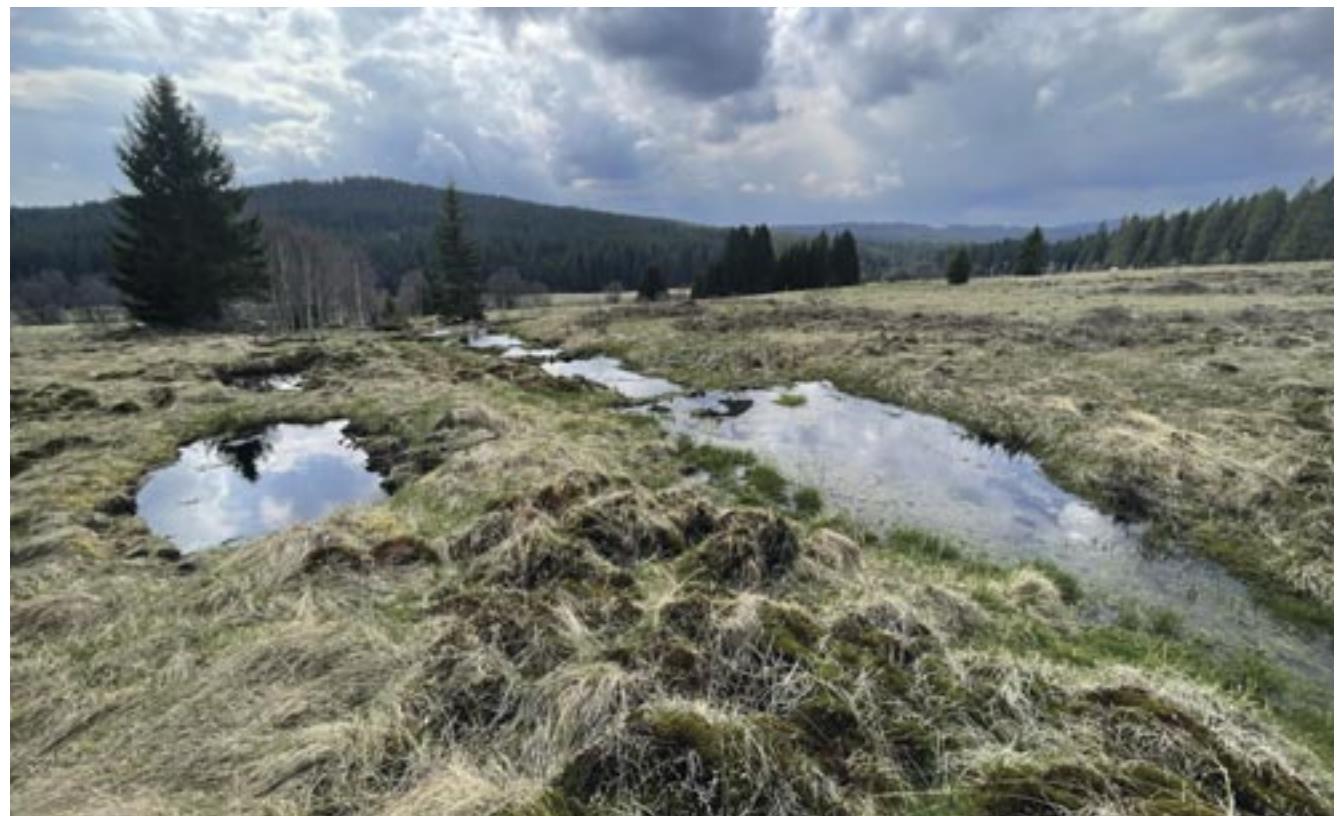
Fig. 66: The created shallow depressions can serve as a suitable source of soil and vegetation for infilling of ditches, U Tremlů location, May 2022 (L. Linhart)

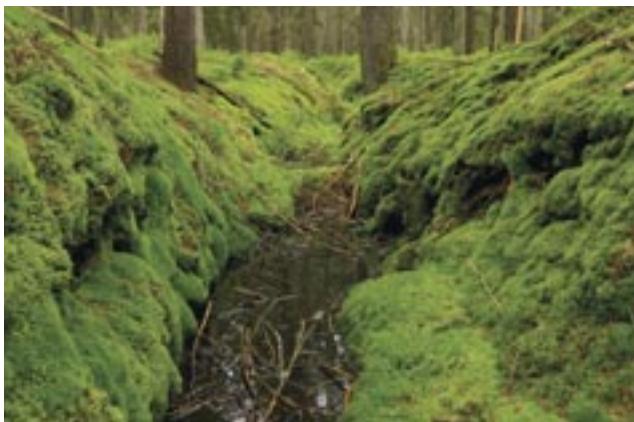
Fig. 67: Wetland and peat vegetation on drained habitats is often concentrated at the bottom of drainage channels, Na Ztraceném, September 2009 (I. Bufková)

Well-functioning drainage channels dry out their surroundings so much that wetland plants gradually disappear from it. However, remnants of wetland vegetation sometimes manage to survive at the bottom of the drainage channels, which is closest to the groundwater and, paradoxically, represents the wettest place in the drained wetland (Fig. 67).

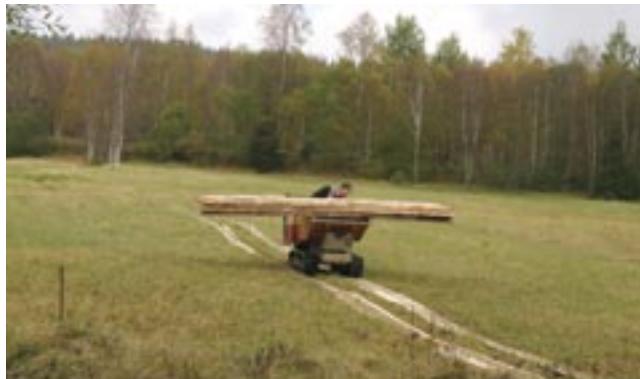
Fig. 69: An example of the use of a light dump truck to transport material on a sensitive surface. The use of planks made it possible to cross the peat meadow several times without signs of damage, Žhůří, I. stage, October 2014 (I. Bufková)

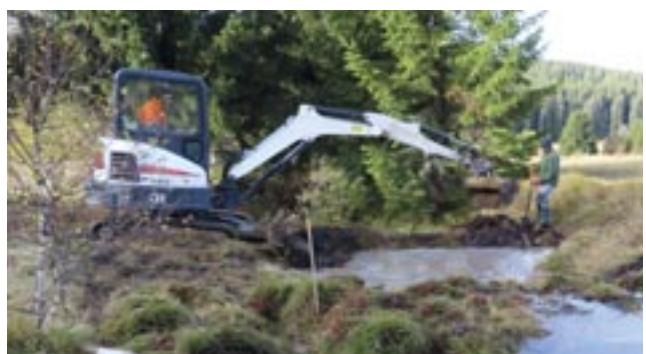
Fig. 70: An example of a light three-ton excavator, U Tremlů, October 2021 (L. Linhart)

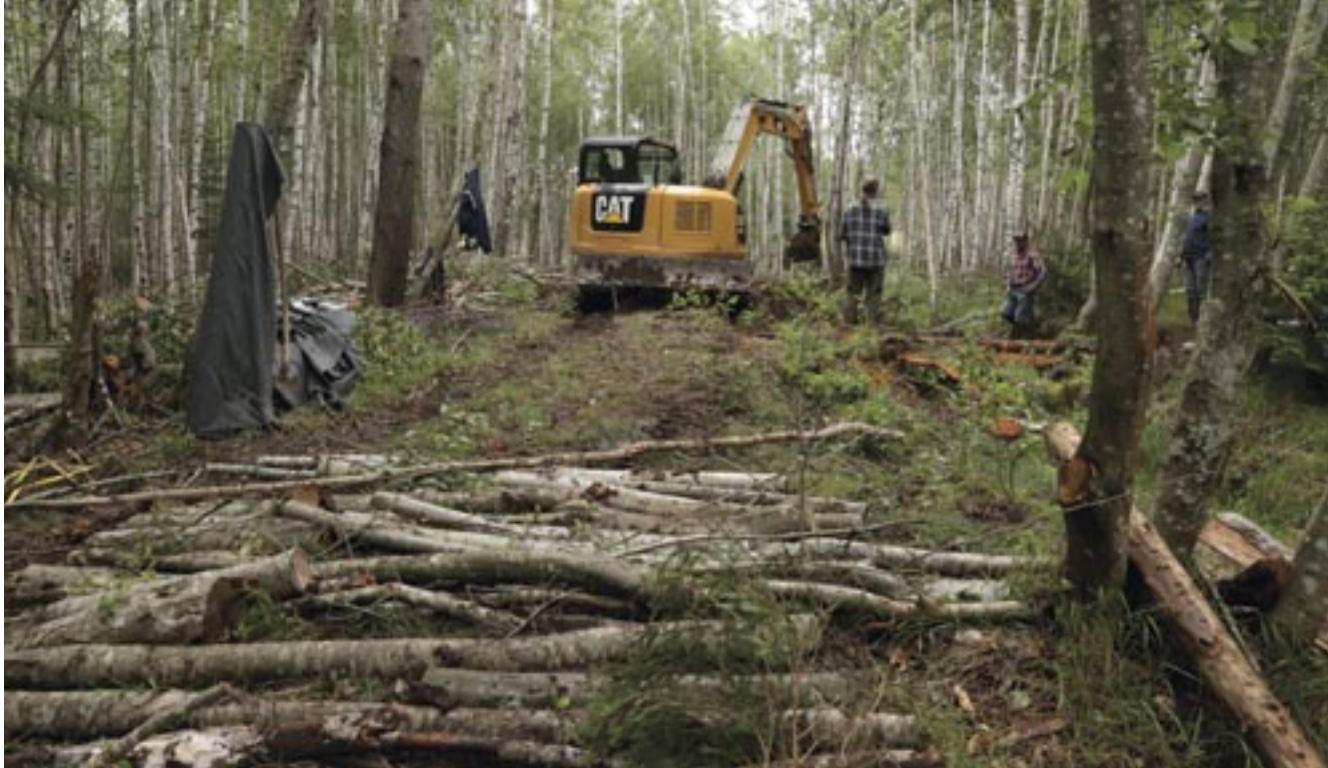
Fig. 71: Use of cut trunks to drive over wet parts with technique, Malý Bor, July 2020 (I. Bufková)

In some inaccessible locations, heavy waterlogging makes it difficult for machinery to reach areas with sufficient surface bearing capacity. In such cases, it is necessary to use pontoon ground boards made of suitable material, which the excavator places in front of itself (Fig. 107). Sometimes a temporary route can be constructed using cross-laid logs of felled trees to cover waterlogged areas with low ground bearing capacity (Fig. 71). Similarly, temporary crossings over drainage channels or small streams can also be constructed.

Another option is the use of cut tree trunks stacked as a temporary wooden walkway and across an unstable muddy section of the route (see Fig. 71). Waterlogged crossings paved only with natural material should be short (no longer than 20 m). Always consider the risk of habitat damage as a priority and implement necessary restoration measures manually where unavoidable.

The machinery can be used mainly in dry or slightly wet parts of the site. Possible short crossings over wetter sections (in the order of meters) must be solved by pontoon boards (Fig. 158) or a temporary wooden walkway using the material from the prunings (Fig. 71) in agreement with the investor or designer. Machines can also usually only move in one direction, as frequent back and forth and changes of direction lead to disproportionate damage to the site (for more details see p. 64).

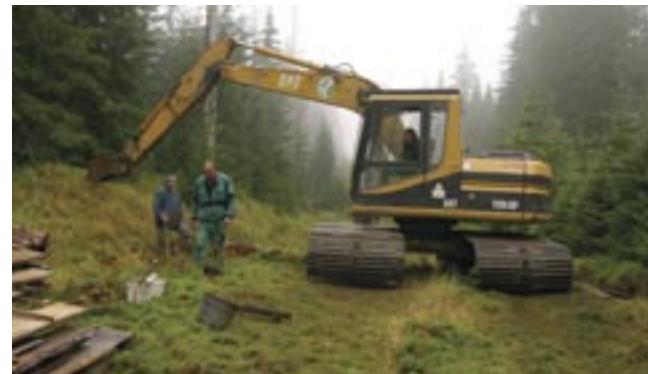
Fig. 72: Mud excavator with wide belts during the blocking of huge erosion grooves in the Černohorský močál mire, September 2014 (I. Bufková)

When building wooden dams, it is advisable to use lighter crawler machinery (excavators, dumpers) weighing up to 3-5 t depending on the bearing capacity of the terrain. The width of the tracks should be at least 35 cm, the wider the better (Fig. 72). It is highly desirable to use the machinery wherever the bearing capacity of the terrain and the vulnerability of the habitat allow it. Of course, sensitively, with great care and particularly in dry periods. However, blocking channels using the machinery is more perfect, more stable and more durable. This is not only due to the possibility of working with larger volumes of soil for the backfilling of the dams and the filling of the channels, but also due to the more thorough anchoring of the dams and the compaction of the backfills, which are better able to resist erosion in the future. Some restoration measures, such as the restoration of old stream routes and beds, or the resurfacing of mined peat bogs, cannot be carried out without machinery.

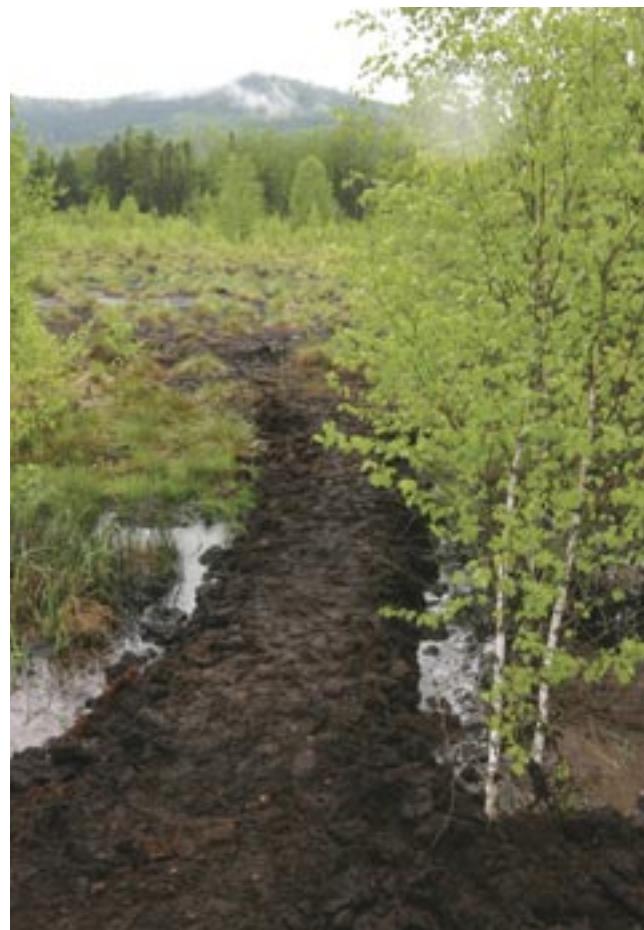
Fig. 73: The gravity dam created from compacted peat on Soumarský Most bog, June 2012 (I. Bufková)

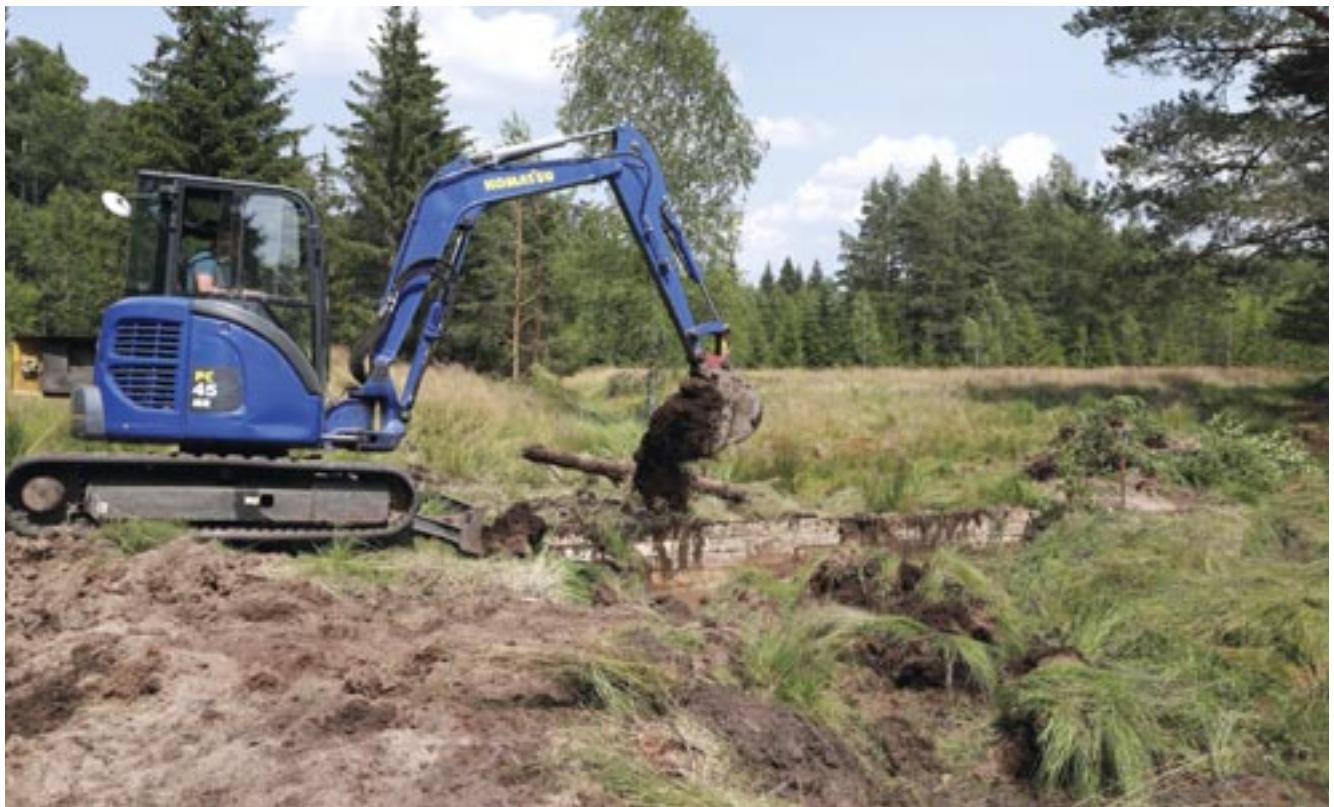
Fig. 74: Backfilling of dams with soil from bank mounds in the Raškov locality. The soil for backfilling should have a good consistency and adhesion. Clays are especially suitable, but also peat or moist loamy soil with only a small admixture of sandy fraction and stones (I. Bufkova)

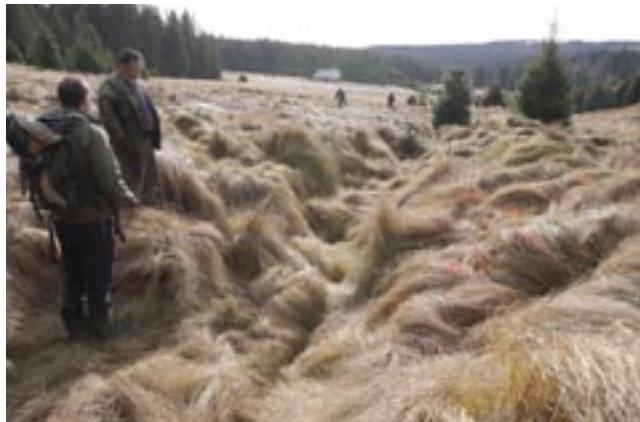
Fig. 75: Well-preserved and bulk embankments along the drainage channels are a welcome source of material for infilling the channels, Pod Skelnou location, April 2016 (I. Bufková)

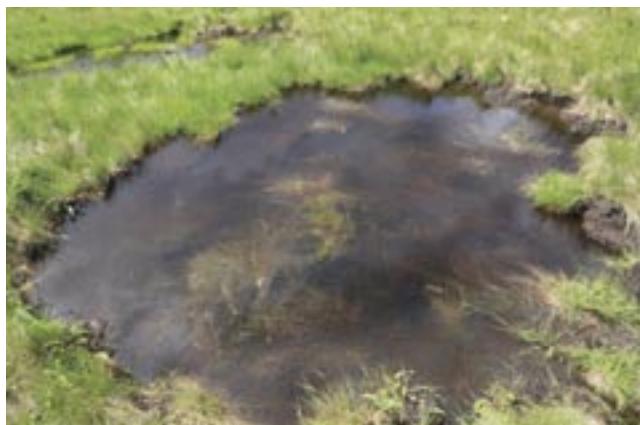
Fig. 76: An example of a shallow depression excavated in order to obtain soil for filling channels, Rybáry I, June 2022 (I. Bufková)

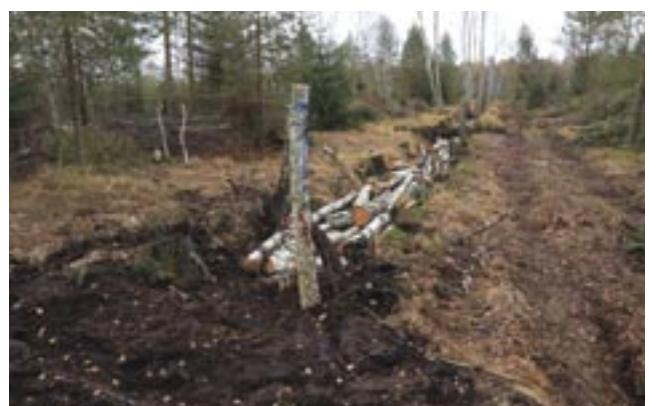
Fig. 77: Filling the space between dams in the blocked drainage channel using logs from prunings, Borková bog, October 2022 (I. Bufková)

Birch trunks are very suitable, they decompose very quickly and are easily joined with other material into one organic mass (Fig. 77).

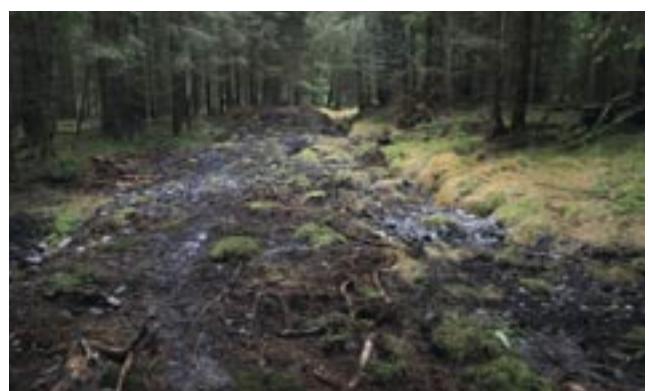
Fig. 78: Drainage channel blocked by a cascade of wooden dams and completely filled with soil, Devítky site, November 2020 (I. Bufková)

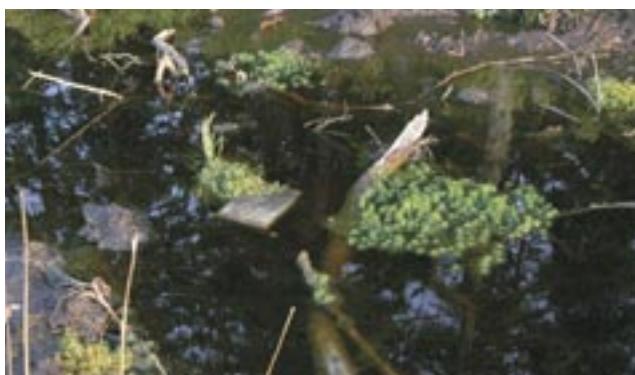
Fig. 80: Clumps of sphagnum put into the shallow water bodies between the dams, always near the banks or a support made of branches, Černohorský močál, August 2010 (I. Bufková)

It has been a successful method to insert clumps of bog mosses about 20 cm in size to the places where they will be in contact with either the banks of the ditch or with pieces of wood projecting towards or floating on the water surface. Bog mosses grow better if they have support. Approximately 5-8 clumps can be used per 10 m² of water surface. If the conditions are right, they can increase their biomass up to threefold in one growing season.

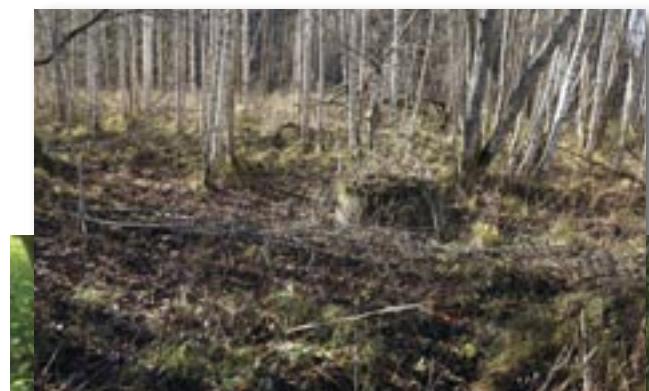
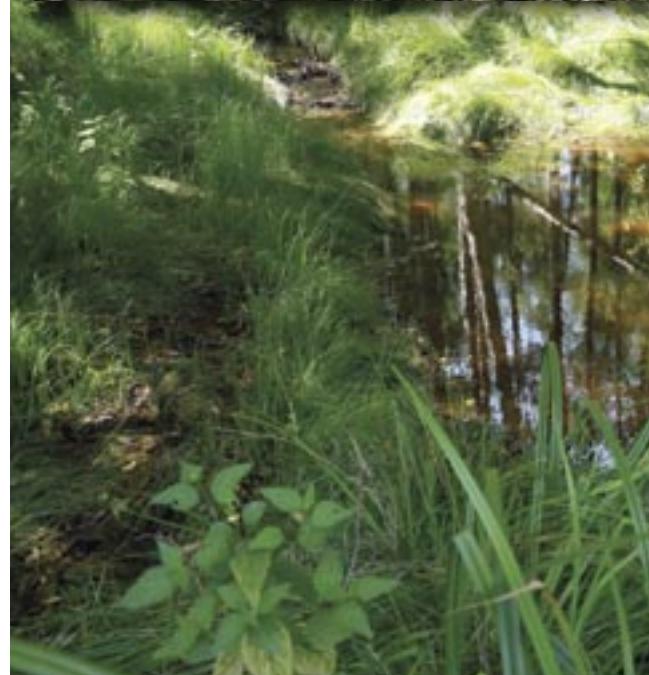
Fig. 81: After removing the concrete ring from the piped drainage, a very natural-looking pool with a varied composition of plant and animal species can be created. The picture shows a stream flowing from upstream section and then through the pool. The stream was also released from underground pipes to the surface. The Dobrovodské louky location, in the third year after restoration, July 2024. In the upper left corner, you can see the same place just before restoration in November 2021 (I. Bufková)

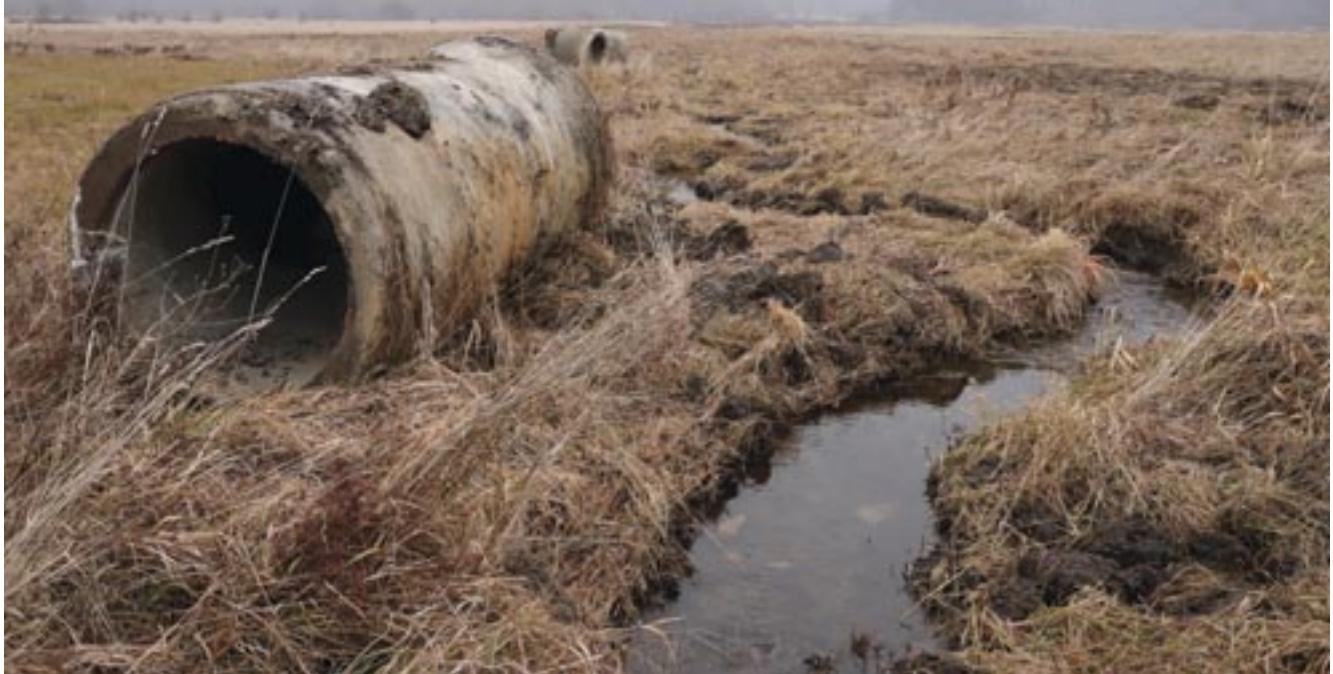
Fig. 82: Removal of concrete pipes forming the main drainage facility (HOZ) and restoration of the natural small stream at the Dobrovodské louky locality, immediately after restoration, November 2021 (I. Bufková)

mentioned methods is well feasible on agricultural and other treeless land. By opening and removing the main drainage pipe (HOZ), its flow will usually return to the surface and a small water flow can be restored with appropriate measures. The main principles and various methods of restoration of small watercourses are described in detail in the AOPK methodologies (Just et al., 2021). The technologies that have been proven on the sloping terrains of Šumava are also described in Chapter 5 of this book.

The entire area including the Vltavský luh floodplain and the once waterlogged foothills of the adjacent slopes were drained drastically in the past. Historical drainage systems (including pre-war piped drainage systems) are intertwined with modern reclamation carried out in the 1980s. The slopes above the floodplain were intensively drained by piped drainage and all four unnamed right bank tributaries were directed into massive concrete pipes 0.8 m in diameter (Fig. 82).

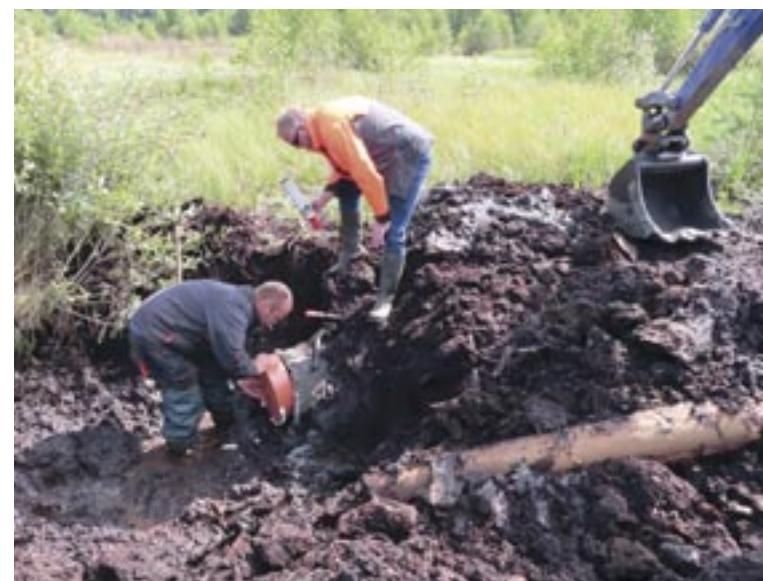
Fig. 83: Blinding of the remaining pipe segments with suitable plastic ends of the corresponding diameter on the mined Vlčí Jámy bog, August 2021 (E. Václavíková)

These require excavation down to the level of the drainage and removal of sections of pipe at least 2-3 m in length. The distance between the broken sections should be approx. 5-10 m, more in flat terrain. At the point of break, it is advisable to blind both ends of the remaining drainage pipes. A wooden "plug" can be used to block the inlet and outlet sections, which will be insulated with an impermeable material such as clay and backfilled with soil or peat. The excavated section must be backfilled with peat, preferably with compaction. On sloping terrain, a wooden dams may be installed closely to both open ends of pipes and backfilled into the excavated section with sufficient overhang to the sides and bottom to prevent bypass of the clogged drainage below the surface. This measure is most suitable for use on industrially mined peat bogs.

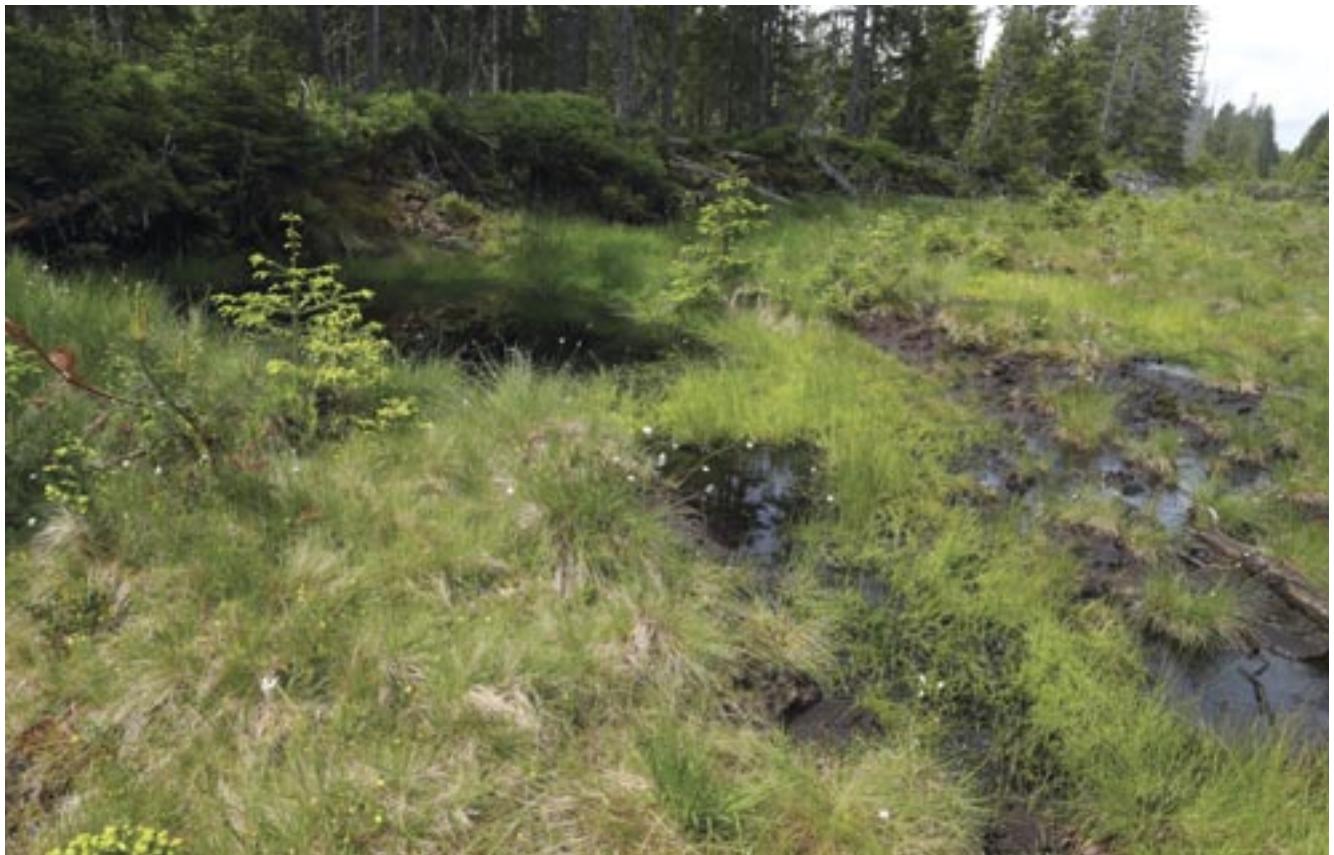
Fig. 85: The overlap from the blocked canal at the Černohorský močál II location looks very natural after 10 years and is well functioning, June 2024 (I. Bufková)

When blocking channels, it is advisable to consider the transfer of excess water from the ditch to suitable parts of the wetland while respecting the original outflow directions and routes. Various kinds of shallow overlaps and their prolonging to the sides are effective (Fig. 85).

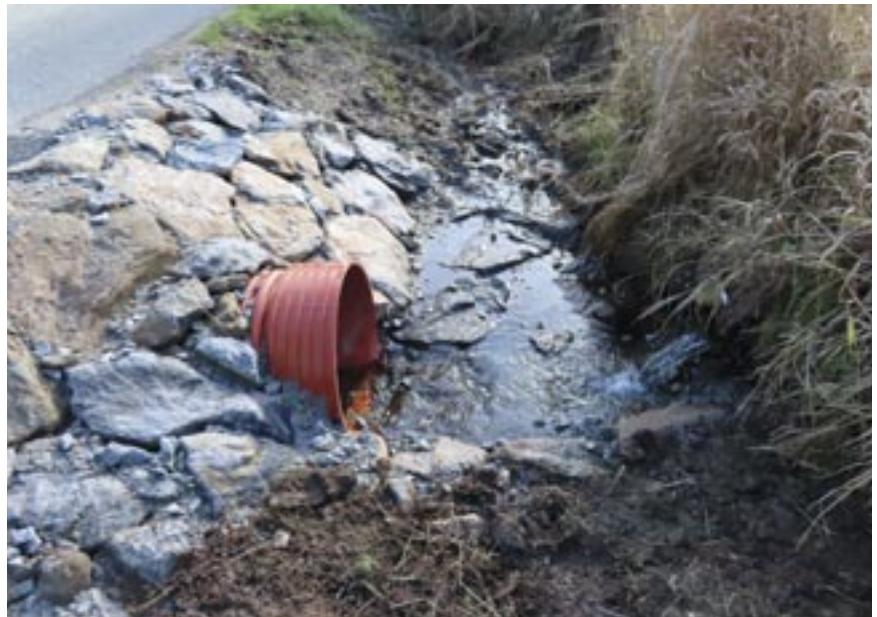
Fig. 86: New culverts installed in the construction of roads on slopes are also an important measure, as they will enable a more even transfer of water to the drying parts under the road, Novosvětské slaté, April 2022 (E. Václavíková)

When restoring the natural movement of water, one of the important measures is the placement of new culverts in the road network, not only in the places where the restored streams will flow (Fig. 86). For contour roads on slopes, it is advisable to place culverts more often so that water from the upper part of the sloping wetland above the road reaches the wetland below the road not only through one concentrated inflow, but in several places. Or that it at least reaches the wetland below the road, because the transfer of water through road ditches to a completely different micro-watershed is a relatively common phenomenon.

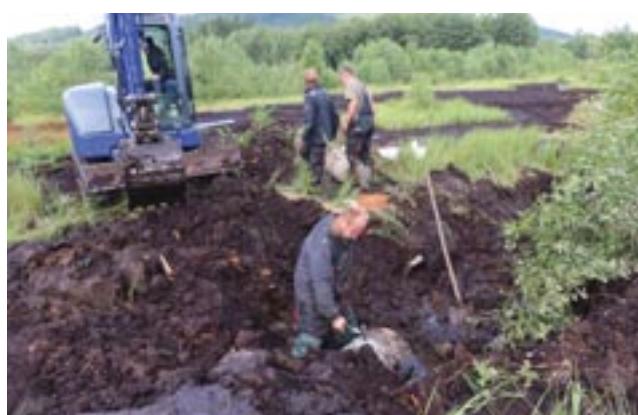
Fig. 87: Removal and blocking of piped drainage channels on mined bog Vlčí jámy, August 2021 (E. Václavíková)

Blocking of ditches is a basic hydrological measure also on mined peatlands (Fig. 87). However, it is advisable to implement it only after landscaping has been carried out or, even better, in a mutual coordination with them, so that there is no flooding of spaces for machinery and at the same time moving machinery does not destroy the surface modifications that have already been carried out.

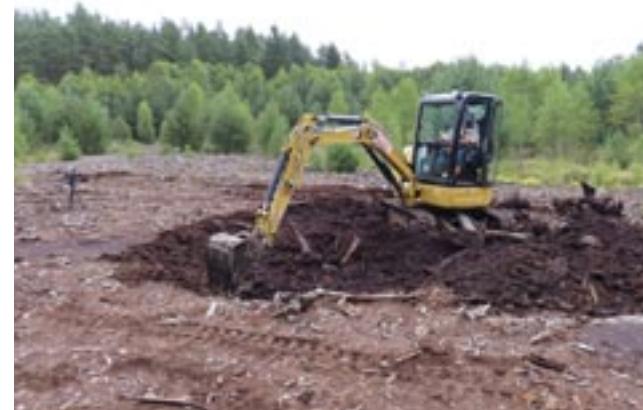
Fig. 89: Excavation of shallow depressions (pools) on the mined bog Vlčí jámy, August 2021 (E. Václavíková)

Small shallow depressions with a depth of up to 0.5–1 m (depending on the thickness of the residual peat layer) with an area of 20–30 m² should be dispersed in the mined area, ideally with respect to the existing (albeit periodic) surface outflow routes, so that water is retained. The shallow created pools should have an irregular shape and, with its longer dimension, should be placed perpendicular to the slope inclination (Fig. 89). On sloping terrain it is also important to place the deeper part of pools higher up the slope.

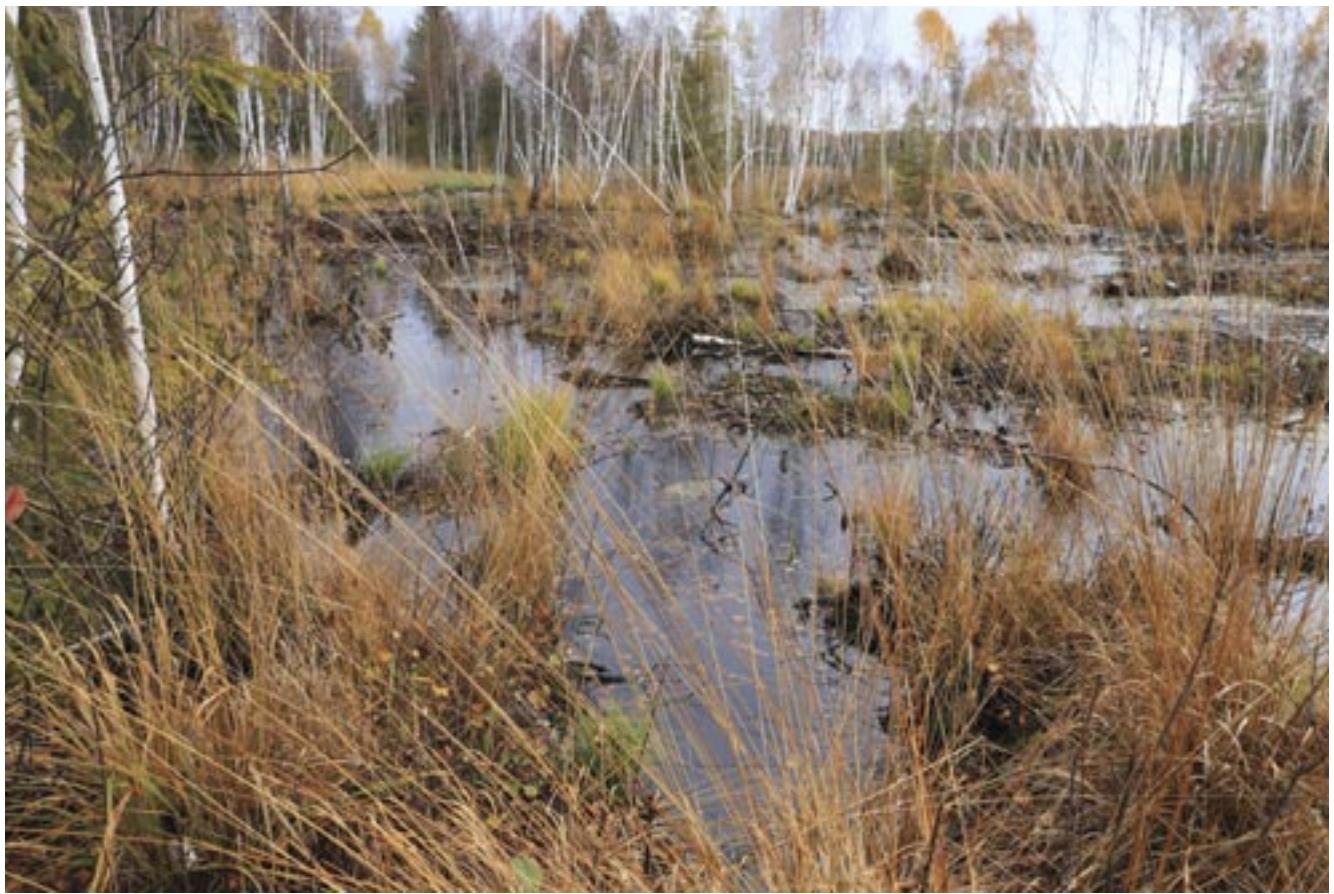
Fig. 91: View of the shallow flooded areas on the mined bog Borková in its lowest part near the shoreline of the Lipno reservoir in the first year after restoration, October 2022 (I. Bufková)

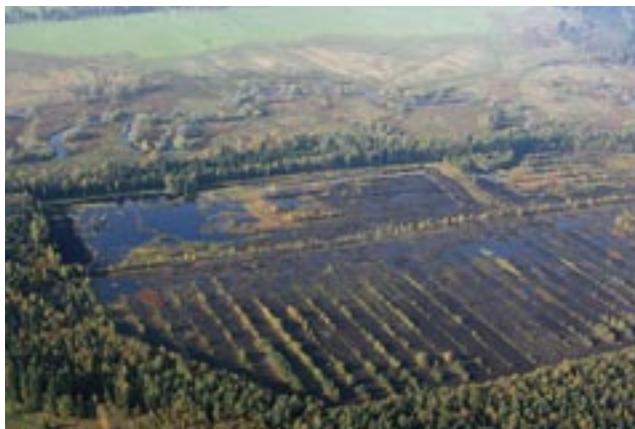
Fig. 92: Aerial view of the mined Soumarský Most peat bog in October 2005, shortly after restoration. Good re-wetting and the gradual onset of wetland vegetation on areas of bare peat are evident (Z. Křenová)
