Hydrological restoration

**Summary of experience
with restoration of wetlands,
springs and streams in the Šumava region**

Project "LIFE for MIRES"

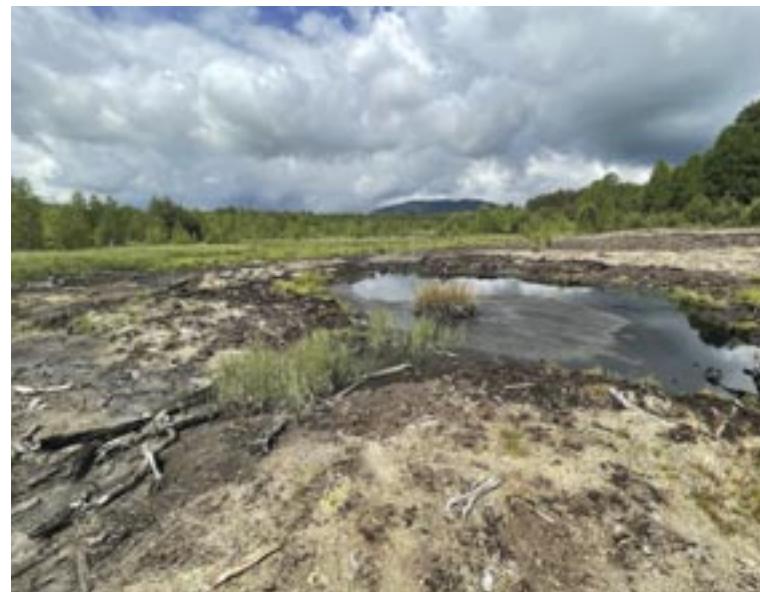
Fig. 93: A created shallow lake and areas of bare peat covered with a layer of mulch that protects scattered clumps and fragments of bog mosses, at the bog Vlčí Jámy one year after restoration, June 2023 (L. Linhart)

The areas with spread bog mosses are covered with a layer of mulched plant biomass or hay, approx. 5-10 cm thick (Fig.

93, 116). Laid biomass has to be of a suitable composition (peat-forming vegetation), so that it also acts as a source of suitable diaspores. It is optimal to use material obtained by mowing peat meadows or transitional mires from the surrounding area.

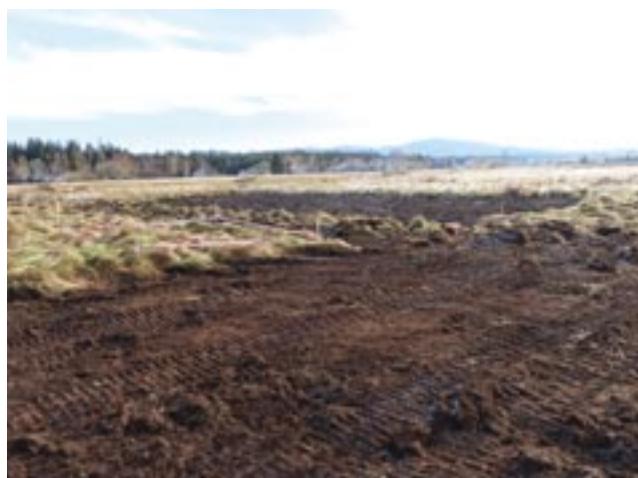
Fig. 95: Areas with bare peat in the site Dobrovodské louky in the floodplain of Vltava river (Vltavský luh) after vegetation and the upper degraded layer of peat have been torn down, October 2021 (E. Václavíková)

This method is carried out in two steps. The first step involves the removal of vegetation and topsoil/peat layers to a depth of 20 or 40 cm depending on the degree of degradation (Fig. 95). Subsequently, in the second step, a layer of mire meadow hay is applied to the exposed surface, which corresponds in vegetation character to the restored habitat. (Klimkowska et al., 2009). This biomass serves as a source of seeds and diaspores that help to restore native vegetation, including key peat-forming species. These are important for the initiation of peat-forming

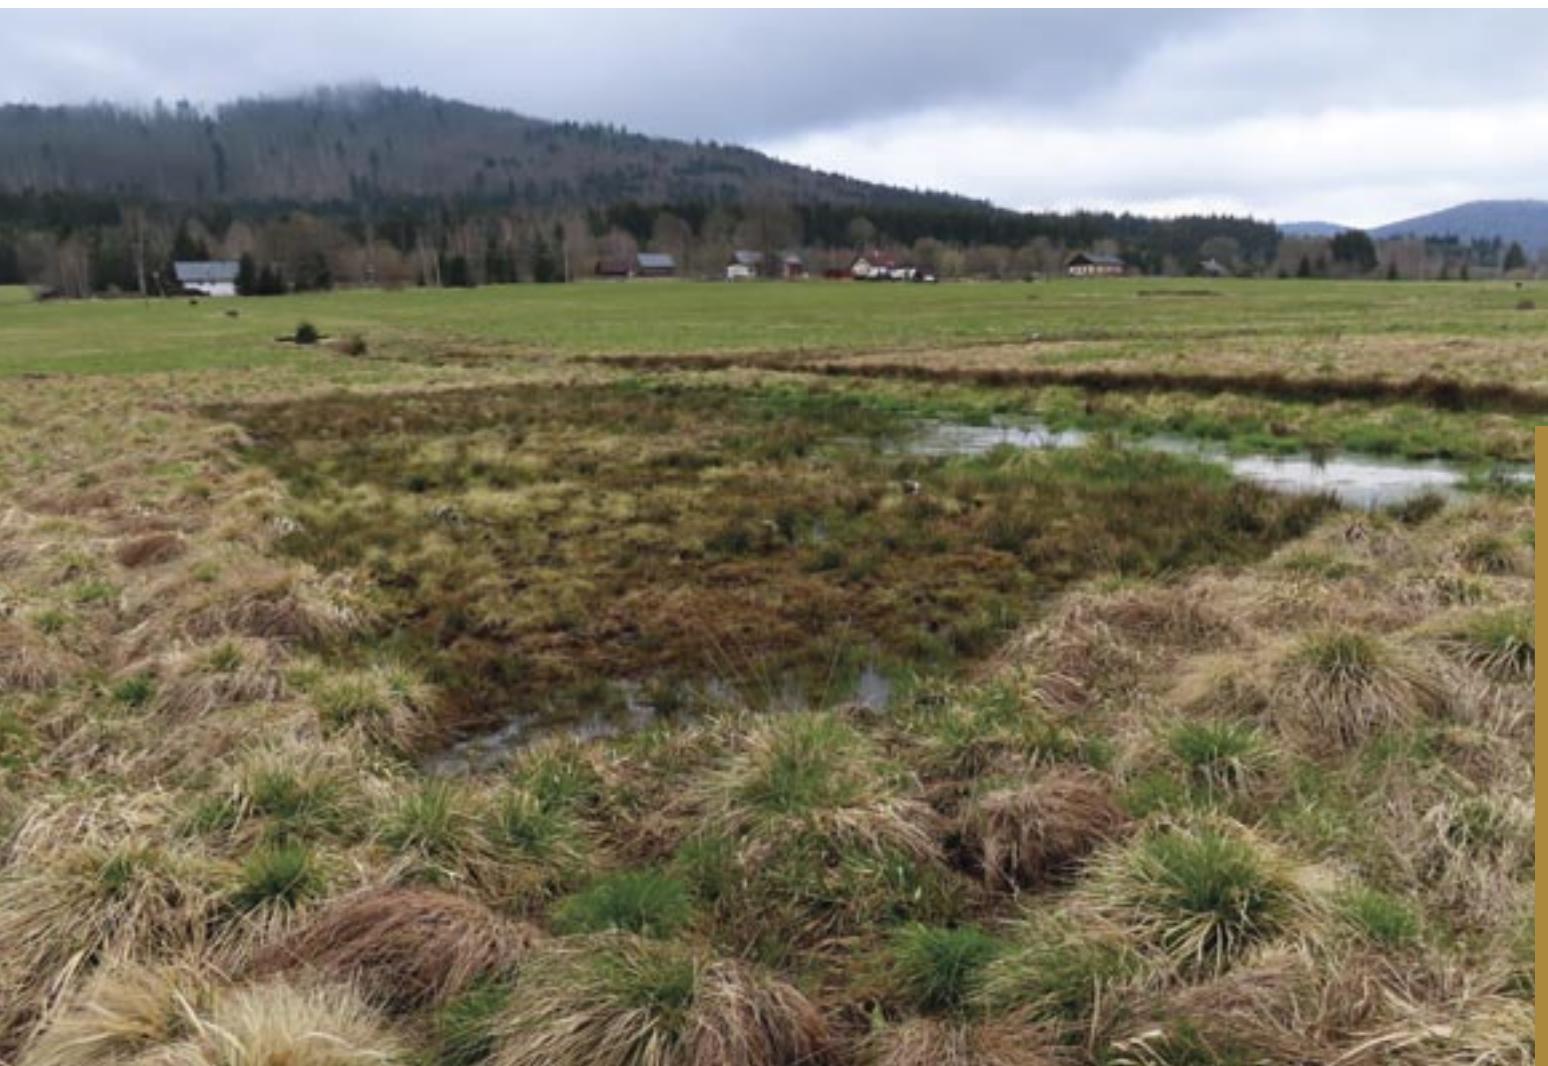
Fig. 98: Prepared geotextile and stabilization stakes, in the background a lately installed board dam in a deep channel at the site Dobrovodské louky. In this case, the logs were placed incorrectly and had to be delivered also to the air wall of the dam, November 2021 (I. Bušková)

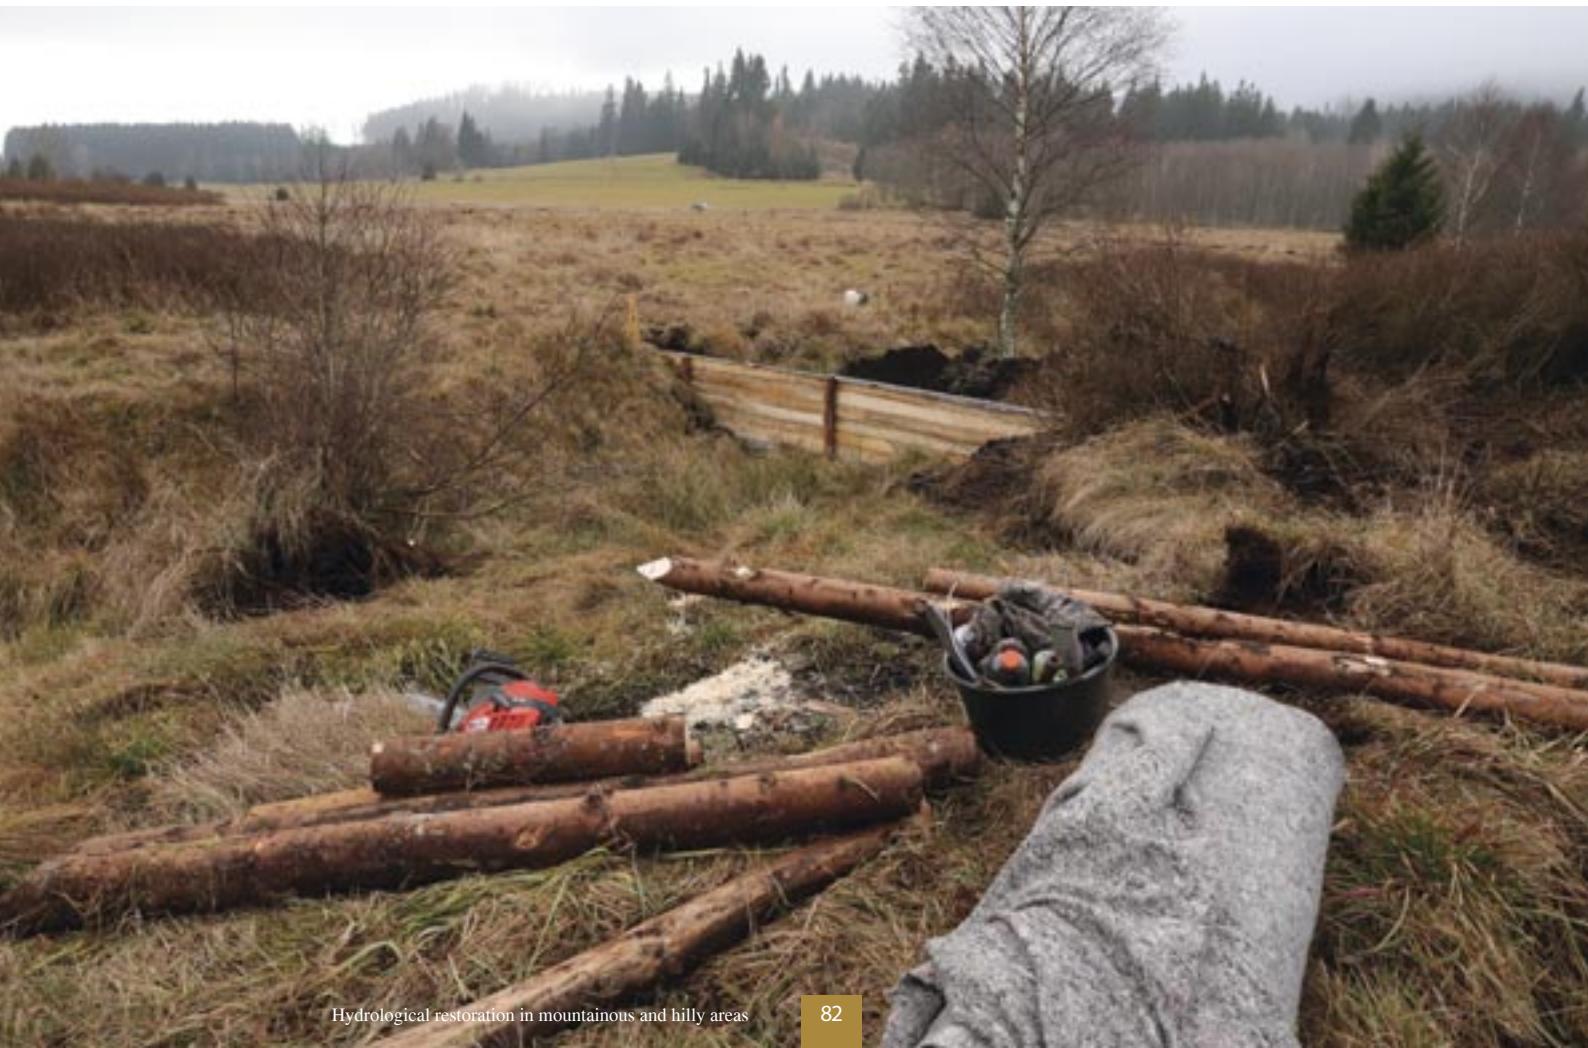
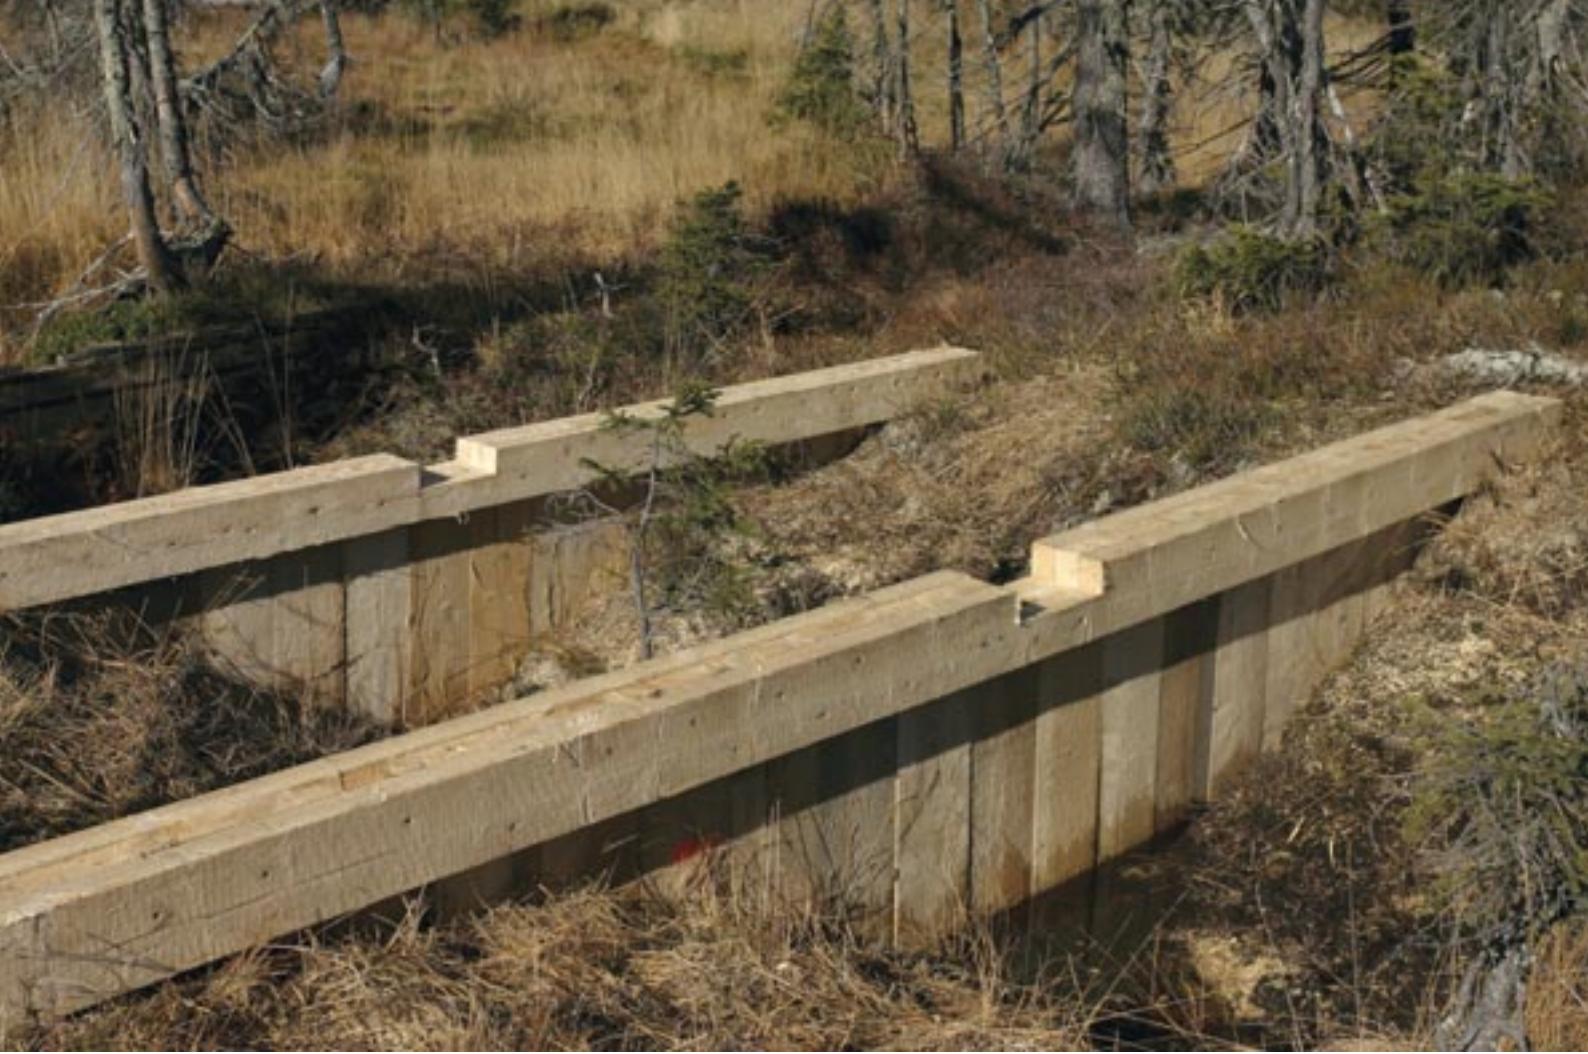
Fig. 99: Dams made of vertically hammered planks immediately after installation, before filling the channel with soil material and water. Luzenská slatě, October 2005 (I. Bufková)

The dam is formed by joining individual planks that are installed vertically in the channel. The planks are prepared in advance for a tongue-and-groove connection or a two-tongue system with a batten inserted in the middle (Fig. 99 and 100). Care must be taken when preparing the planks to ensure precision, in particular when making the tongue and groove, the specified dimensions must be observed. The length of the timbers is cut on site as required. The surface of the assembled dam must be reinforced transversely with clamps on both sides. In the case of a very wide channel, more clamps must be used. The clamps must reinforce the entire surface of the dam, including its overhang with the channel banks. If there is an overflow on the dam, the clamps must be placed just below the spillway.

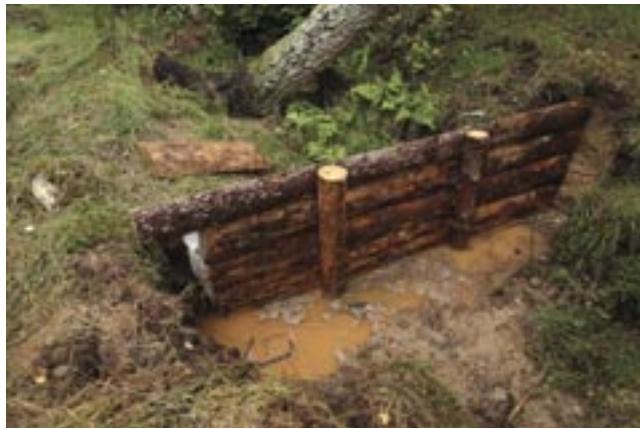
Fig. 101: Improperly constructed and inserted dam made of raw boards. The beveling of the board wall at the left bank and the failure of the side edge of the dam to reach the edge of the notch are evident, July 2020 (I. Bufková)

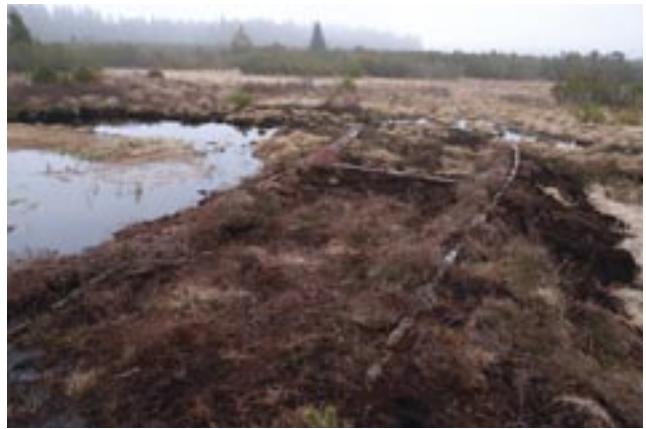
Fig. 102: An example of a massive double dam from planks with a large interspace filled with peat on Ježerní slat bog. The embankment of the dam is not sufficient considering the dimensions of the site, but it is functional. The water retained above the dam is re-directed into the peat bog on the left bank, February 2024 (I. Bufková)

In extreme cases for giant channels with high water pressure, a system of double dams can be used. Here, two plank dams are embedded at a distance of approx. 0.7 - 1 m behind each other and the space between them is filled with soil material. Thorough backfilling is necessary (Fig. 102).

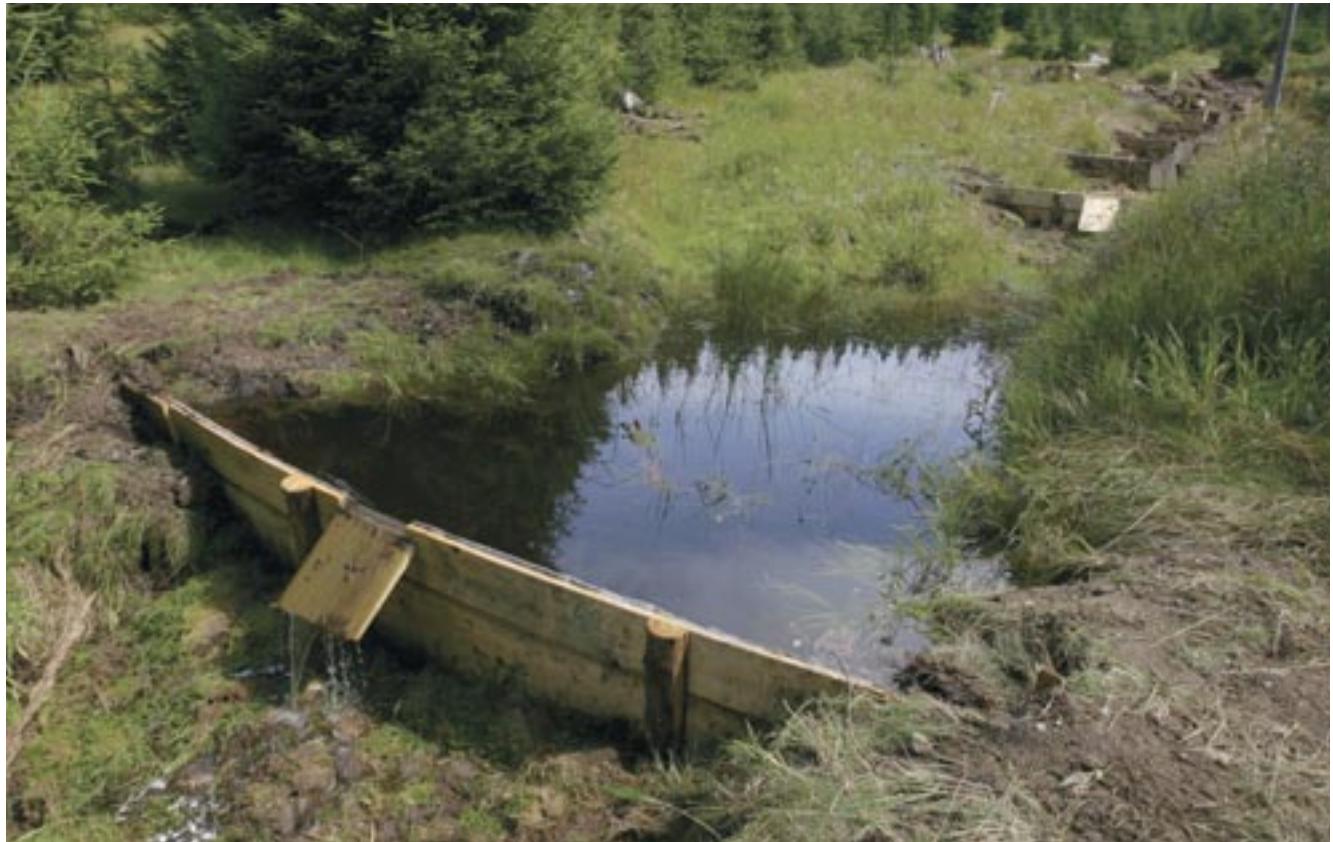
Fig. 103: In many respects, the damming was wrongly executed. The backfill is insufficient and the dam is not stabilized and protected. The spillway is too short, so the stream of water hits the bottom just below the dam, which soon erodes and washes away. Such a measure is pointless, the cascade will break down over time and the function of the drainage channel will be re-established, project site Nad Rybárnou, August 2008 (I. Bufková)

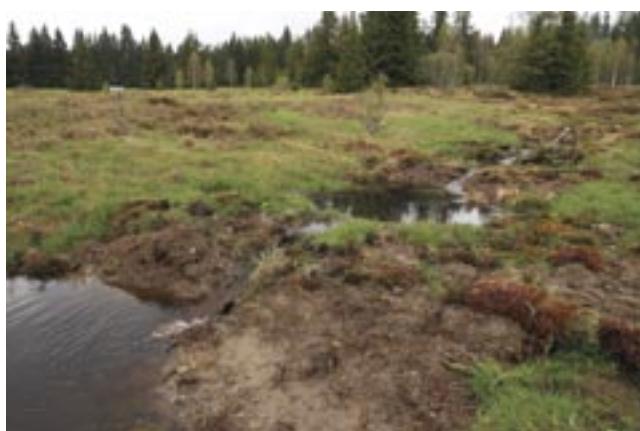
Fig. 104: Correctly carried out backfilling of dams at the U Tremlů location, May 2022 (I. Bufková)

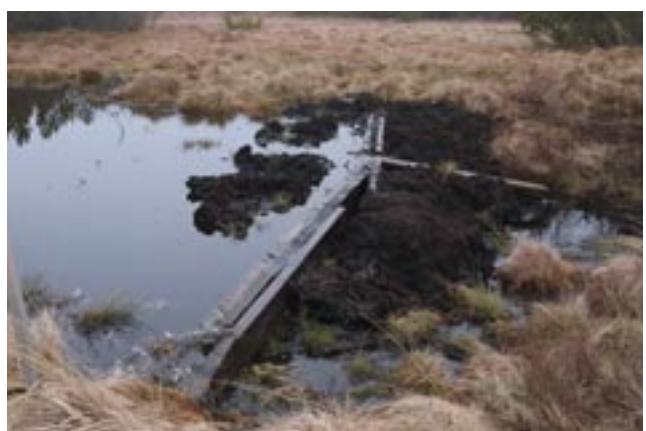
Fig. 105: Washing out unsprinkled and poorly inserted dams (I. Bufková)

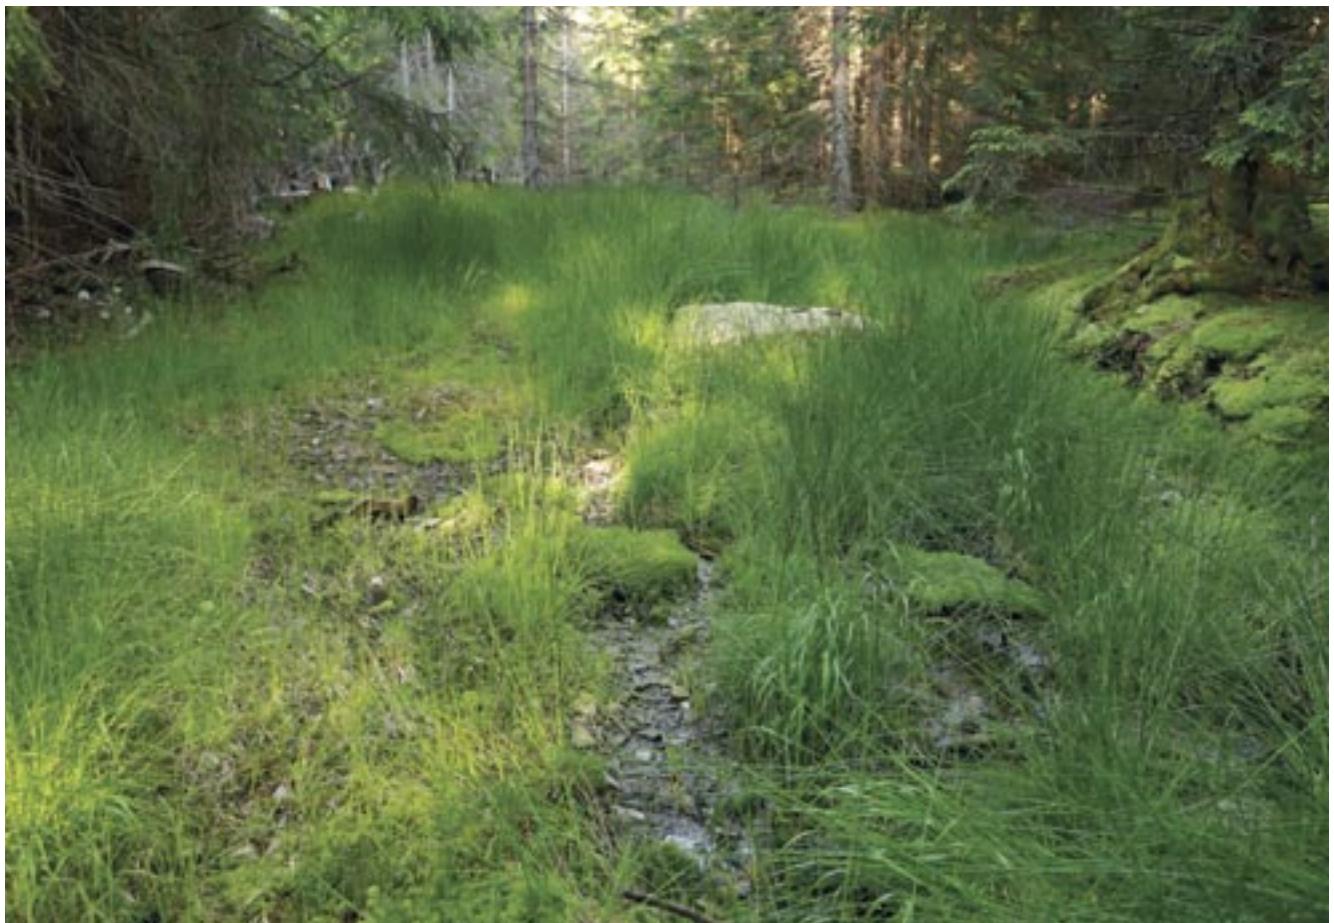
Fig. 106: The onset of wetland vegetation on the bare surface of the soil after movement of the excavator and on the surface of the soil infilling in the drainage channel, state in the third year after restoration, Gerlova Hüt, June 2024 (I. Bušková)

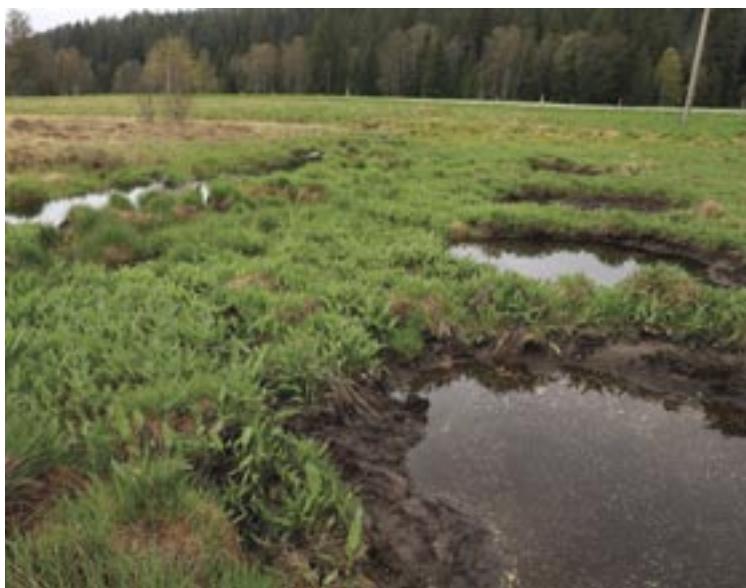
Fig. 108: Incorrectly placed depressions in one line close behind each other can lead to the creation of a new concentrated water runoff on slopes, U Tremlů, May 2022 (I. Bušková)

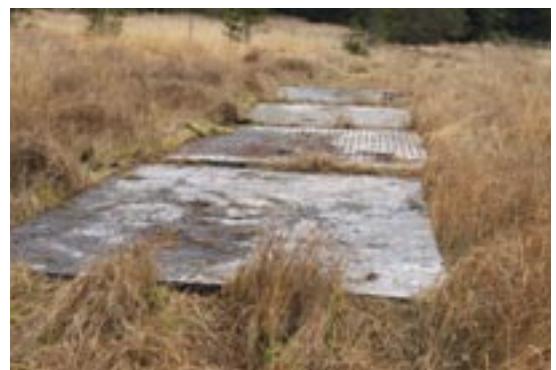
Fig. 107: Pontoon plates for increasing the bearing capacity of the terrain, Nové Údolí, November 2020 (I. Bušková)

In some inaccessible locations, heavy waterlogging makes it difficult for machinery to reach areas with sufficient surface bearing capacity. In such cases, it is necessary to use pontoon ground boards made of suitable material, which the excavator places in front of itself (Fig. 107). Sometimes a temporary route can be constructed using cross-laid logs of felled trees to cover waterlogged areas with low ground bearing capacity (Fig. 71). Similarly, temporary crossings over drainage channels or small streams can also be constructed.

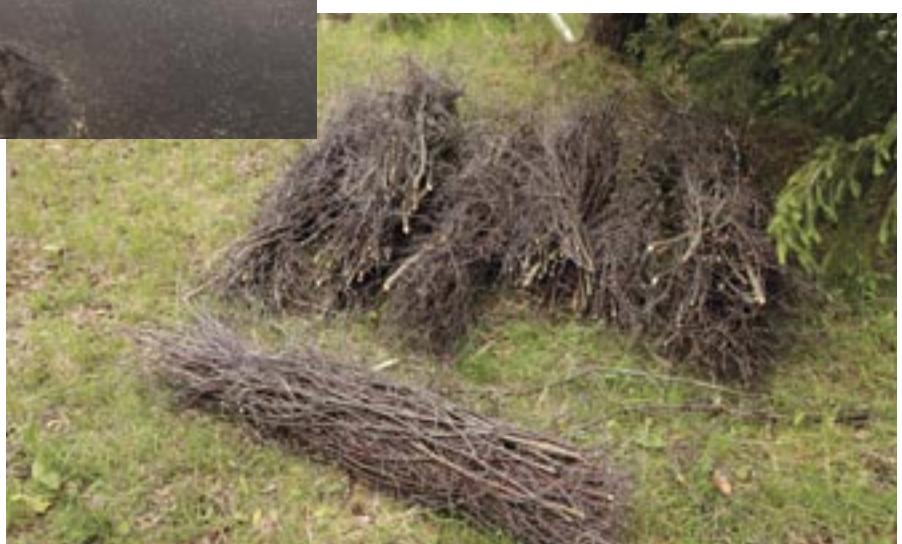
Fig. 109: Example of bundles made from birch twigs, Malý Bor, July 2020 (R. Placková)

It is very useful to fill part of the free space between the partitions with the help of fascines tied from branches (Fig. 109). Branches up to 2 cm in diameter, tied tightly together with thin uncoated wire. The branches are tied tightly together with thin uncoated wire.

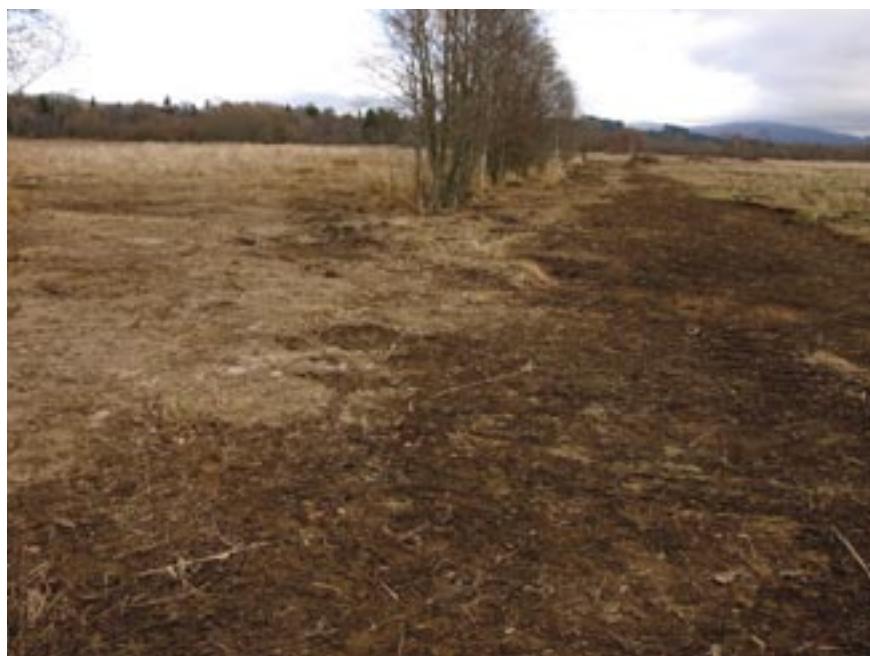
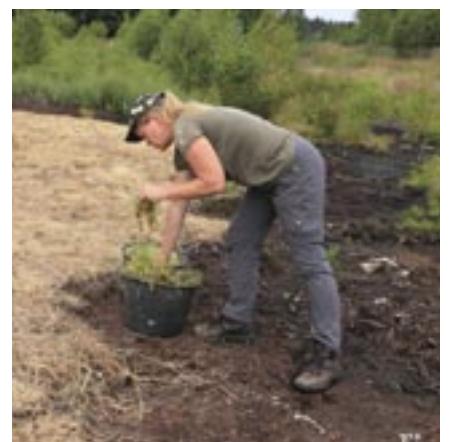
Fig. 111: Distribution of bog mosses in the site Vlčí jámy bog, July 2022 (I. Bufková)

Clumps of suitable peat moss species are placed on the peat surface in suitable locations, preferably in small shallow depressions. Small scattered pieces of bog mosses may also be spread over the area (Fig. 111).

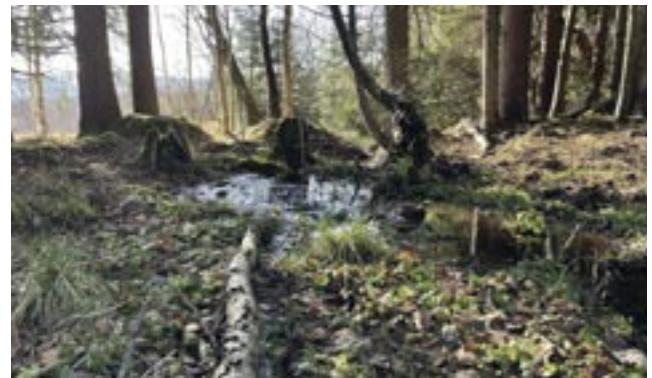
Fig. 113: Restored spring area at site Pod Skelnou, November 2021 (L. Linhart)

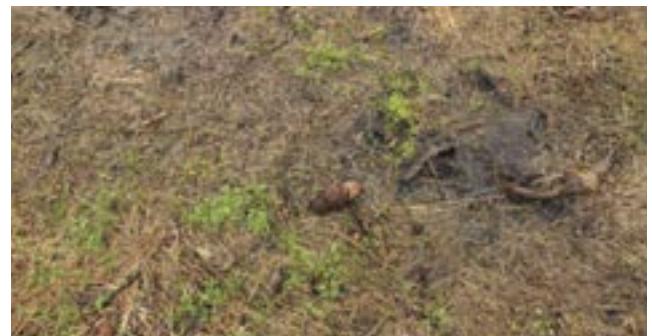
Fig. 114: Spread of undesirable non-peaty species on places where unsuitable mulch from peat-free sites was used, Vlčí jámy bog, August 2023 (I. Bufková)

If unsuitable mulch material is used, there is a risk of spread of non-mire species, which, in large quantities, can even stop the re-start of peat-forming processes (Fig. 114).

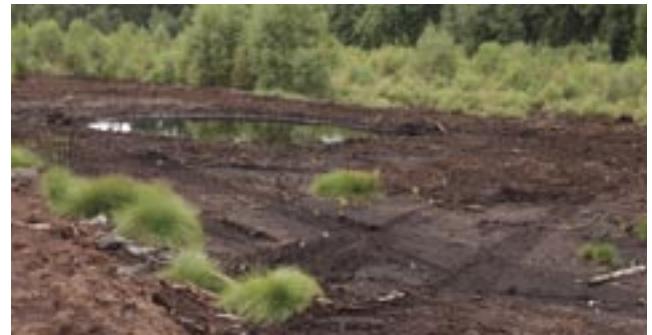
Fig. 115: Restored peat pools on the mined bog Vlčí Jámy immediately after creation, August 2021 (I. Bufková)

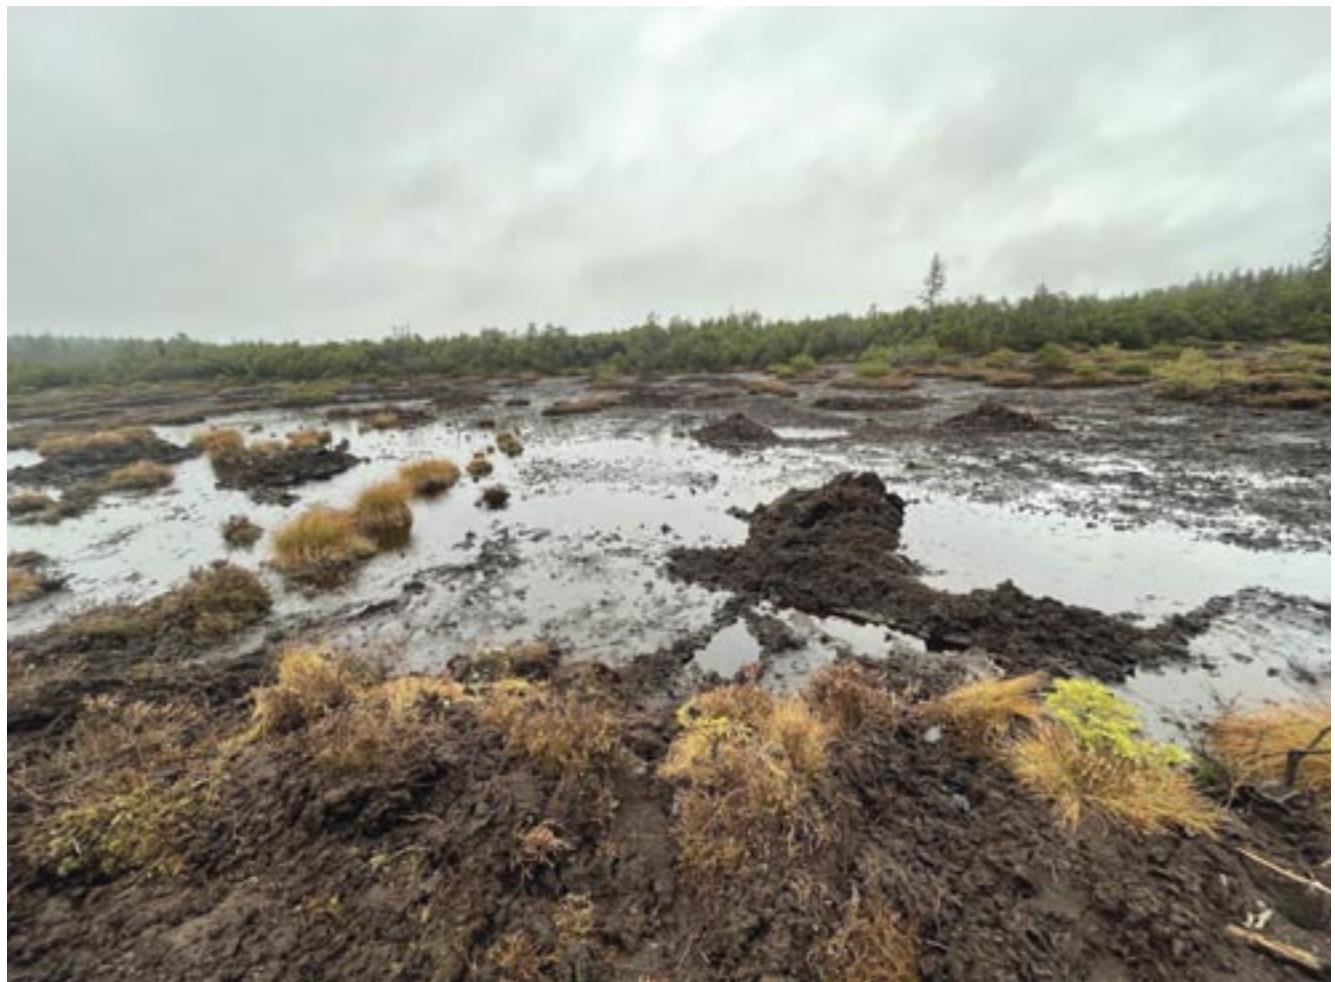
Fig. 117: The surface of the exposed peat at the Mezilesní slat bog after interruption of the erosion trickles by dispersal dams made of logs with backfill, October 2022 (L. Linhart)

These are used on areas of extracted peat to disperse concentrated runoff from eroding shallow surface trickles. Logs approx. 20-25 cm in diameter and approx. 2 m in length (material from surrounding stands can be used) are laid in an excavated cut across the narrow trickle (depth of cut up to approx. 20-40 cm but determined by the crack depth, approx. 1/3 of the thickness of the bottom layer of logs should be below the bottom of the trickle). Usually 3 logs per channel (2 base, 1 on top) are sufficient.

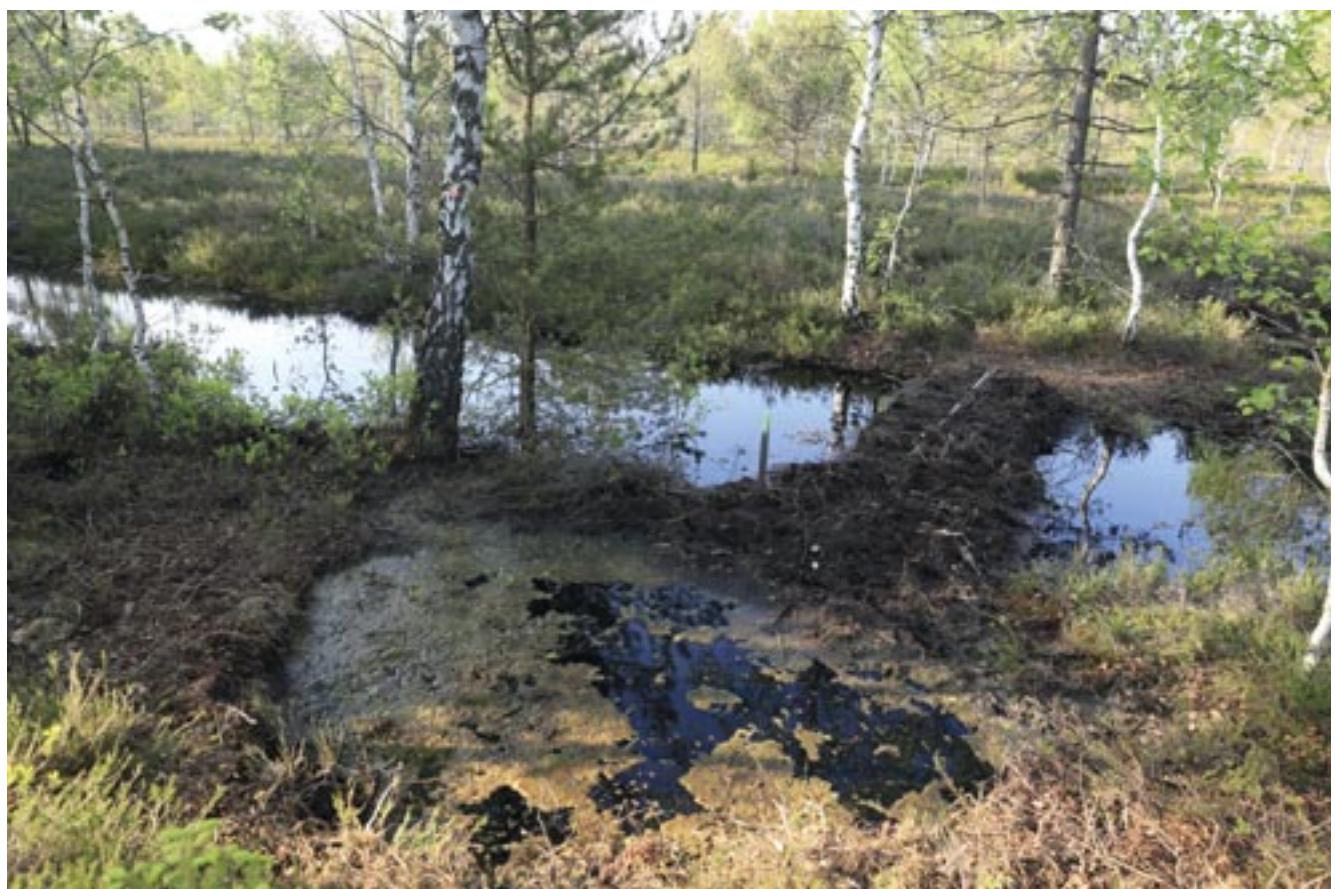
Fig. 118: Incorrect location of the depression made to obtain soil to fill the canal. The pool is too close to the edge of the dam backfill which could be easily bypassed by water flow and gradually washed out, May 2023 (I. Bufková)

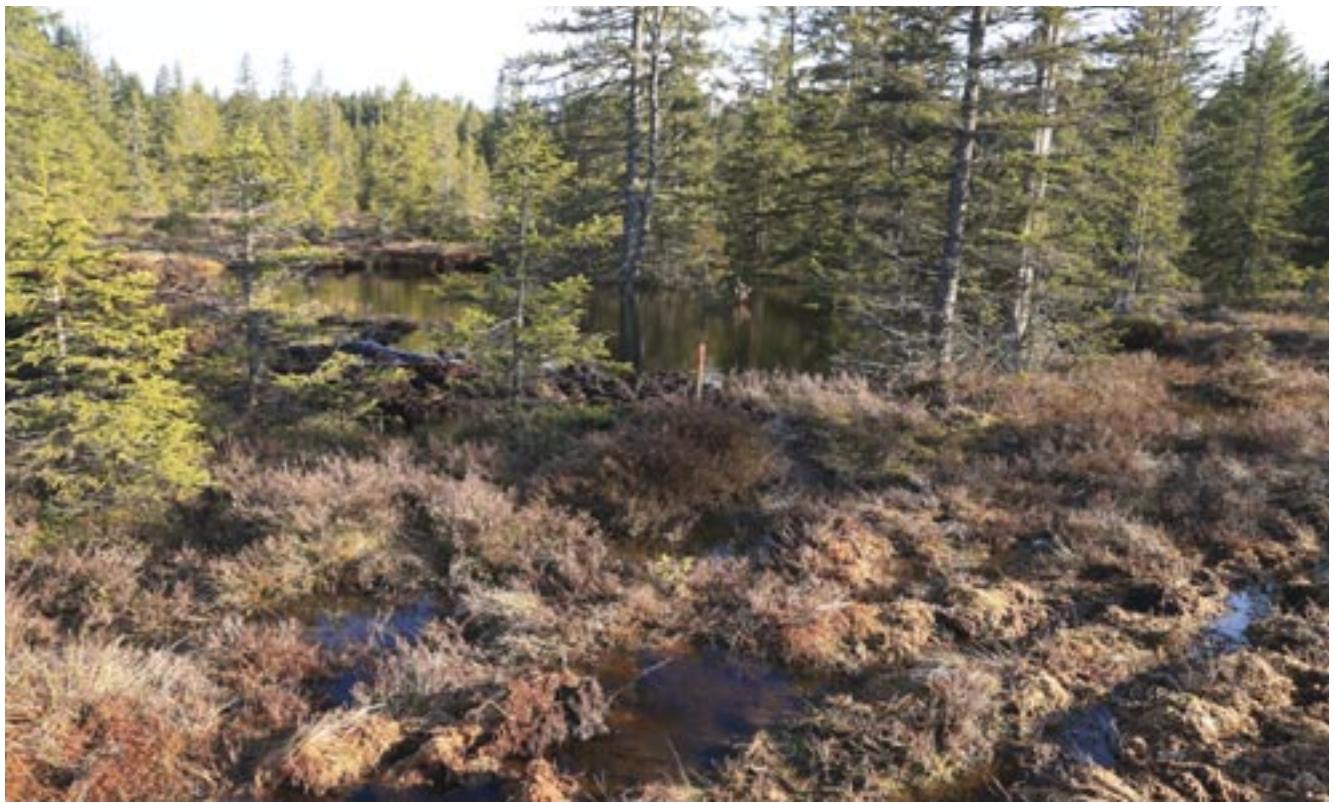
Fig. 119: Shallowly scraped peat mounds in the area of the manually mined Hamerská slat' bog supported the irrigation of the dry surface, April 2023 (I. Bufková)

Due to the sloping terrain, rill erosion occurs in the straightened streams and their beds are therefore secondary deepened (Fig. 119). This caused decreasing of water table in the surrounding wetlands, a fluctuating water regime and rapid runoff from the area. Streamwater leaves the very deep beds only rarely, and the alluvial wetlands and adjacent areas lack water from occasional flooding. Even on gentle slopes, modified streams can affect relatively large areas in their vicinity. Within hydrological restorations in the Sumava region, the smallest streams of the first and second order are usually addressed, often representing capillary runoff leaving the spring area. Flows of higher order tend to be hydrologically linked with mires, in this case mainly with fens, only in areas of lower altitudes.

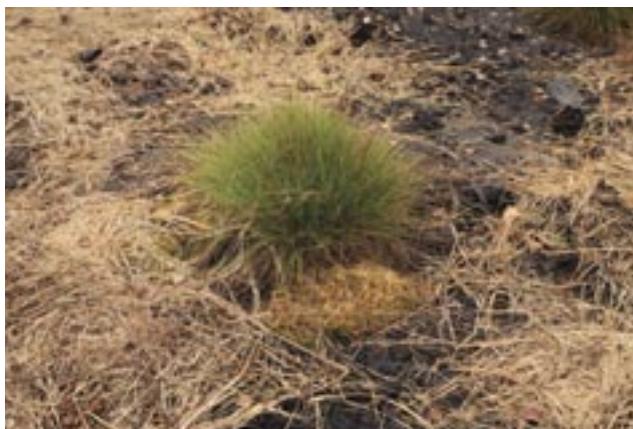
Fig. 120: Tussocks of hare's-tail cottongrass create a more favourable microclimate and increase the probability of attachment of spread small sphagnum bundles and their growth on exposed peat. A layer of mulch from peat meadows is visible in the surroundings, Vlčí Jámy, October 2022 (I. Bufková)

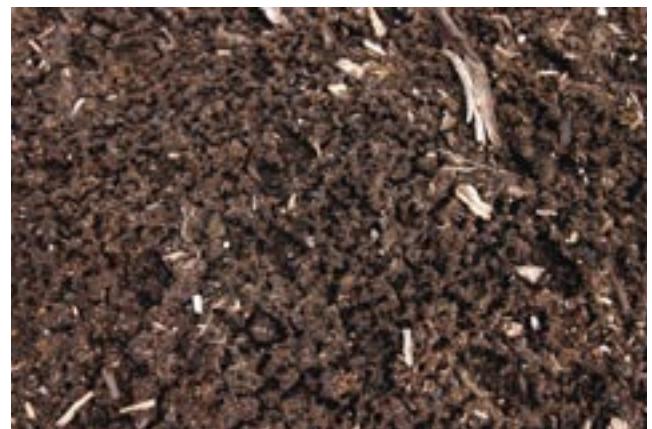
Fig. 121: View of the structure of freezing crust formed on the surface of bare peat exposed to frost without snow cover, Vlčí Jámy bog, March 2016 (I. Bufková)

A rough crust about 10 cm high is very often formed on areas of mined peat by repeated freezing, overheating and drying of the bare peat surface (Fig. 121). The crust creates a very unfavourable environment for the attachment of plant seedlings and the spread of any vegetation, let alone wetland vegetation. It is therefore advisable to scrape it off, preferably at places where further measures to encourage peat-forming vegetation will be implemented. The scraped peat surface layer can be used to fill drainage ditches.

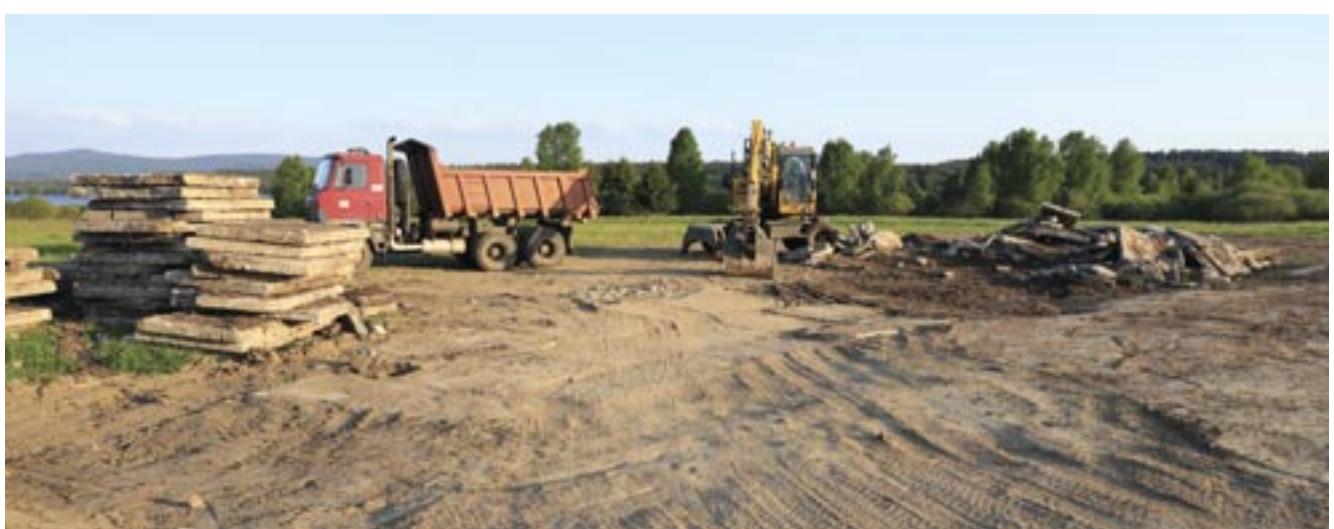
Fig. 122: Removal and disposal of firmed roads made of concrete panels that allowed the movement of technique during peat extraction is common part of the industrially mined bog restoration. Temporary deposition of panels intended for removal on the edge of the restored Borková peat bog, May 2023 (I. Bufková)

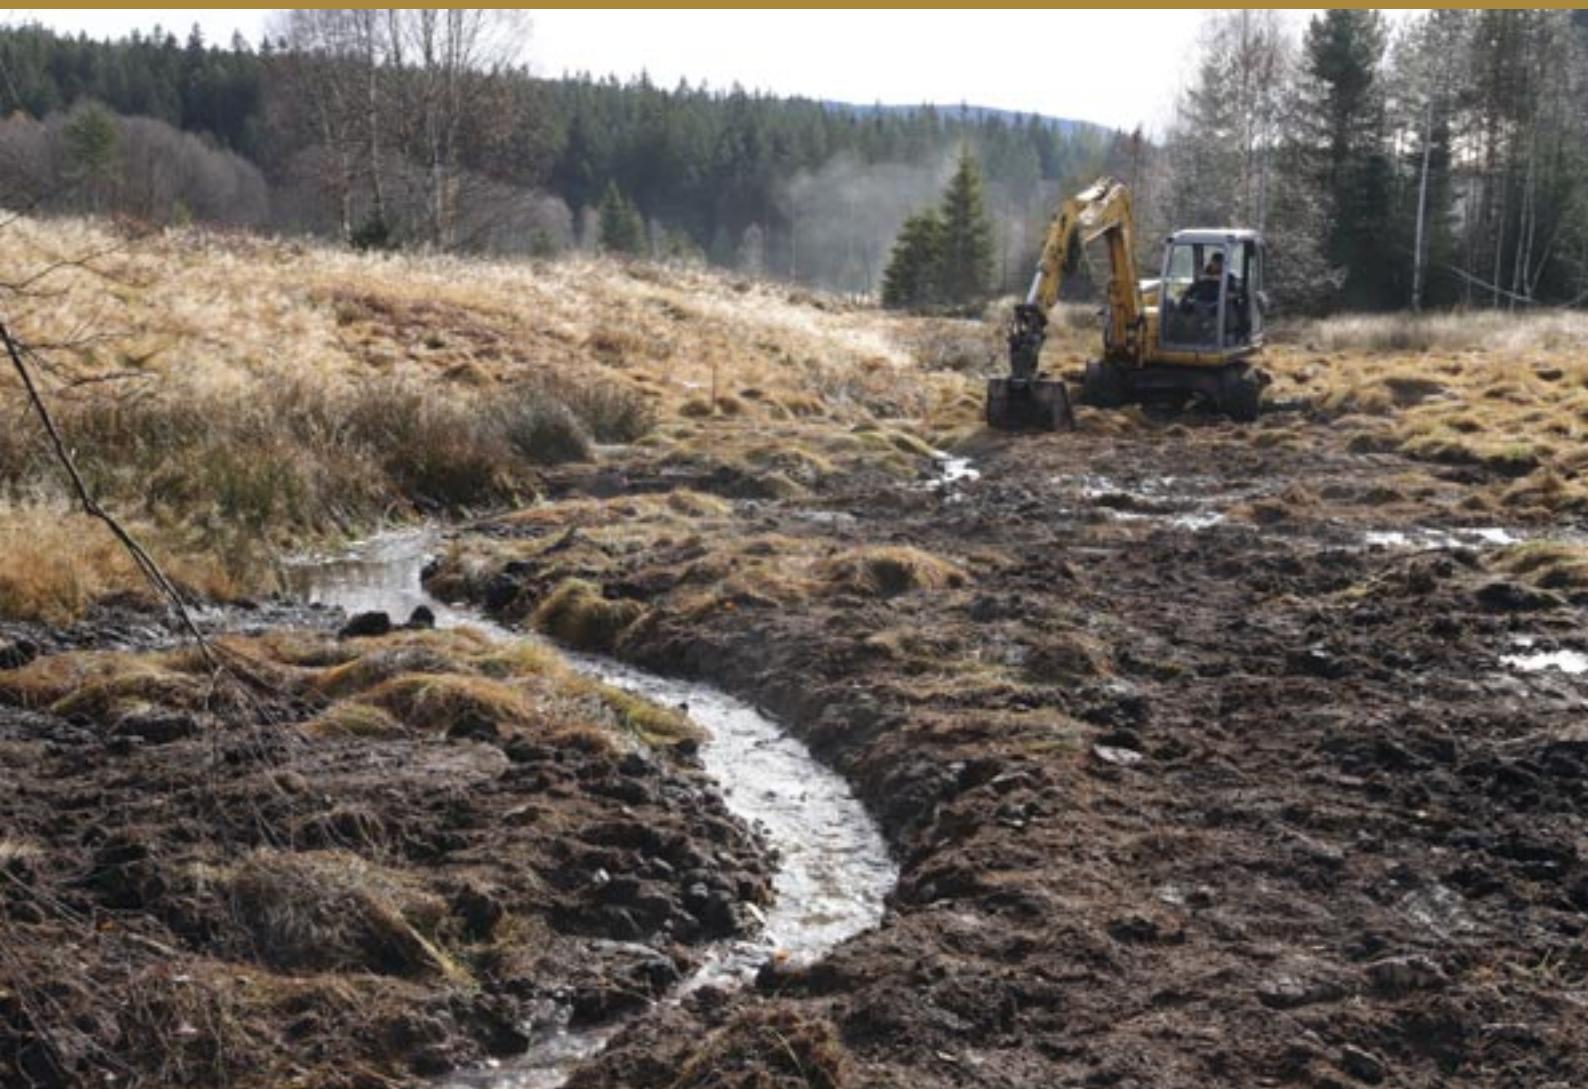
Fig. 123: Restoration of a small stream near the spring at the site Pod Skelnou, November 2021 (I. Bufková)

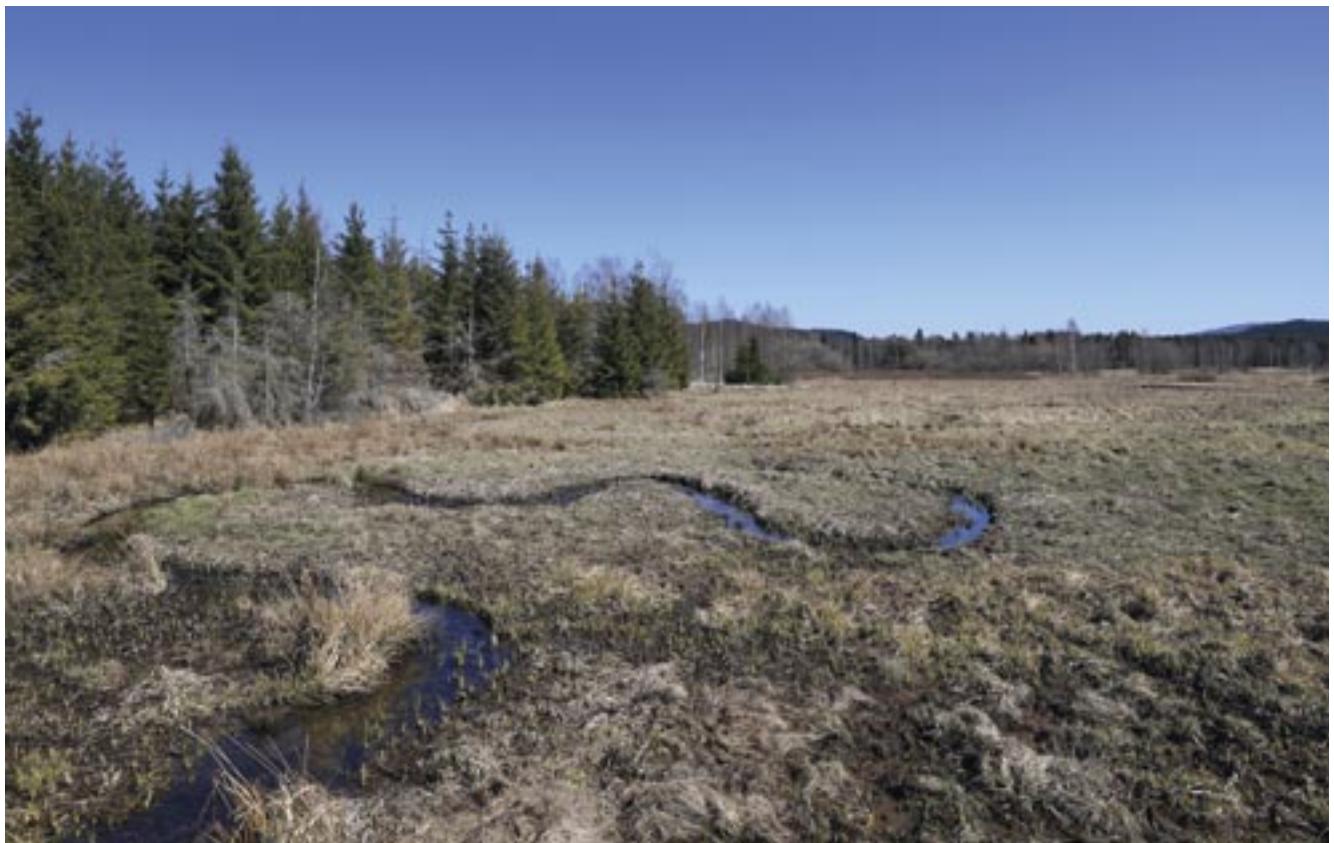
Fig. 124: The Žlebský stream and alluvial wetlands in its floodplain were restored together in 2013. Situation in spring 7 years after restoration, April 2020 (L. Linhart)
