Hydrological restoration

**Summary of experience
with restoration of wetlands,
springs and streams in the Šumava region**

Project "LIFE for MIRES"

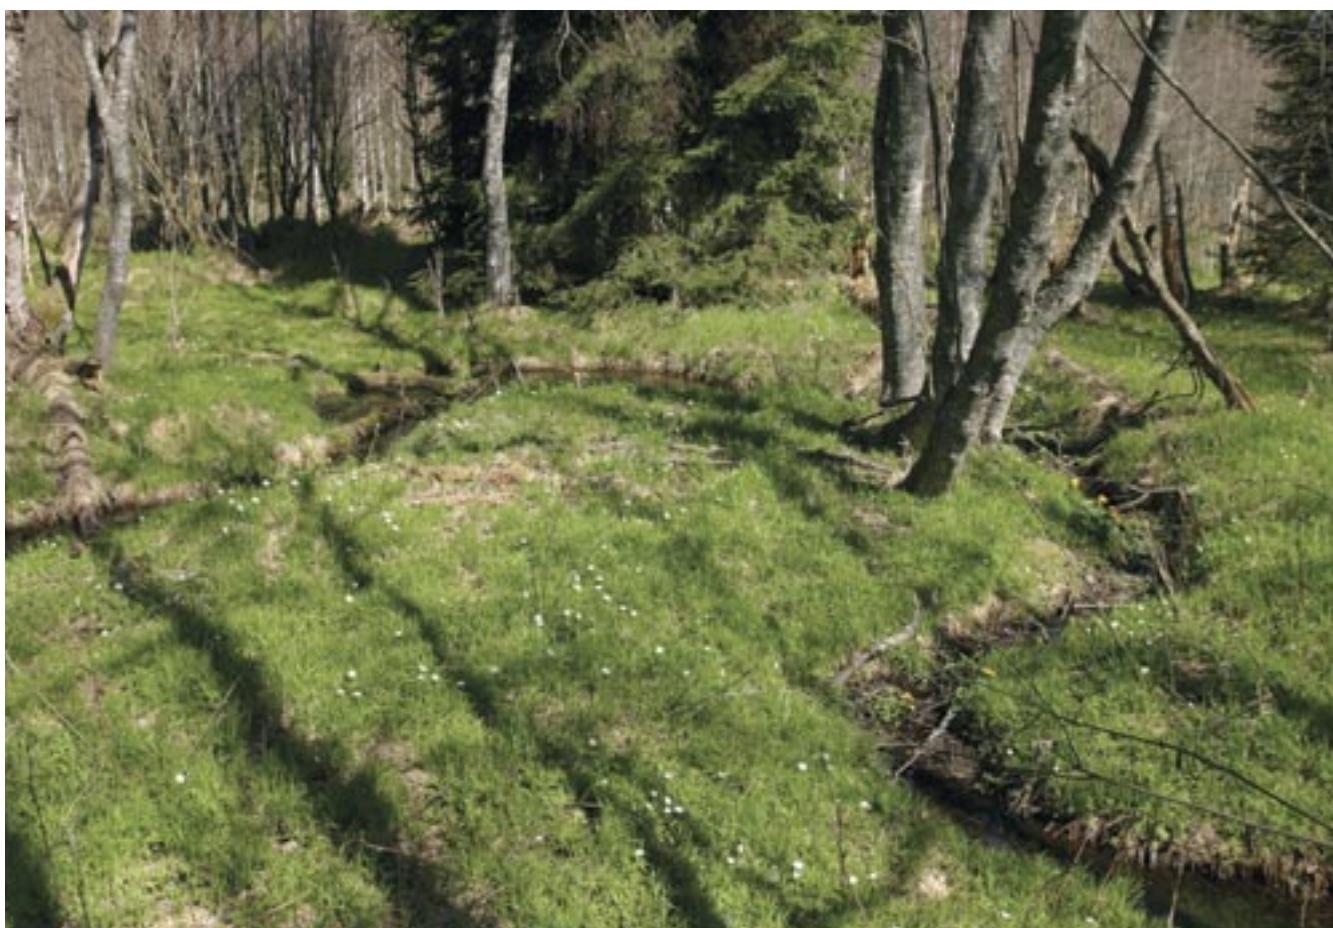
125: Simplified drawing of returning the stream to a preserved historical stream bed

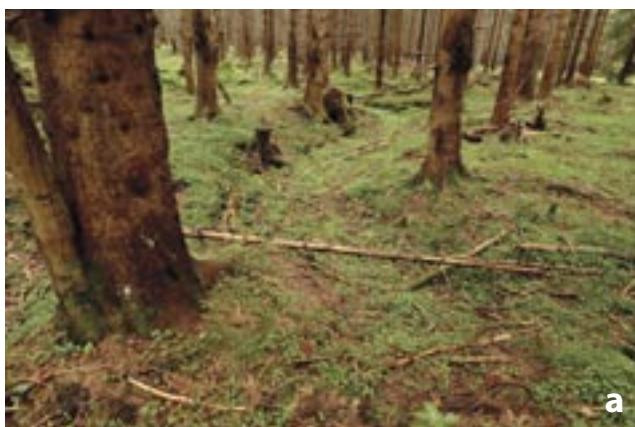
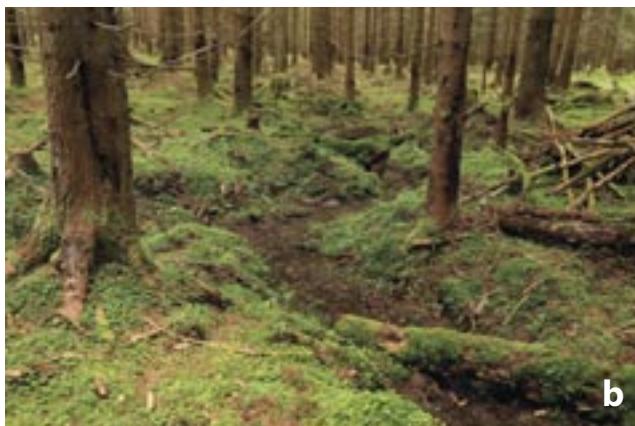
Fig. 127a, b: Historical natural bed of a forest stream before (a) and after restoration (b), Nové Údolí, August 2020 (a) and October 2020 (b) (I. Bufková)

It is one of the most natural and technologically easiest ways to revitalise watercourses (Fig. 125). Many small watercourses in the Šumava region have been diverted from their natural beds into artificial drainage systems. In such cases, the original stream beds have remained without flow and have gradually disappeared due to terrestrialization or artificial landscaping. Sometimes, however, it has been possible to trace the preserved sections and return the water flow to them during restoration (Fig. 126, 127a, b).

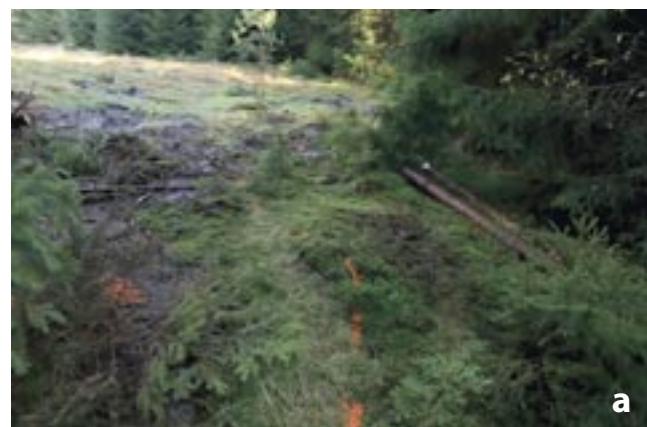
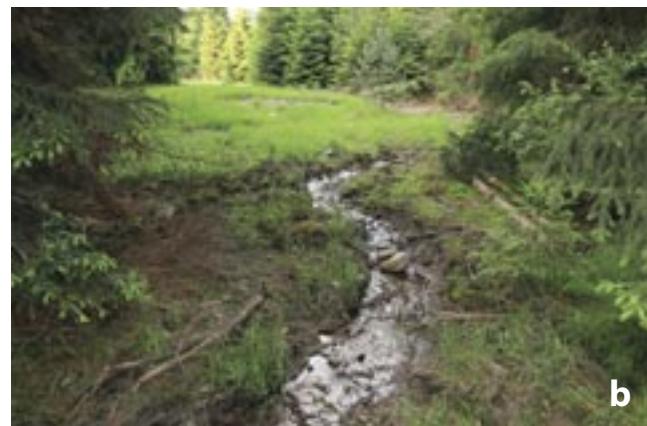
Fig. 128a, b: Marked future route of a small forest stream (a) and restored stream (b), Roviny site, November 2022 (a) and June 2023 (b) (I. Bufková)

The creation of a new cunette/stream bed in the original runoff route is the most common method of restoring watercourses in the Šumava region. The bed is shaped with the help of excavator in sections where the water flowed in the past, but no historical stream bed has been preserved so far (Fig. 128a, b).

For the actual implementation, the routes of all streams with a stream bed width of up to 1 m were "drawn" with spray paint directly on the ground surface. This unambiguous identification of the stream bed for communication with the driver of excavator proved to be the most suitable in the final analysis. Marking the stream route with wooden stakes was only used for larger stream beds. For these, the gradient of the newly created stream bed was also verified, especially in the riffle sections between meander loops.

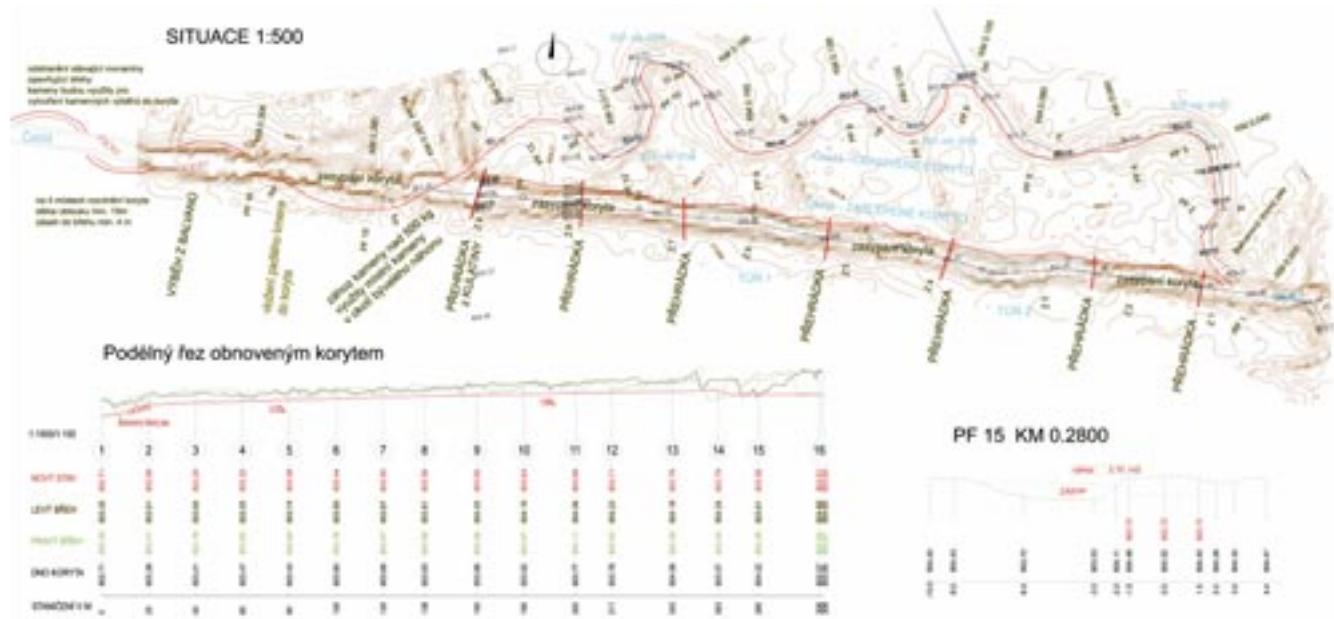
Fig. 130: Situation drawing, longitudinal and cross-section of the newly shaped bed of the Častá river from the technical documentation elaborated for restoration of the Stráženská slat' site, prepared by Martin Dobeš, January 2022

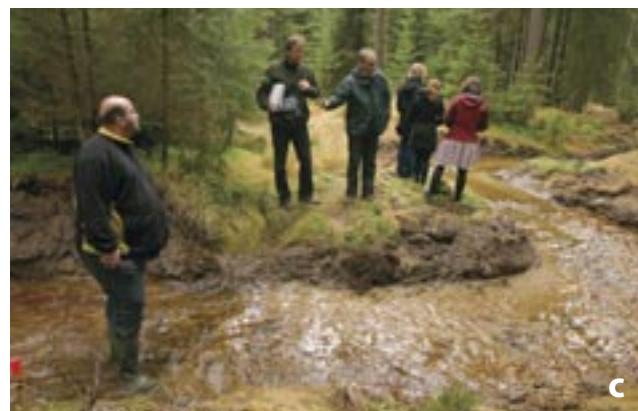
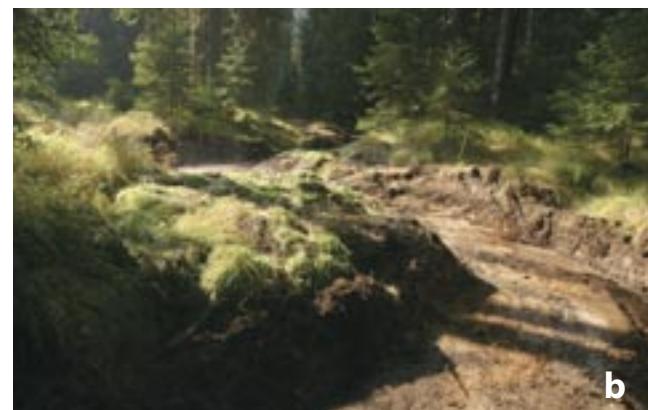
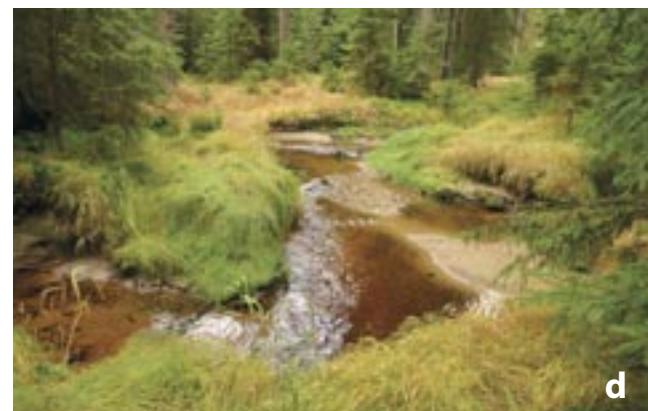
Fig. 131a, b, c, d: Shaping of the new cunette of the Hučina stream in its original stream route, September 2013 (a), October 2013 (b, c), October 2016 (d) (I. Buřková)

In forming a new natural stream bed in the original route, the goal has always been to create a shallow, low-capacity, and rugged stream bed interacting with the surrounding floodplain. The specific restoration of the natural cunette for very small streams with a bed width of up to approx. 0.8 m was usually based on the local morphological pattern. This means that it imitated, as far as possible, the natural shape, dimensions and stream bed structure of comparable natural watercourses in the vicinity.

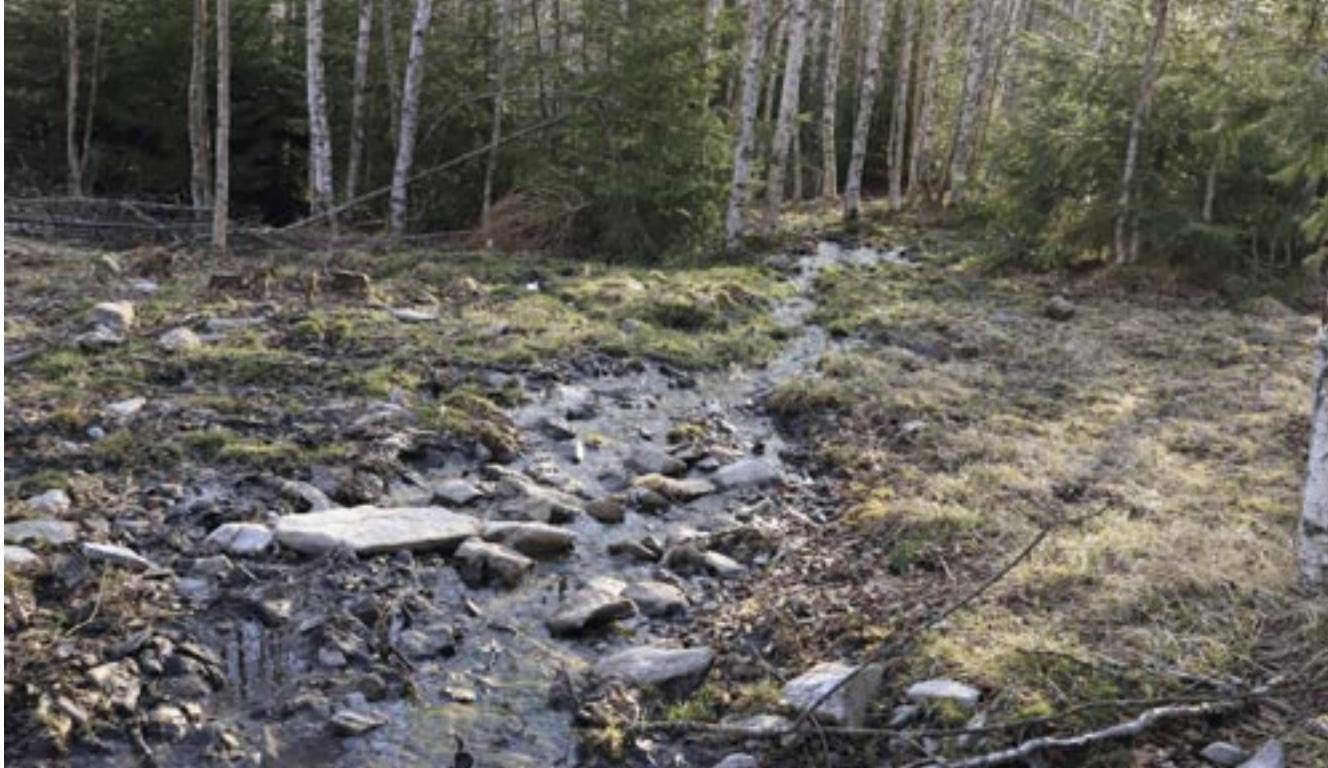
Fig. 132: Free re-direction of water flow to the historical stream belt at the Malý Bor location in the second year after restoration, March 2021 (I. Bufková)

For the smallest flows on gentler slopes with a longitudinal gradient of up to 3 % and flows of up to about 5 l/sec, it was possible in certain cases to allow free release of the runoff into the original or most likely line of the stream belt without dredging the channel. One important condition was the presence of stony soils with a well-developed vegetation cover and a stable surface (e.g. involved grassland with sods). This method of natural stream restoration was used in the Šumava region only locally and rather on short sections. A total of 11 km of watercourses were restored in this way.

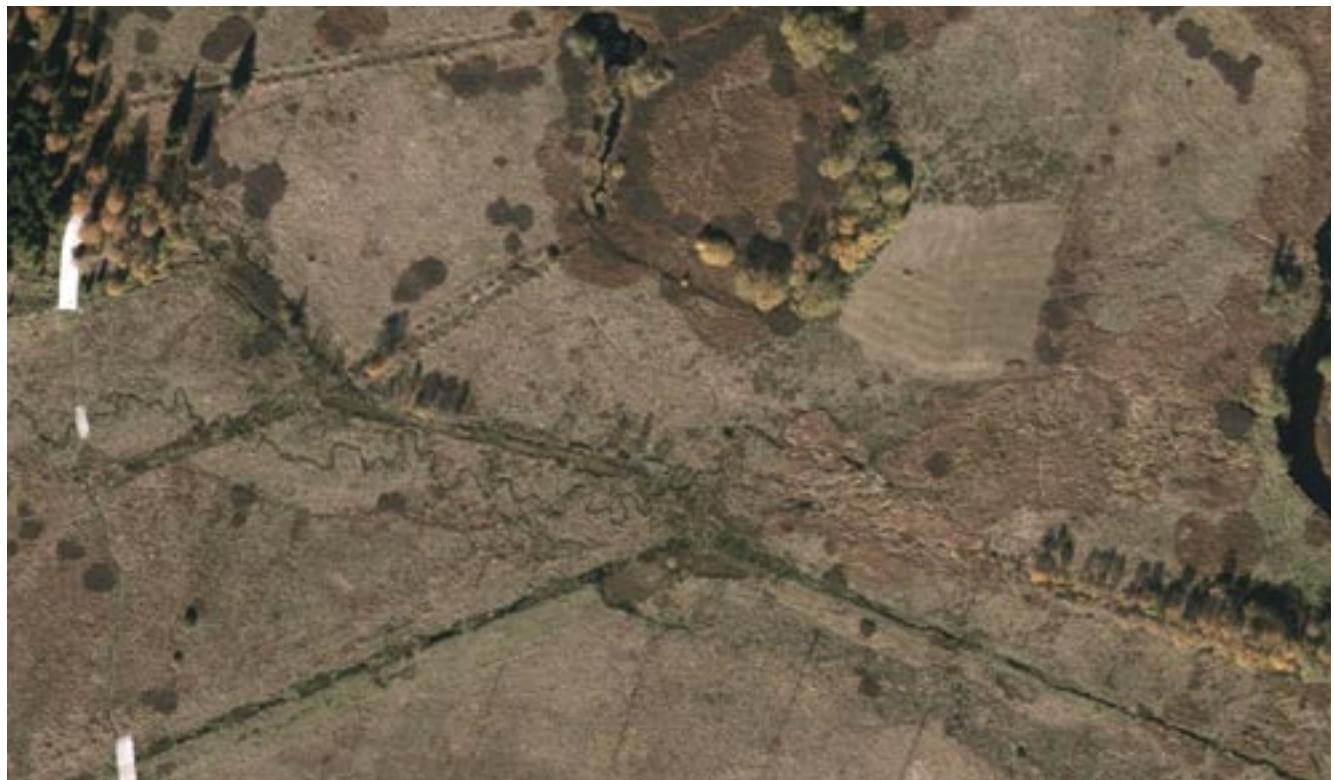
Fig. 133: The combination of the shaped cunette of the Žlebský stream with its returning to the preserved sections of the stream bed (on the left of the picture) and free release into the natural runoff route in the stands of tall sedges and reeds (on the right of the picture) on the background of an aerial photo. The start of the free releasing runoff is marked with a red dot.

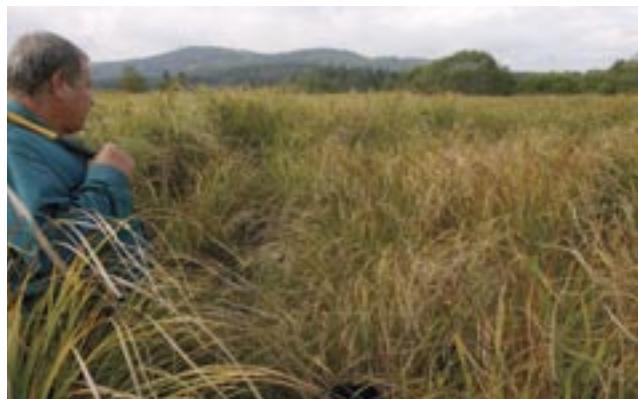
Fig. 134: The free released flow of the Žlebský stream hidden in marshy thickets of tall sedges and reeds, poorly permeable for machinery, September 2015 (I. Bufková)

Route identification was carried out in the same way and using almost the same data sources as for creating a new cunette (see Chapter 5.1.2.). For free runoff, the risk of vertical erosion, the likelihood of spontaneous development after the restoration and its possible consequences need to be assessed more than ever. It is necessary to know where the water will flow along the entire route and approximately where it will flow into the next watercourse.

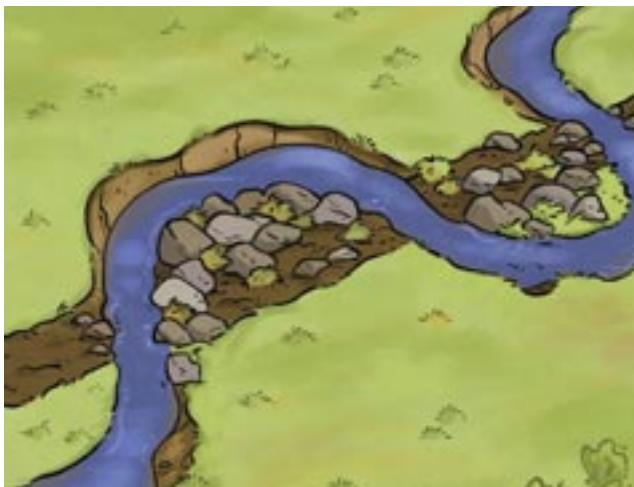
Fig. 135: A simplified drawing of the stream re-weaving by shaping its banks

of stream cunette can be achieved by simply releasing and shaping the banks. Ideally in combination with the insertion of suitable natural features into the stream bed. This method is suitable for straightened but relatively shallow channels on gentler slopes with a gradient of up to 5 % or in flat areas.

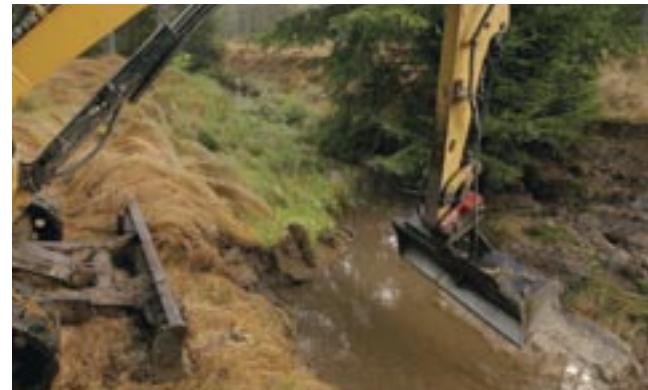
Fig. 136: Cutting out an arch into the future cut bank and moving soil mass to the opposite bank during the re-weaving lower downstream section of the straightened Hučina stream, October 2013 (I. Bufková)

In such cases, it has been shown to be effective to remove material from the future cut bank to an extent appropriate to the proposed meander bend and to move this material to the opposite bank (see Fig. 136). This becomes the point bar. The displaced soil from the opposite bank must be well stabilised, particularly at its upstream end, so that it is not eroded by the water flow and washed away in the most sensitive period immediately after the restoration. Stabilization can be provided by larger stones, logs, root balls, sods, etc., suitably placed at the edge of the relocated soil mass, preferably at its upstream part. Transfer of soil mass from the banks must be carried out at the level of the bottom or just above it and in no case must cause further deepening of the bottom. The only

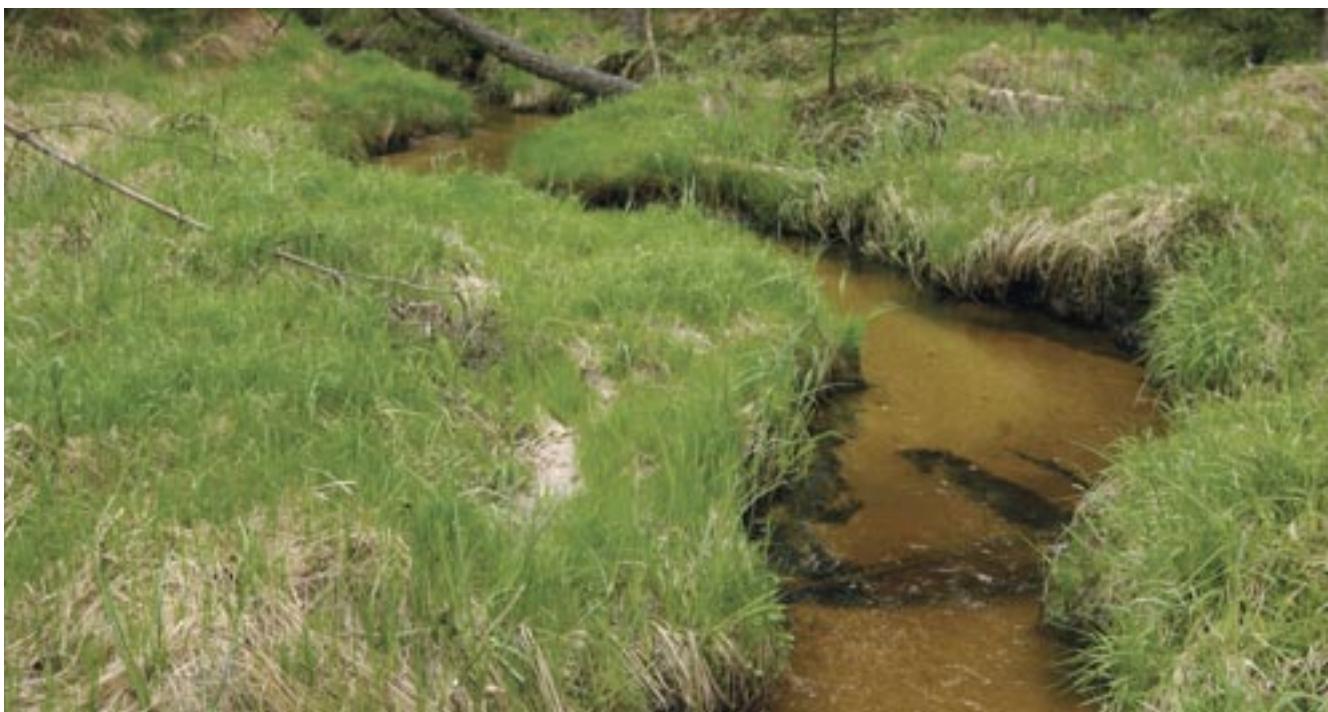
Fig. 137: Meandering former straight channel of the Hučina stream 3 years after restoration, May 2016 (I. Bufková)

In the Šumava region, several streams have been restored by loosening their banks and re-meandering them. The oldest of these is part of the lower downstream section of the Hučina stream, where these measures were carried out 11 years ago (in 2013) and are still working very well today (Fig. 137).

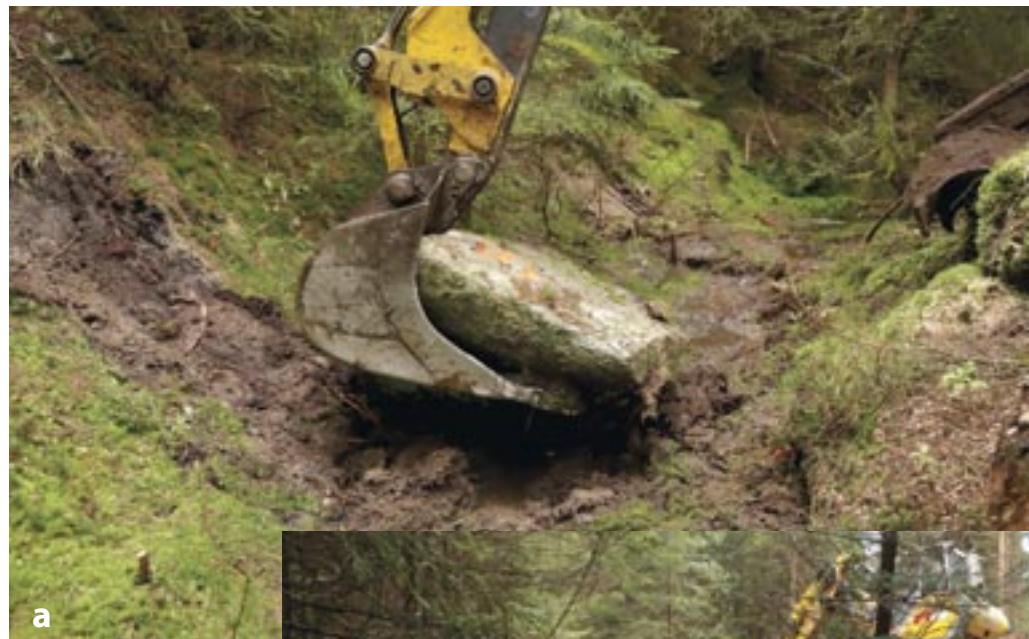
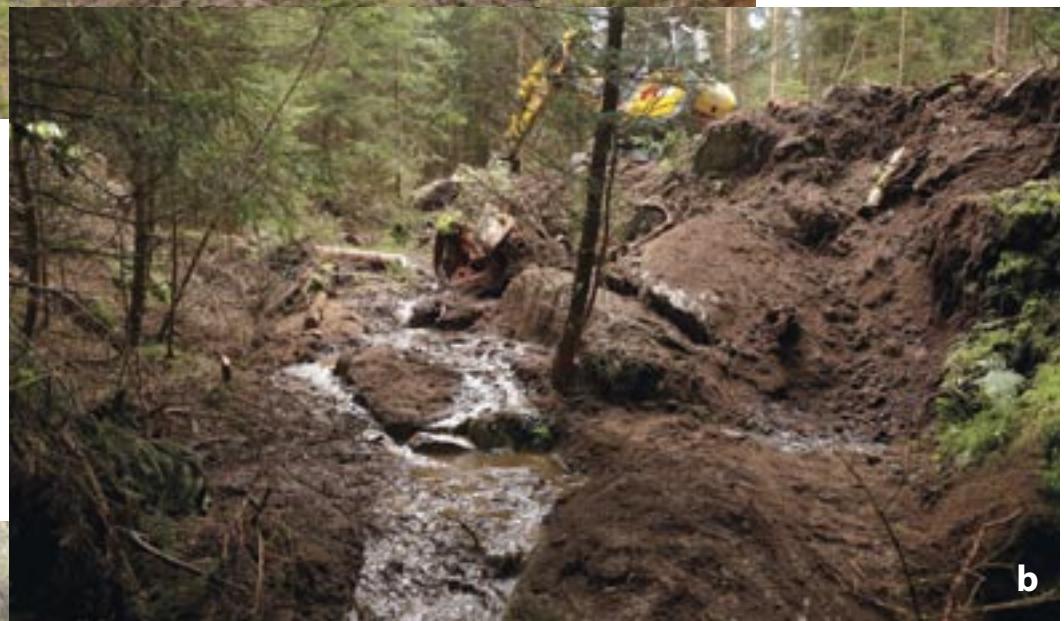
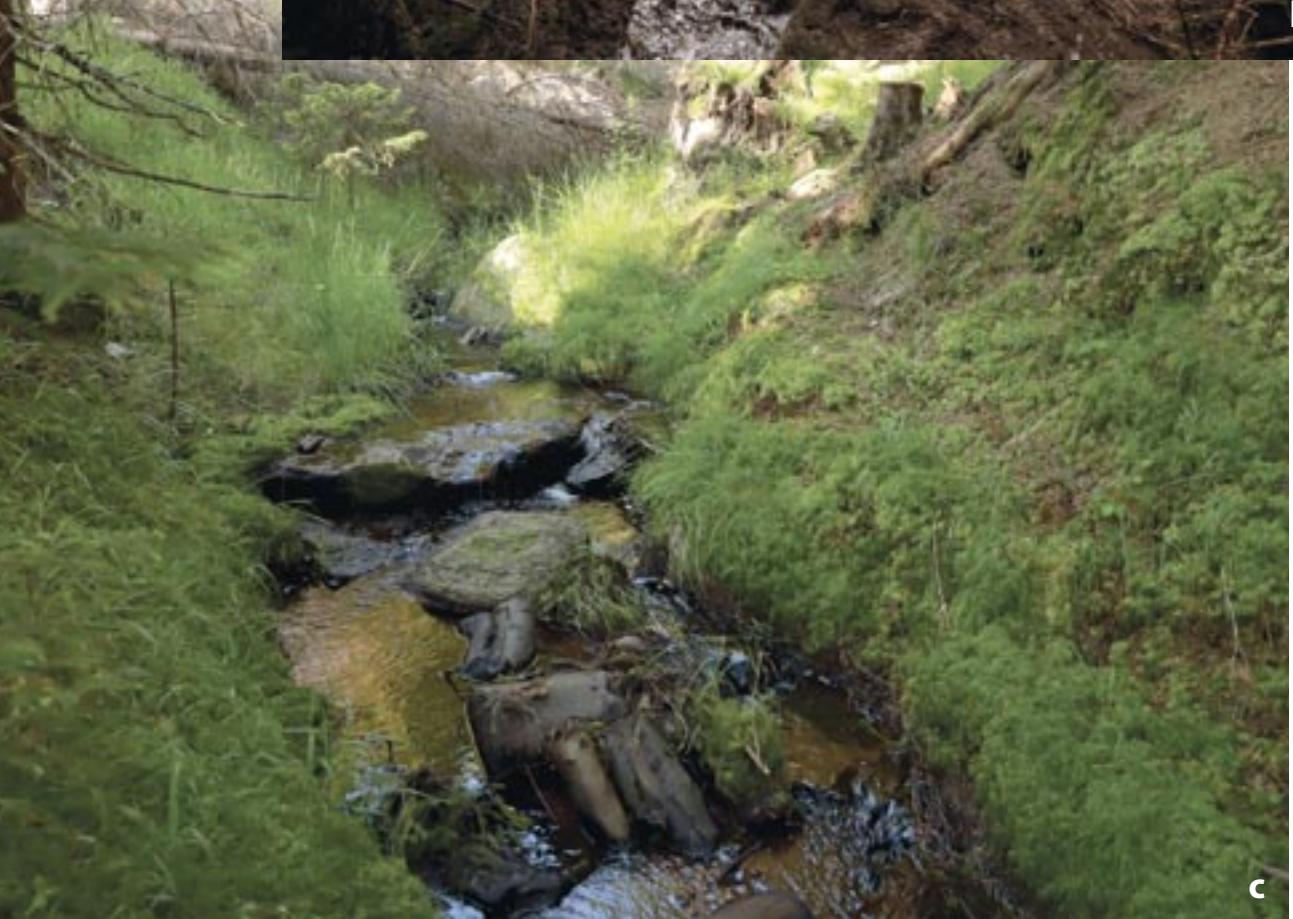
Fig. 138a, b, c: Placing large boulders, soil and sods into the erosion gully in the route of the original stream at the Gerlova Hut locality. Earthworks being implemented by the technique in September 2021 (a, b) and the situation in the third year after restoration in June 2024 (c). The bottom of the stream was raised by a total of 40-50 cm. (I. Bufková)

question. In such cases, the purpose of inserting natural elements into the stream was not only to re-weave the flow, but also to slow down the outflow, support the local deposition of sediments, and reduce bottom erosion (Fig. 138). The elements were always inserted in such a way as to maintain good flow permeability for aquatic organisms and to prevent the creation of undesirable height steps (higher than 10 cm).

Major complications occurred particularly in less accessible terrain on slopes with large longitudinal gradients mostly in forest and waterlogged sites. In such sites, severe erosion and extreme depths of erosion gullies with fast and also fluctuating runoff are a frequent problem (Fig. 138). And these situations are not unique. Access for machinery is basically only possible at or just along the line of the eroded gully. The transport of sufficient quantities of suitable gravel and stones for making stream shallow is practically impossible due to the site morphology and environmental condition (absence of roads, waterlogged soils, sloping gradient, dense forest stands). The same solutions cannot be used here as for well accessible watercourses in open countryside, around which machinery can move freely and transport any quantity of material, e.g. for stone backfill on stream bed.

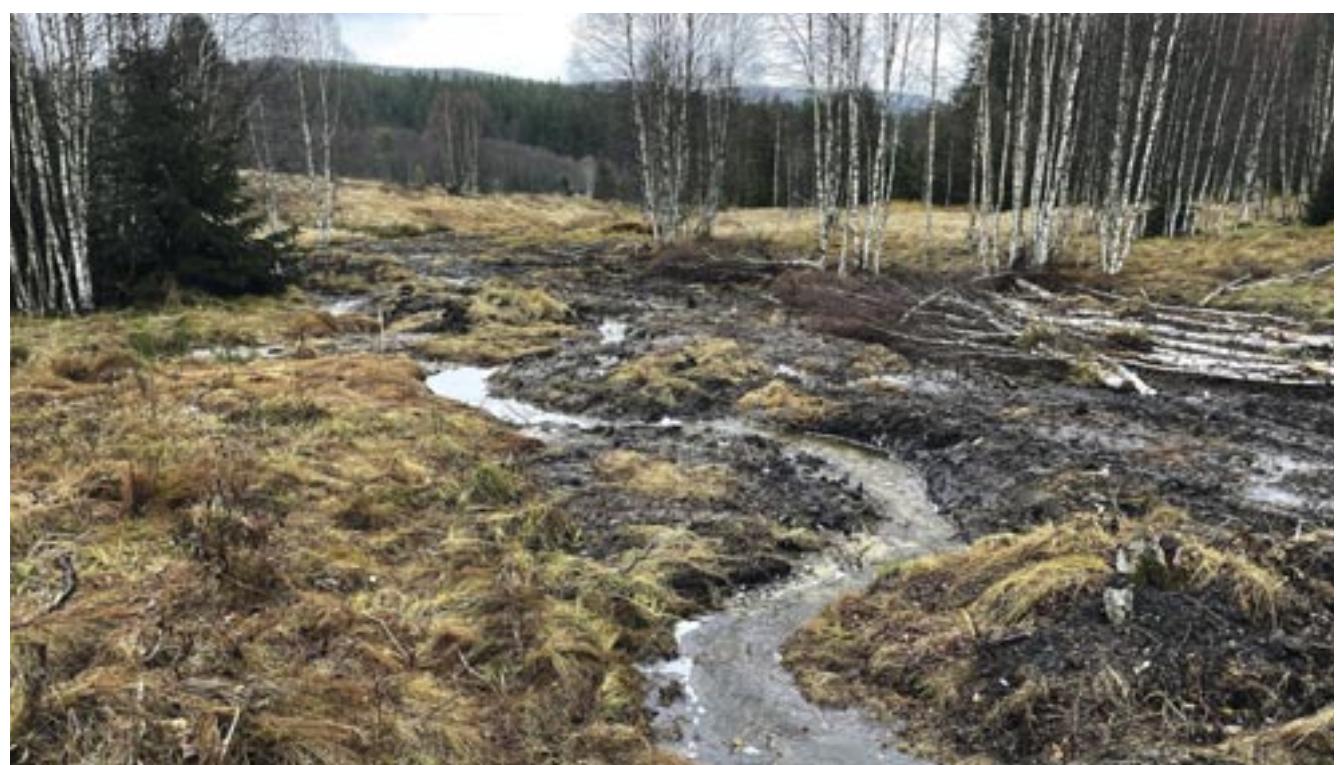
Fig. 140: When done correctly, the restored stream cannot be seen to flow almost one meter above the former bottom of channel. It will be even able to withstand flood situation relatively soon after restoration without any problems. Location Pod Skelnou, November 2021 (L. Linhart)

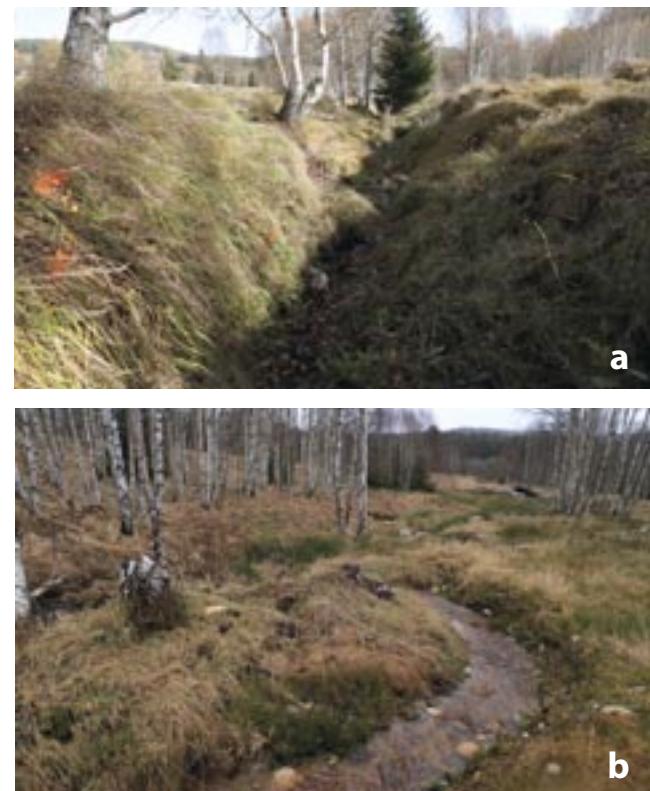
Fig. 141a, b: Restored natural stream bed directly in the line of straightened and modified watercourse 1 year after restoration, Pod Skelnou location, October 2021 (a) and January 2023 (b). The red marker in the foreground shows the level to which the bottom has been raised (I. Bufková)

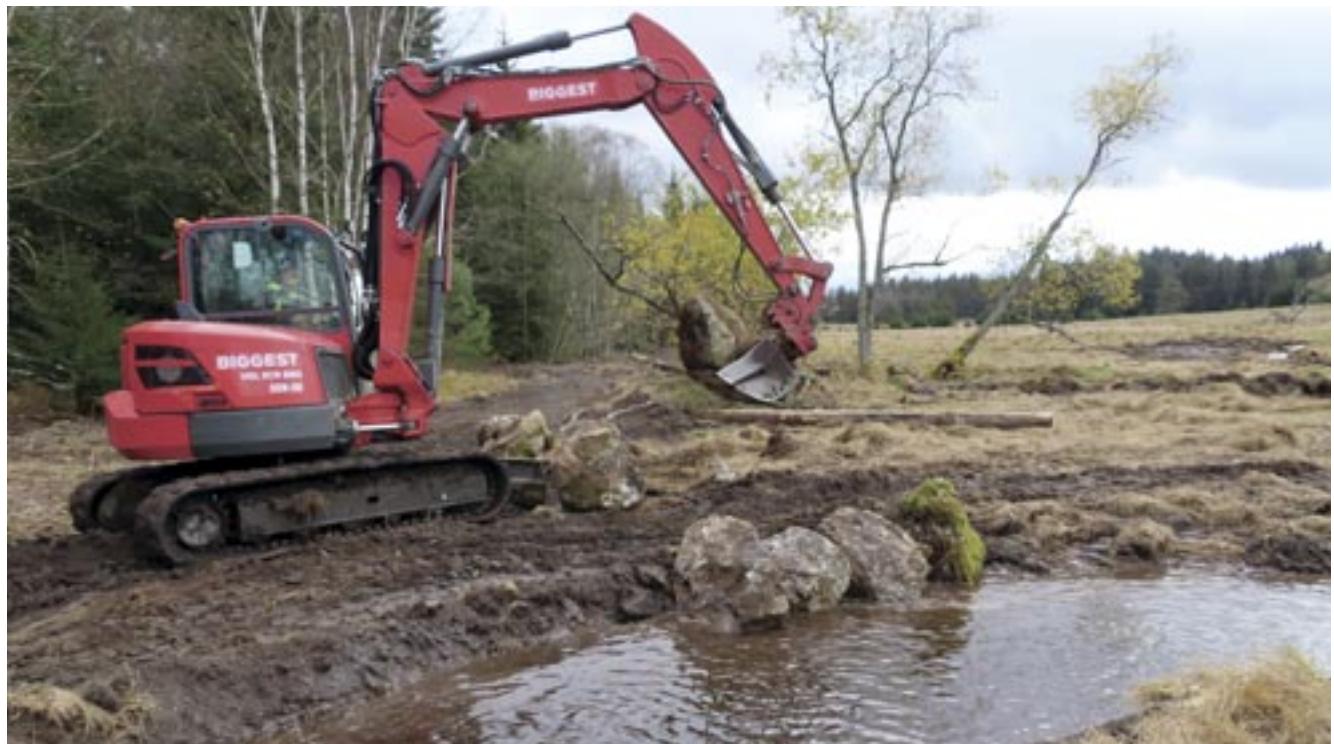
Fig. 142: Bringing the restored Kořenský stream out of the regulated channel in the Stráženská slat locality. The downstream (in this case the left) bank of the stream, which runs along the reinforced dam in the canceled channel, was fortified with large boulders, February 2024 (I. Bufková)

The downstream bank of the crossing stream, which also represents the guide (upstream) wall of the dam backfill, including its overhangs to the banks, must be reinforced with stone riprap in a fraction proportional to the size of the stream. Large stones and boulders are most suitable (Fig. 142). Infilling the former channel below this crossing should be compacted for as long a section as possible. The continuation of the drainage channel below the crossing is dammed in the standard manner by woody dams with backfill. Complete infilling of space between the installed dams for at least 3-5 sections downstream the crossing is optimal. The nearest pool should be no closer than 20-30 metres below the crossing.

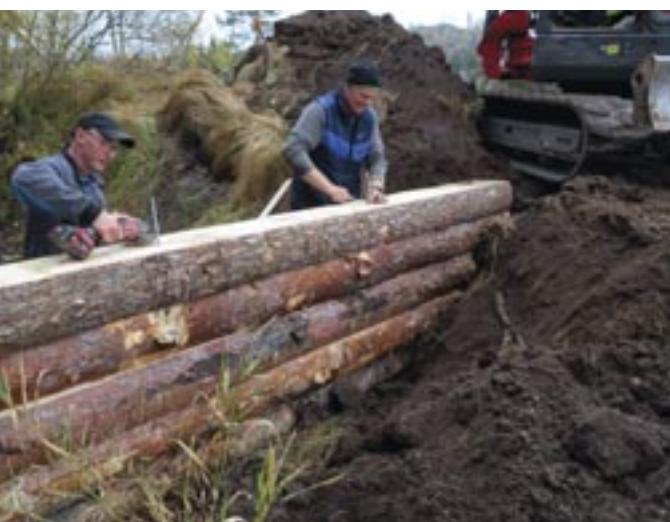
Fig. 143: During the construction of massive dams at the intersections of straight channels with the restored stream, logs cut on the upper and lower sides were used in a number of places, Kořenský stream, November 2023 (J. Zelenka)

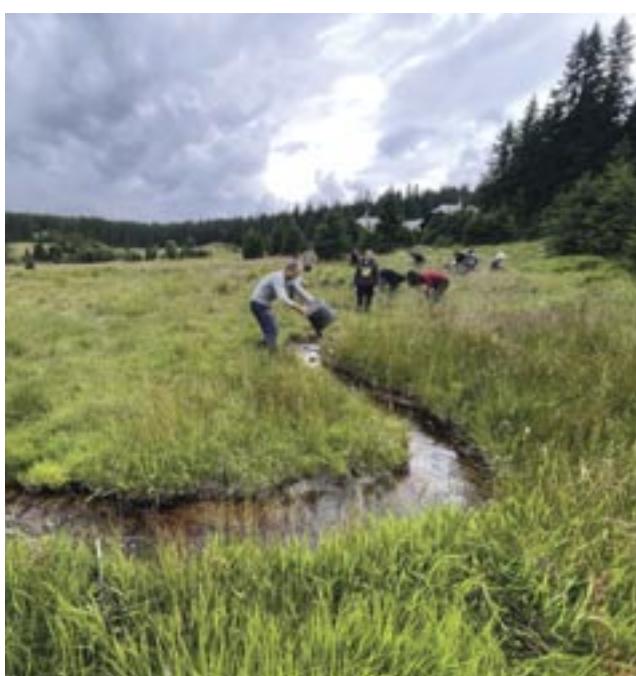
Fig. 145: Volunteers helping to fill in the missing rocky substrate in the stream section of the restored small stream at Rybárný I, July 2022 (L. Linhart)

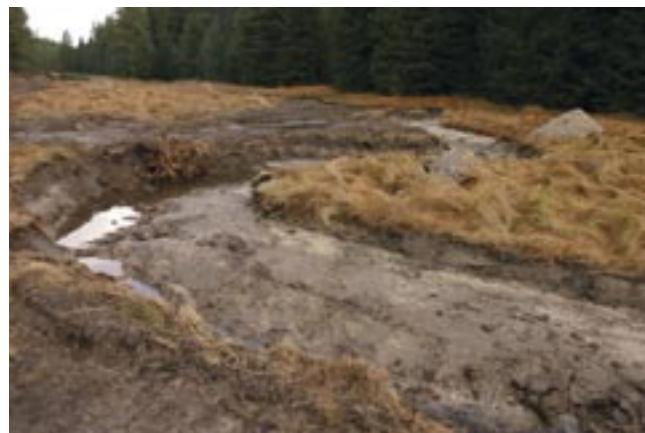
Fig. 144: Initiation piles of sand and gravel misplaced on the banks of the newly formed Hucina channel. The piles do not encroach into the channel and consist of too fine a fraction. Hucina, October 2013 (I. Bušková)

A proven method in less accessible terrain is to locally leave initiation piles of rock and gravel in the channel at the banks (Figure 144). These deposits of externally delivered sediment are subsequently, especially at higher flows, broken up, washed and deposited spontaneously downstream. It is important that the material is actually placed in the channel, not just behind the edge of the bank outside the channel where there is less potential for washing and transporting downstream. In addition, the chances of being carried downstream decrease over time as the piles become overgrown and stabilized by vegetation.

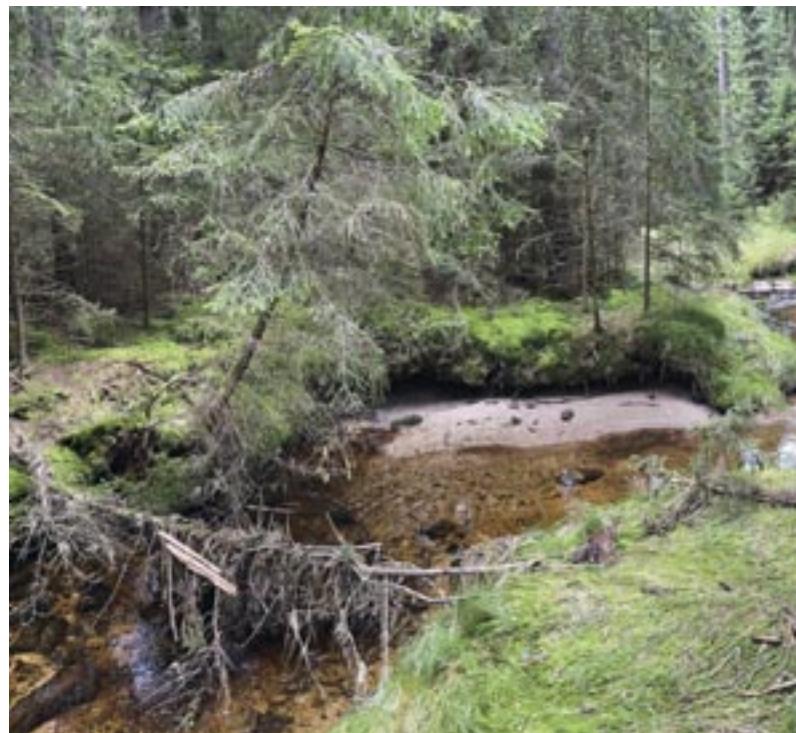
Fig. 146: Trees that have fallen spontaneously into the restored Hučina stream further increase the morphological patchiness of its bed and channel. The picture is a continuation of the time series shown in Fig. 83a, b, c on page 94 (I. Bufková).

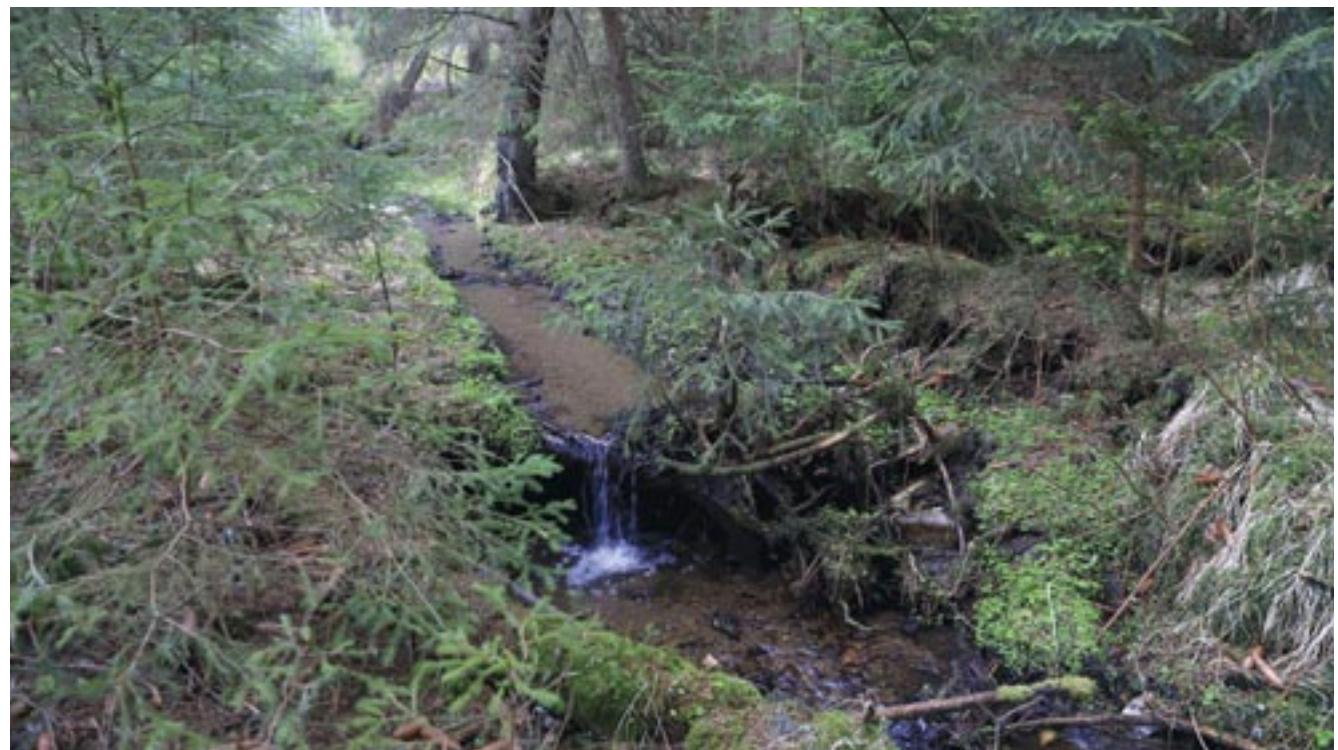
Fig. 147: A small stream with a naturally developed step at the bottom of the channel made of branches and pieces of logs at the Roviny site, April 2020 (I. Bufková)

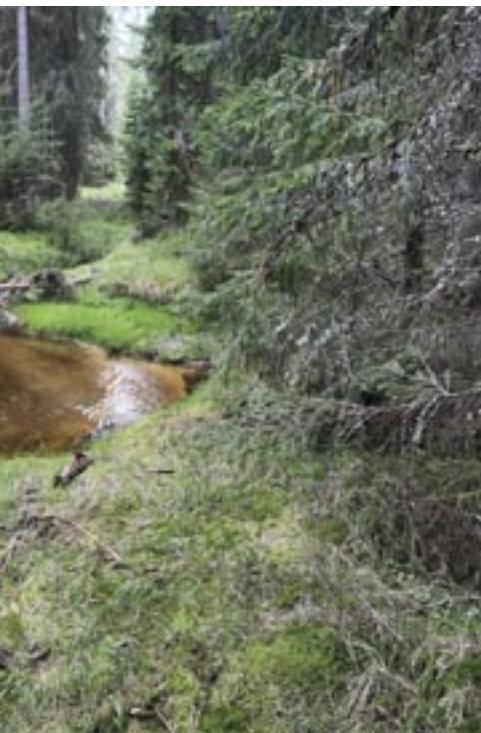
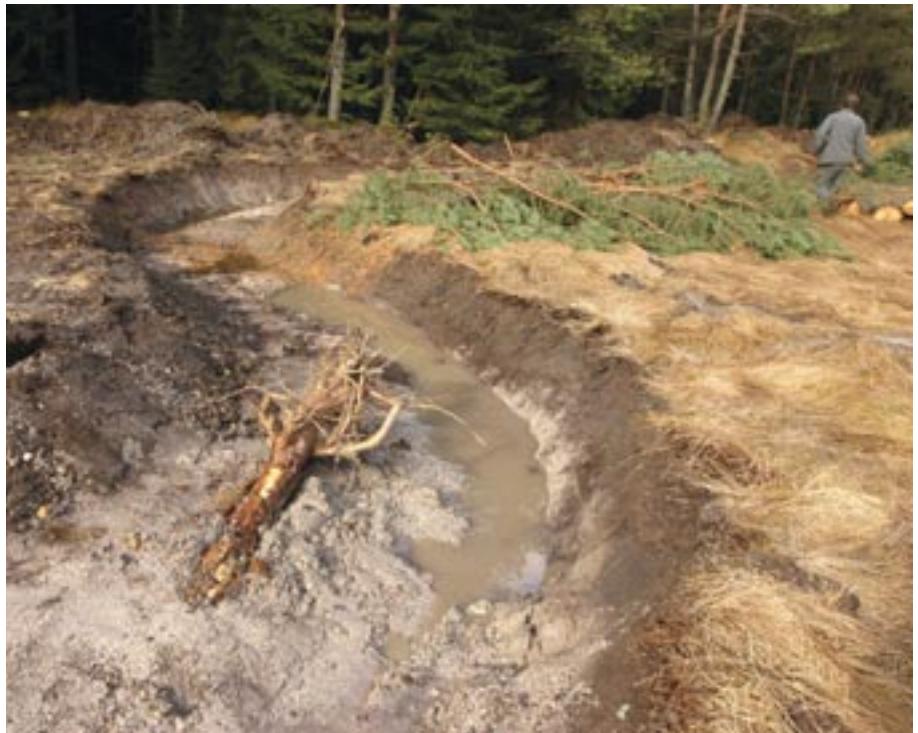
Fig. 148a: Location of the base of a tree with roots on the preserved sediments near the sedimentary bank of the revitalised Hučina stream, October 2013 (I. Bufková).

stabilise the moved point bars during the widening of straightened channels. Felled trees (mostly young deciduous) were placed in suitable locations with the crown facing the stream (Fig. 148).

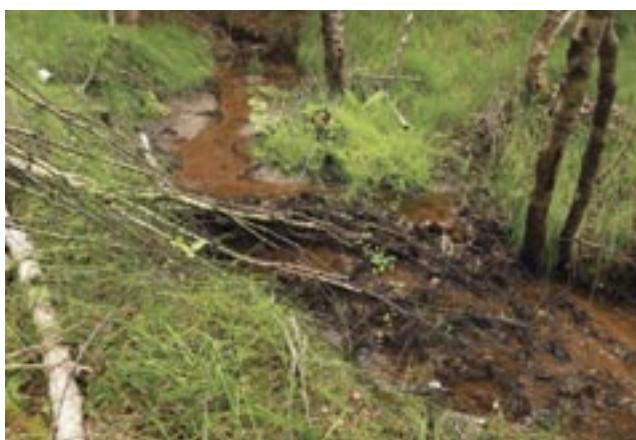
Fig. 149: A tree trunk buried in the bottom sediments of the original channel of the Hučina stream "returned" to the bottom surface after revegetation due to erosion and accumulation processes, April 2015 (I. Bufková)

Occasionally, pieces of logs and woody debris deposited in the original sediments were also left in the preserved beds of larger streams (Figs. 149, 153). These cases have always served as inspiration for similar features installed as part of restoration.

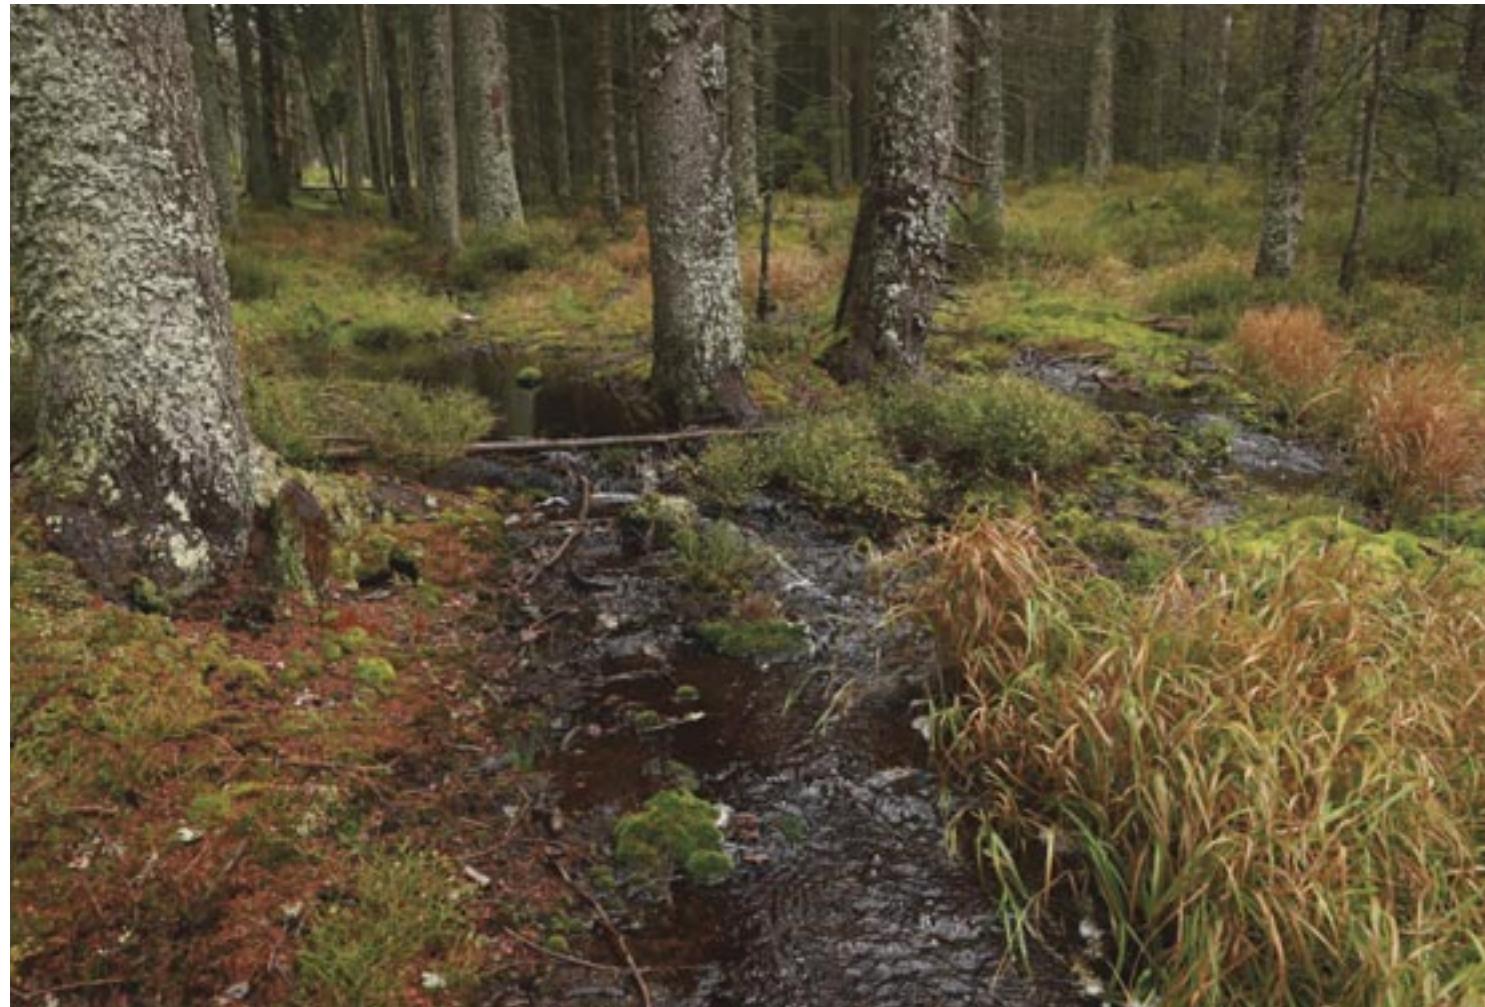
Fig. 150: Free release of water to the natural drainage route in the bog spruce forest on Nová Slat' bog, October 2023 (I. Bufková)

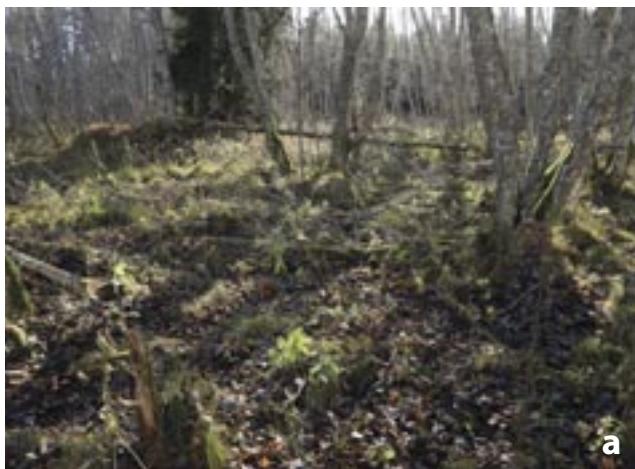
Fig. 151: The inconspicuous fortification of the banks in the small streams with longitudinally placed machined logs is often not visible under vegetation, but is very effective and must be removed, Zhůří, June 2024 (I. Bufková)

If the beds of the modified streams were reinforced (with blocks, stones, tree trunks), this reinforcement was removed. In the pre-war period, mainly natural materials (stones, tree trunks) were used to reinforce the beds (Fig. 151). These can
