Hydrological restoration

**Summary of experience
with restoration of wetlands,
springs and streams in the Šumava region**

Project "LIFE for MIRES"

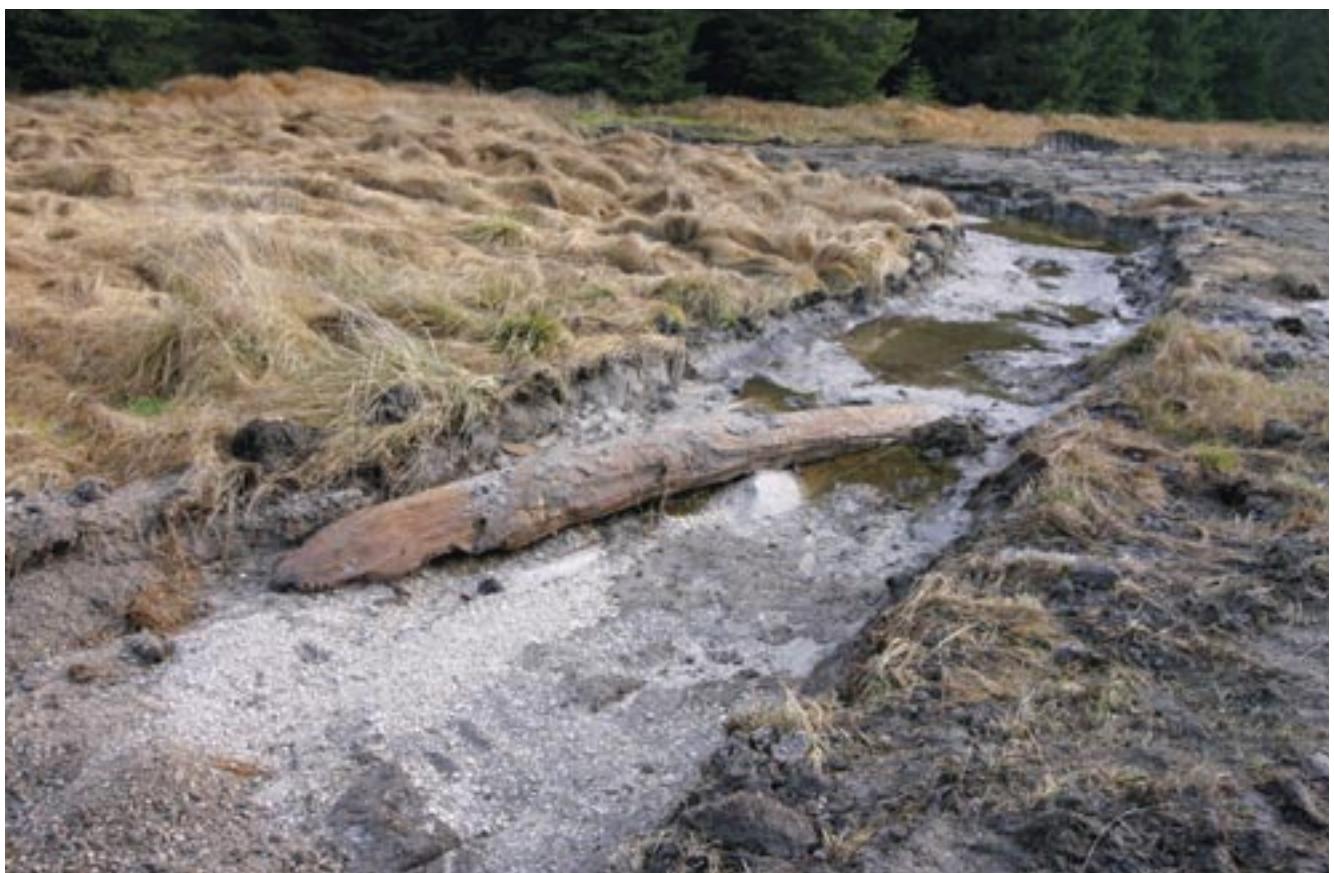
Fig. 152a, b: Nameless stream in the alder woodland on the eastern edge of the Dobrovodské meadows site. The stream was dammed before restoration and was returned to the surface in November 2022. The picture shows the state in November 2021 just before restoration (a) and in July 2024, two years after restoration (b).

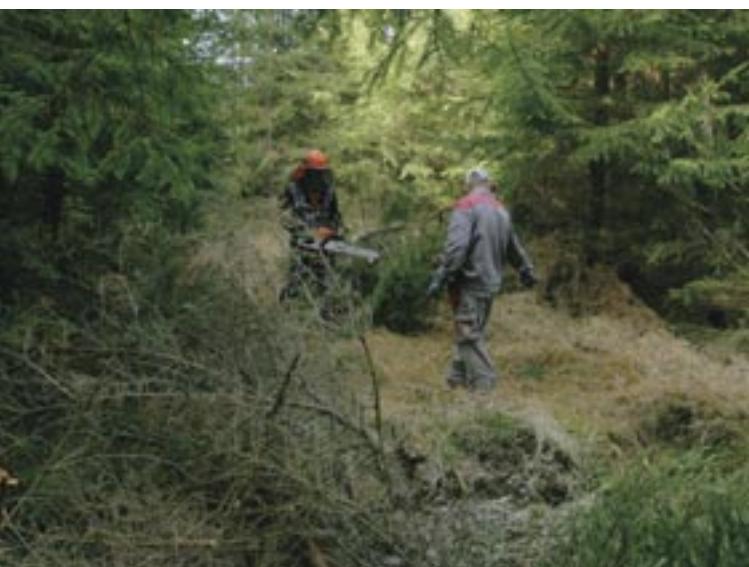
Fig. 155: Marking of trees to be cut for the passage of machinery in hardly accessible terrain at the Stožecá site, April 2020 (I. Bufková)

Under certain conditions and in certain habitats a much more sensitive approach is needed. The tree pruning for passage can be minimised to the specific size and capabilities of the machinery in the form of a "zigzag" passage. This system takes in account a zigzag passage between trees close to the channel, making maximum use of the natural gaps between trees. Here, only trees standing directly in the passage route or on the channel bank where the dams are installed (space approx. 5*3 m according to the terrain configuration) are cut to the width of the excavator. The zigzag approach can reduce the pruning of trees in the route by up to 70 % and is much cheaper and more economical. It requires good field preparation, marking of all specific trees to be cut, signs for passing machinery and a skilled excavator operator.

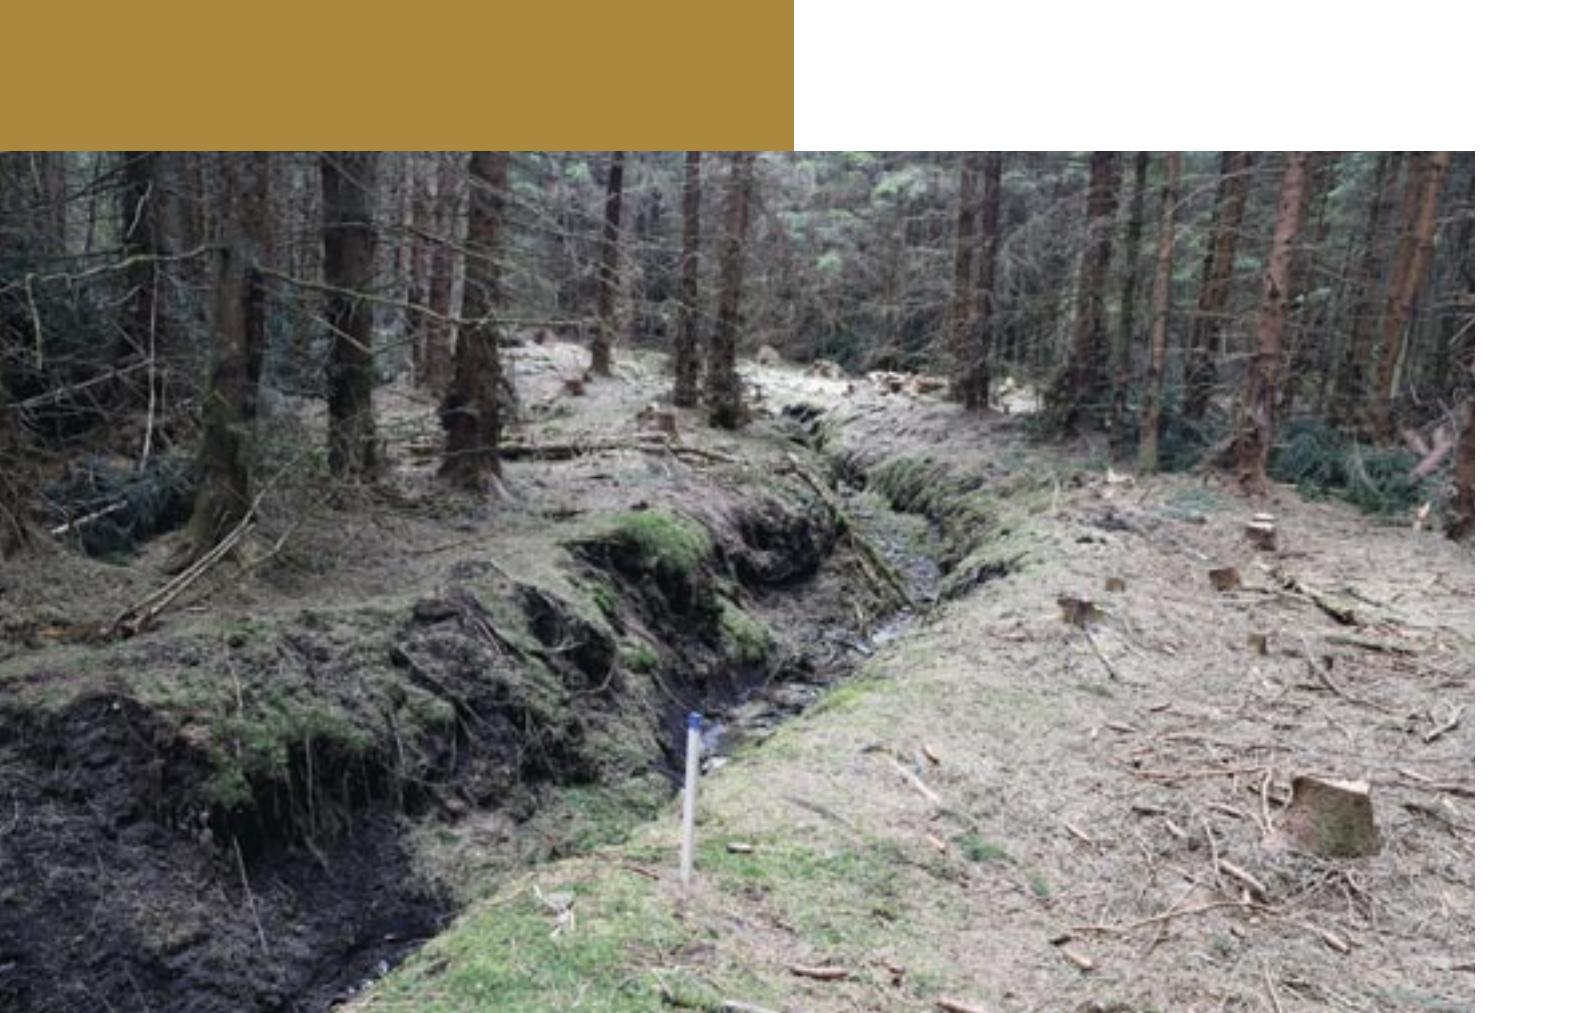
Fig. 156: Cutting a route for an excavator at the Nové Údolí site, October 2019 (I. Bufková)

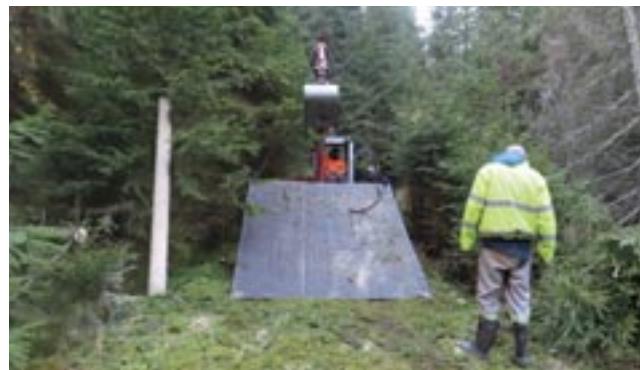
Fig. 157: Tree pruning along the channel to clear the access route for machinery at the Devitka site, April 2020 (I. Bufková)

In general, however, it can be summarized that pruning for passage and movement of machinery is not associated with a greater risk of damage to natural values, as the expansion of trees into dense cover around drainage system is usually the result of drainage and subsequent habitat degradation (see Fig. 157). Once the channels have been removed and re-watered, the natural wetland vegetation regenerates very well on the cut lines (particularly where the soil deposits on banks were removed – see Fig. 159). It will thus more easily replace drought-loving species, mostly grasses or low cranberry bushes, spread as a result of drainage. And if it is possible to use all the material from the tree pruning when filling the channels, then the risk of damage to the habitat due to the transport of wood material is eliminated.

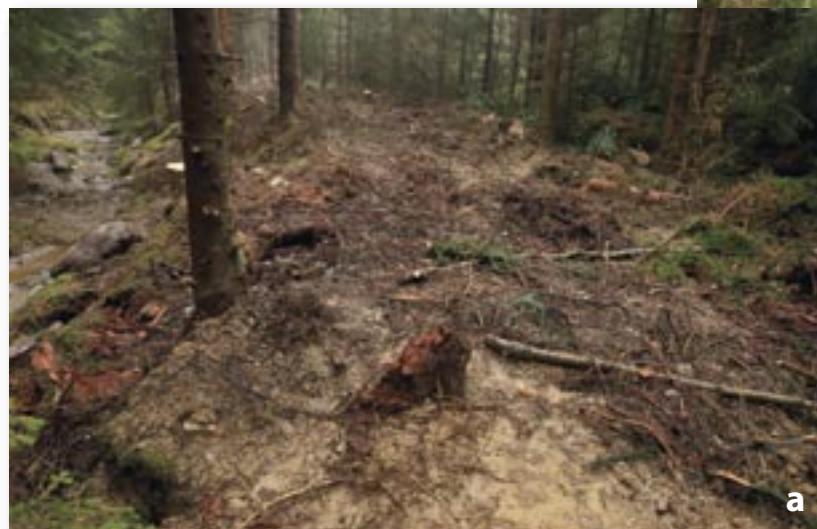
Fig. 158: Transfer of pontoon boards with an excavator during restoration at the Novohůrecká slat' site, October 2021 (E. Václavíková)

In some inaccessible locations, heavy waterlogging makes it difficult for machinery to reach areas with sufficient surface bearing capacity. In such cases, it is necessary to use pontoon ground boards made of suitable material, which the excavator places in front of itself (Fig. 107). Sometimes a temporary route can be constructed using cross-laid logs of felled trees to cover waterlogged areas with low ground bearing capacity (Fig. 71). Similarly, temporary crossings over drainage channels or small streams can also be constructed.

It is advisable to increase the surface bearing capacity on not very long heavily waterlogged sections by laying pontoon ground boards which the excavator lays in front of itself (see Fig. 158). There are a number of suitable types available today that can be used. However, it is important to identify and mark out the sections at risk to machinery in advance and to include the cost of using pontoon ground boards in the project cost.

The machinery can be used mainly in dry or slightly wet parts of the site. Possible short crossings over wetter sections (in the order of meters) must be solved by pontoon boards (Fig. 158) or a temporary wooden walkway using the material from the prunings (Fig. 71) in agreement with the investor or designer. Machines can also usually only move in one direction, as frequent back and forth and changes of direction lead to disproportionate damage to the site (for more details see p. 64).

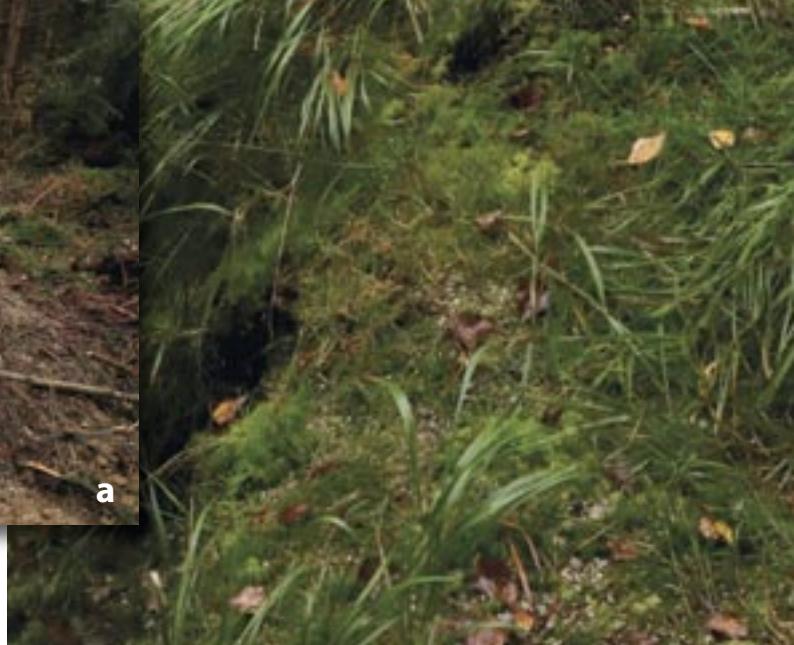
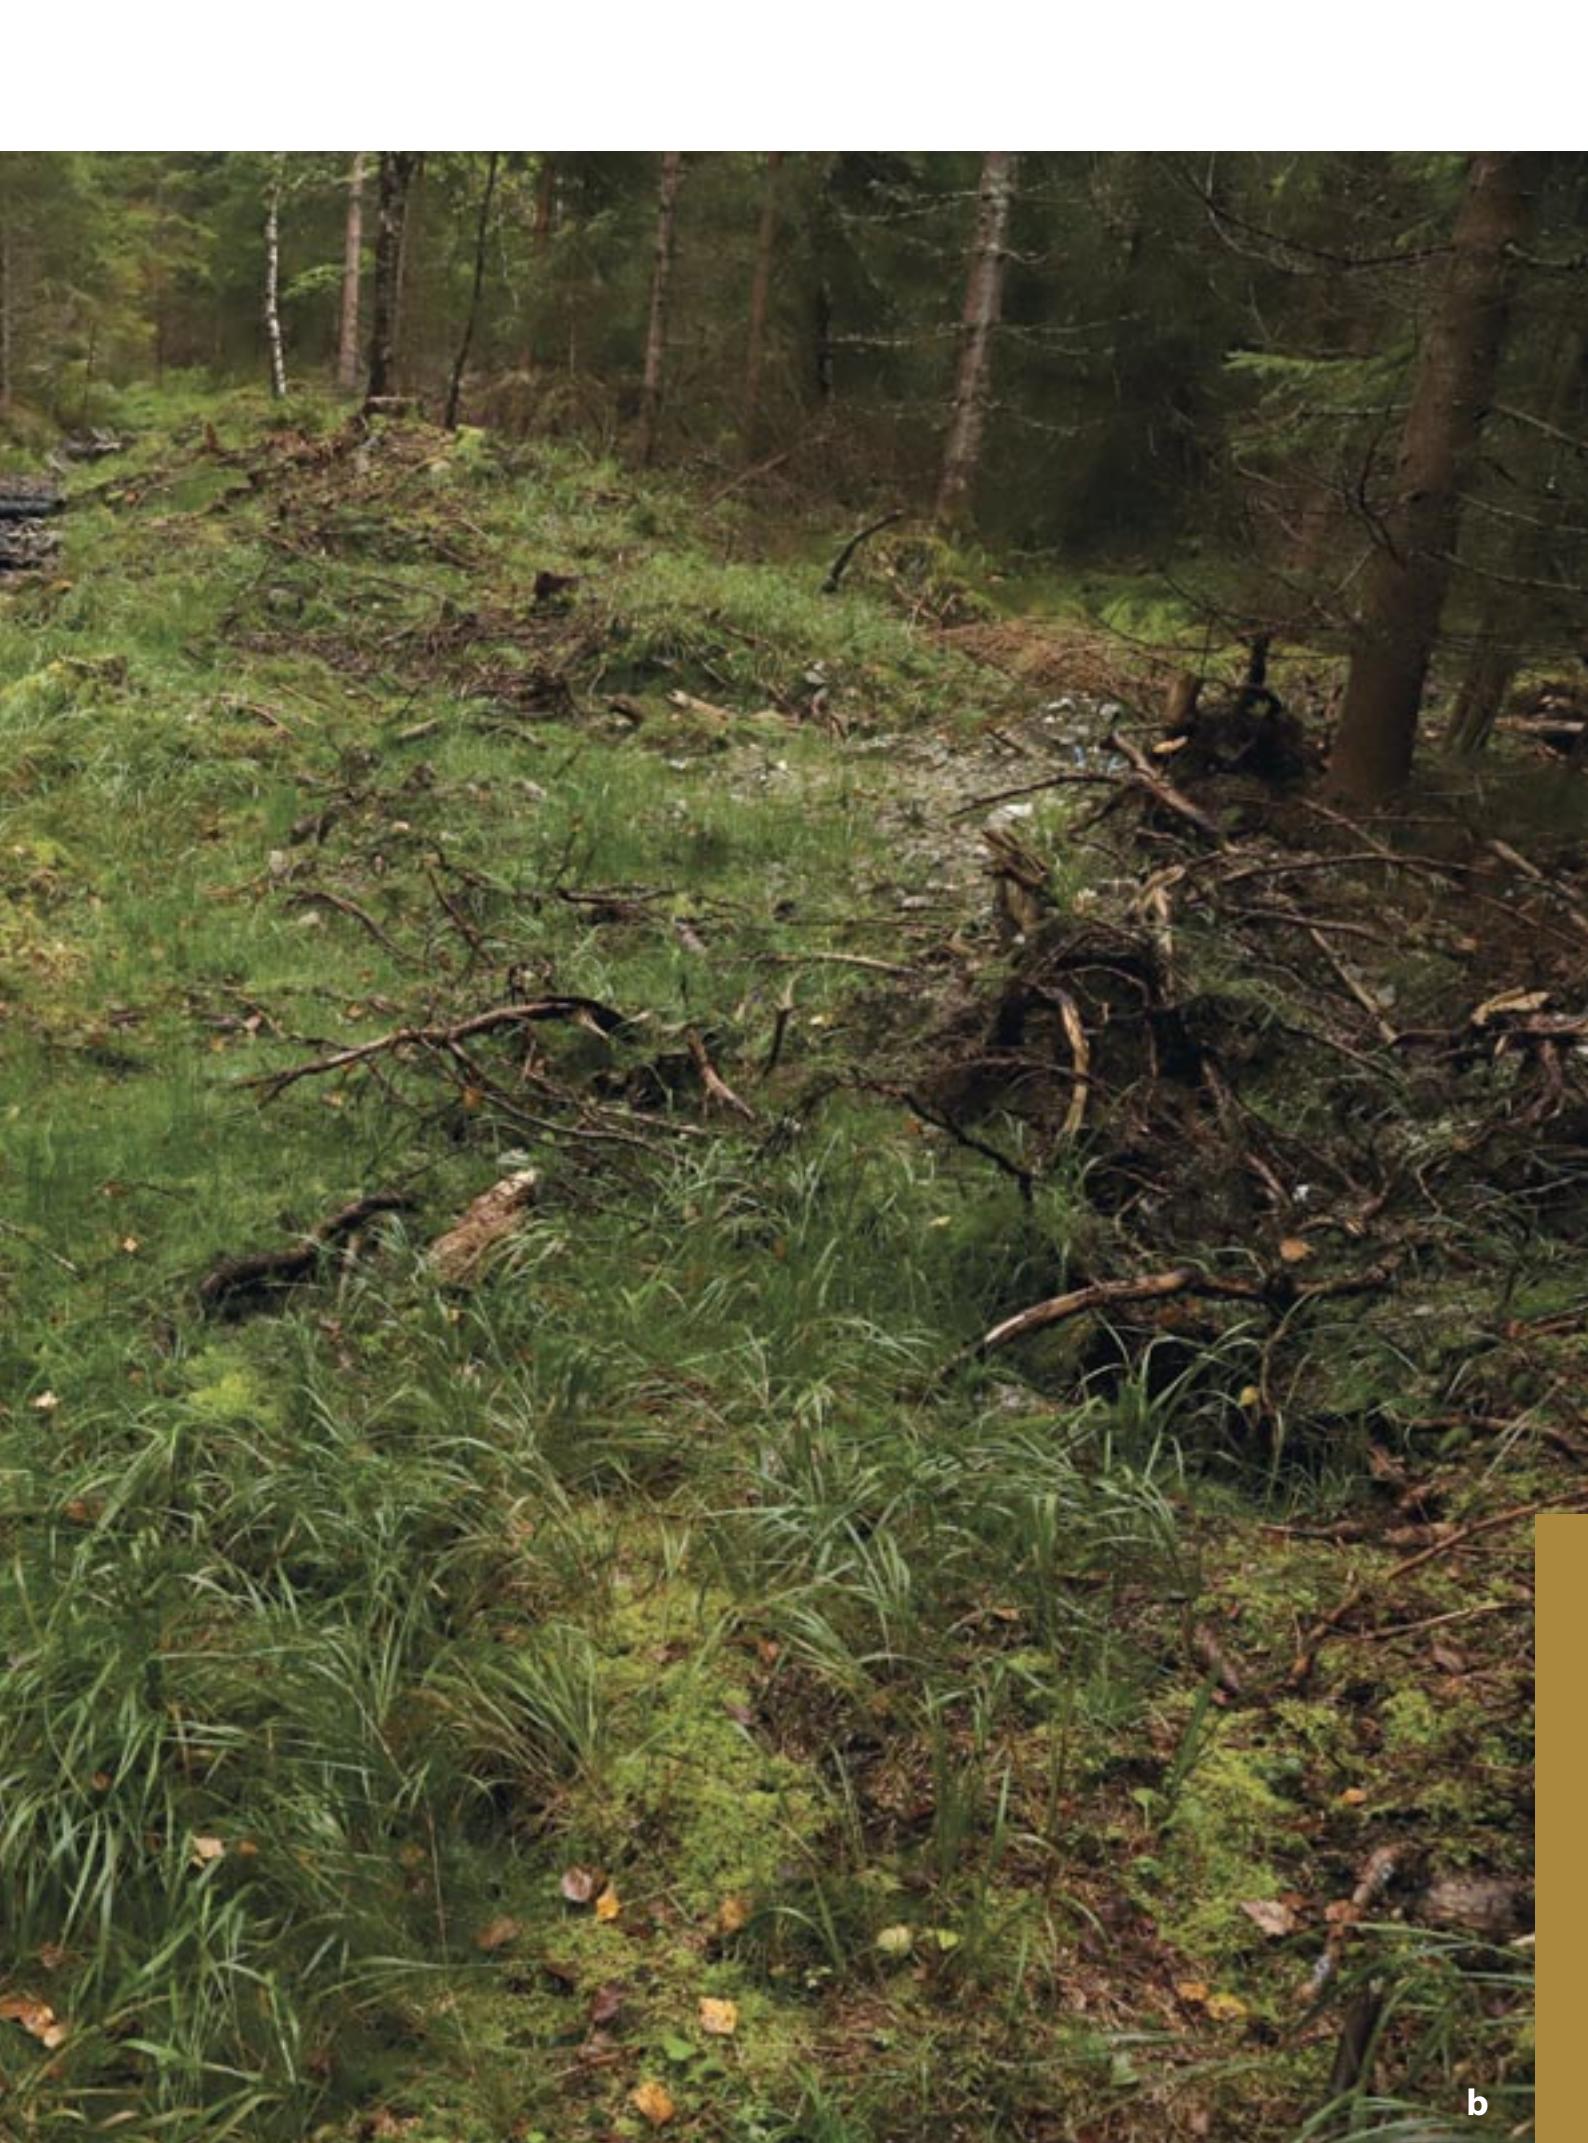
Fig. 159 a, b: Rapid regeneration of routes for the passage of machinery at the Gerlova Hut's site, situation in November 2020 immediately after the end of the restoration (a) and in September 2021, just one year after the restoration (b). The emergence of sphagnum mosses is clearly visible (I. Bufková)

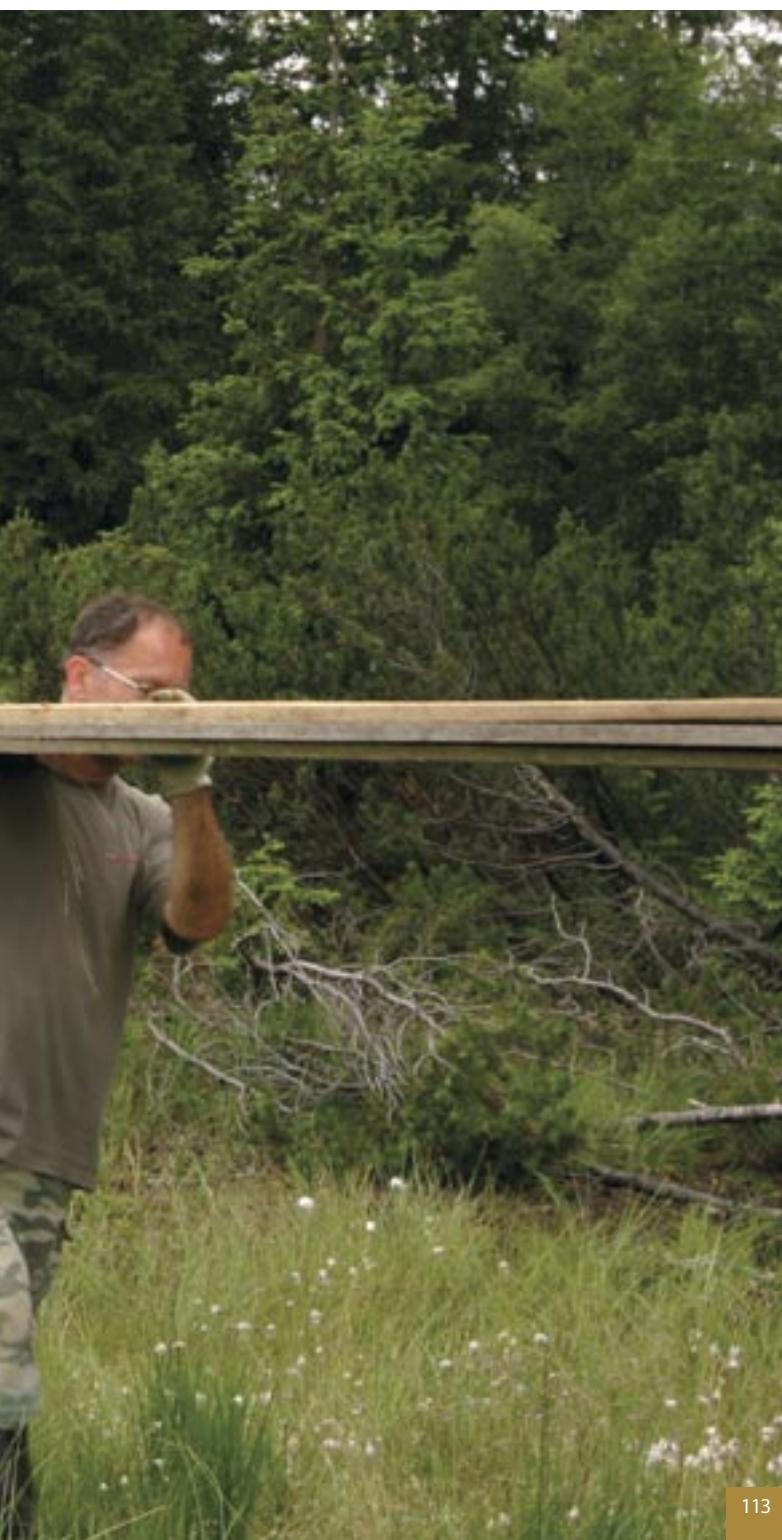
Fig. 160: Volunteers help with the transport of planks and boards for the construction of dams in hardly accessible places, Rokytecké slatě site, August 2013 (I. Bufková)

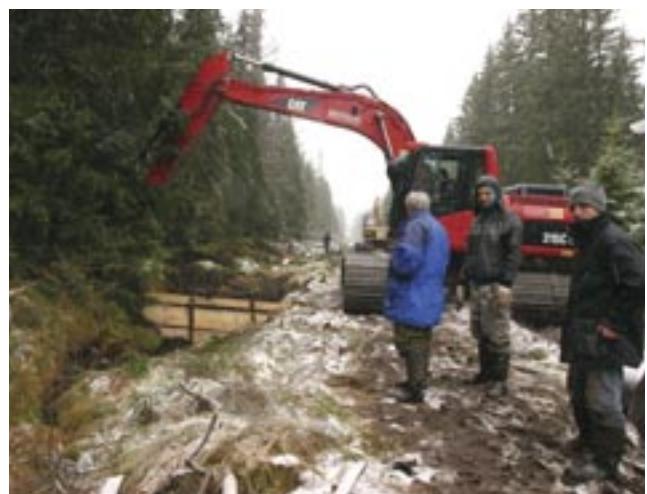
Fig. 161: In sensitive habitats, it is advisable to use mud dredgers with wide tracks, Černohorský močál site, October 2014 (I. Bufková)

Machinery intended for use on mires must have tracks made of plastic. Metal tracks are strictly undesirable as they tear and severely damage the top peat layers.

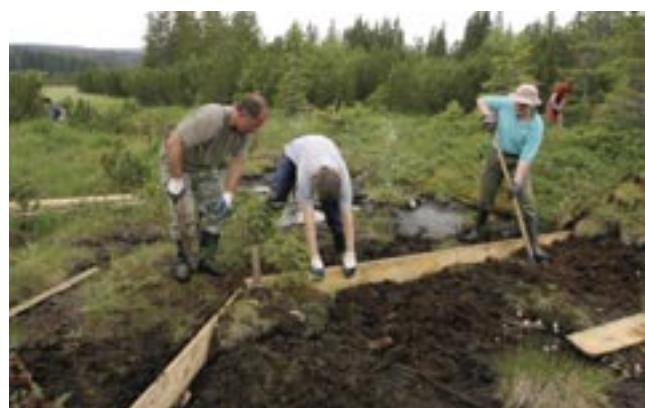
Fig. 162: Volunteers help to stop rill erosion on the line of the former Iron Curtain crossing the Rokytecké slatě site, July 2013 (I. Bufková)

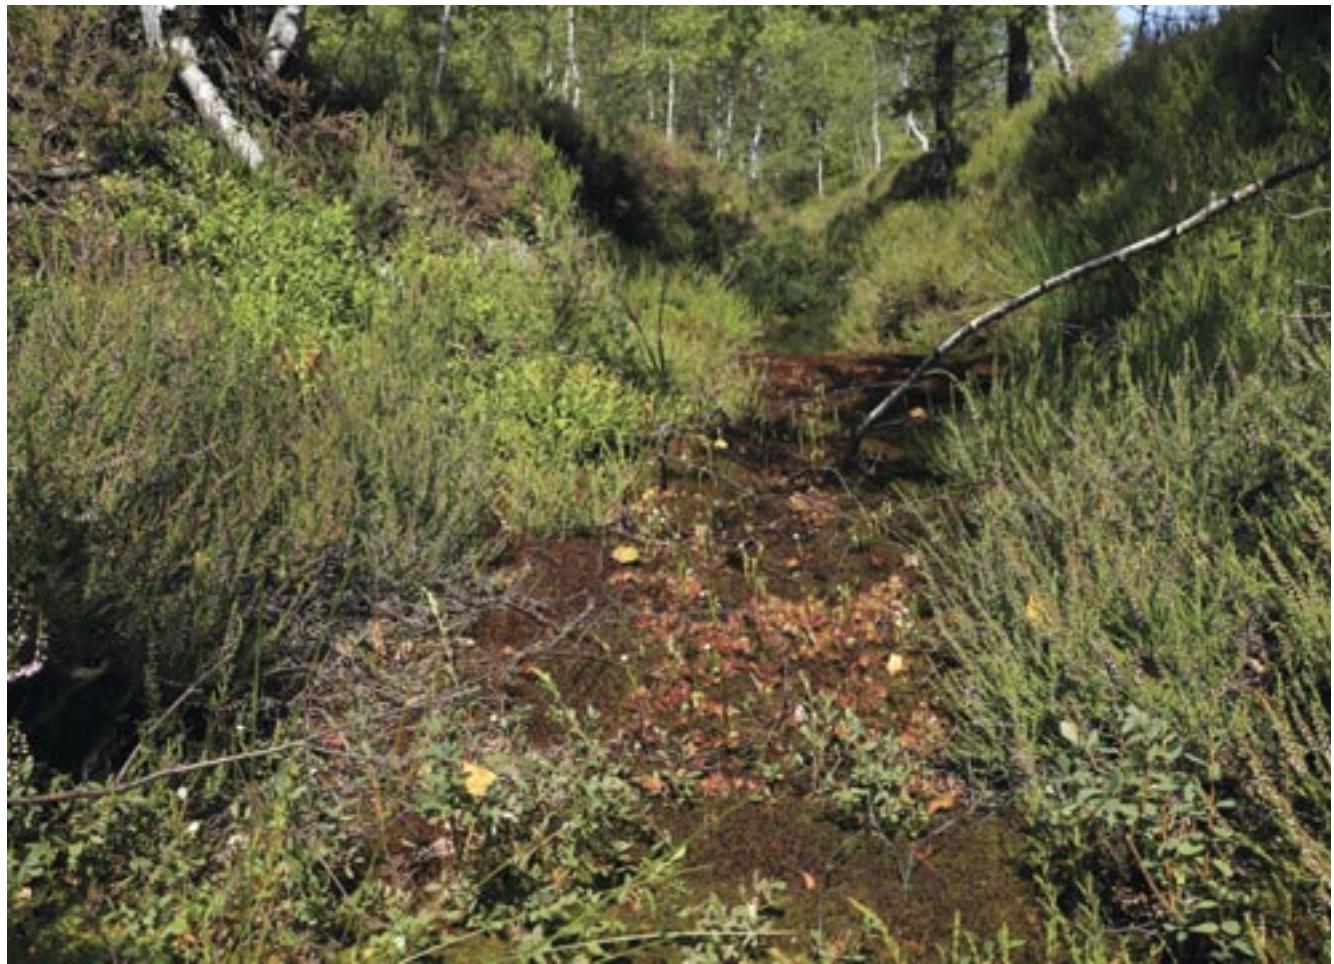
Fig. 166: Bog mosses and Round-leaved sundew (*Drosera rotundifolia*) at the bottom of the drainage channel on the mined peat bog Borková before restoration, July 2022 (I. Bufková)

- Preservation and use of wetland vegetation from canals. On heavily drained sites, wetland species often survive only on the bottom or bankwalls of canals or engineered and straightened channels. Wetland vegetation is therefore removed from the canals prior to blocking and filling and, after the measures have been implemented, placed in suitable and moisture-matched habitats on the restored site. It is always the intention to retain and move all wetland vegetation out of the canals. However, this is often not possible and therefore mandatory percentages of removed and reused vegetation are set at a minimum of 50 % for

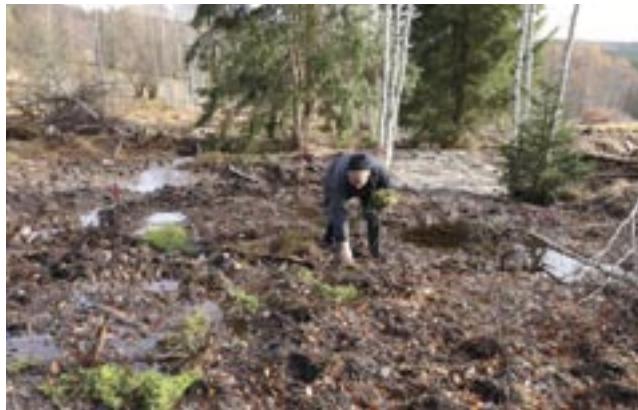
Fig. 167: Vegetation from the bottom of drainage canals returns to the waterlogged soil surface in places where these canals have been blocked and filled in, spring at Pod Skelnou site, November 2021 (I. Bufková).

During the installation of woody barriers and infilling of channels, bales of wetland vegetation are placed on the surface of the soil backfill of the dams and used to fill the space between the dams (see Chapter 4.1.3.). However, it is necessary to place them with living plants on top, which requires a certain amount of skill from the digger. If done correctly, plants easily grow over the lines of the former channel after site re-wetting. In this way, they also very effectively stabilize the bodies of the backfills and significantly accelerate the terrestrialization of the canceled drainage ditches and their disappearance from the landscape. They are also important from the point of view of biodiversity, as they facilitate the return of native wetland species directly from the local source (Fig. 167).

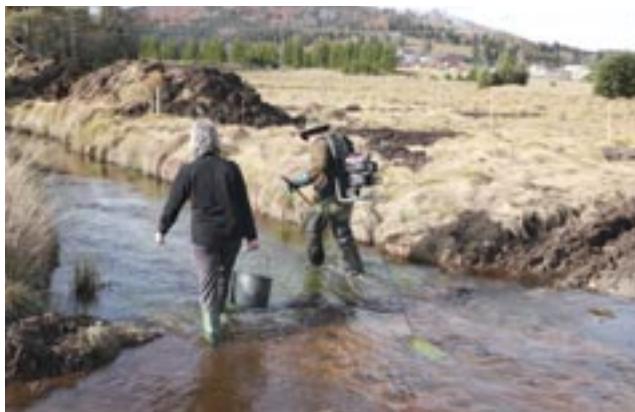
Fig. 168: Catching and transfer of fish from the straightened and altered river Častá before its return to the original meandering bed, Stráženská slať site, November 2023 (I. Bufková)

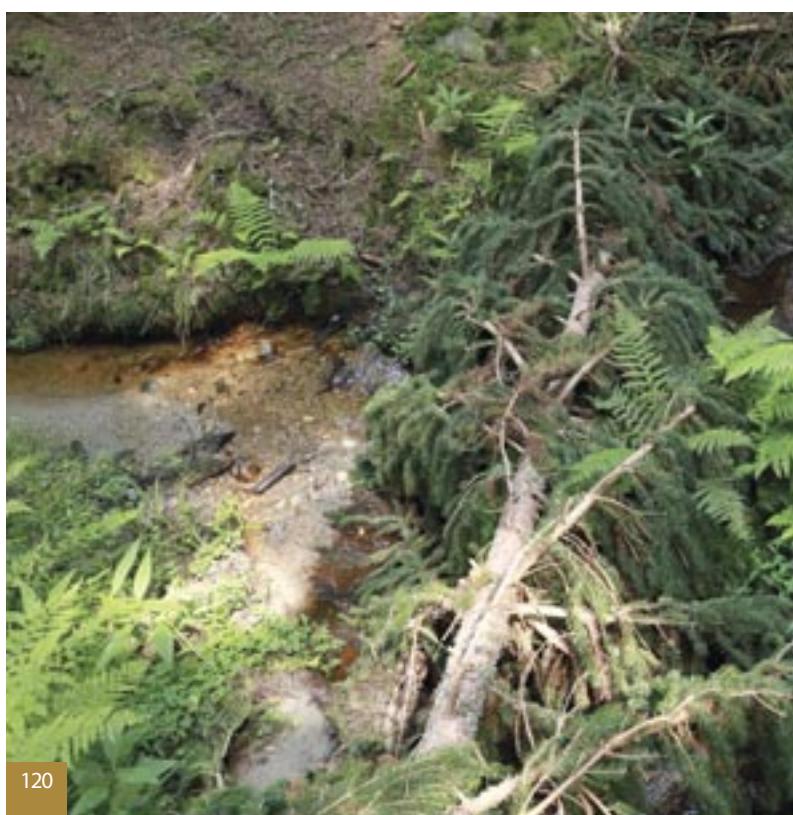
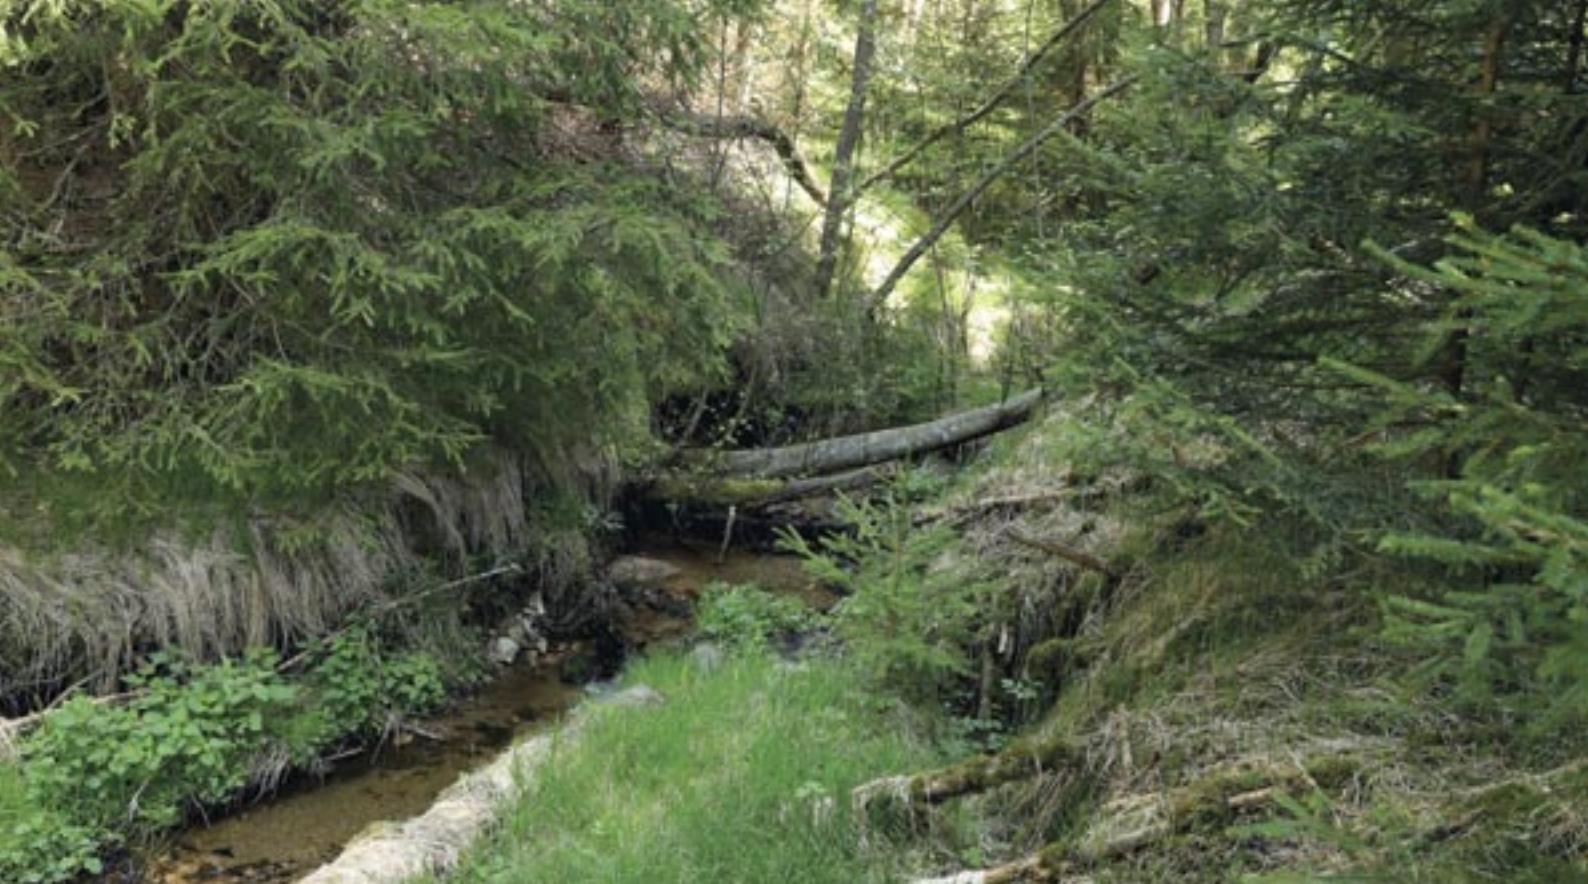
Fig. 173: Spontaneous renaturation of a strongly eroded, straightened stream in the forest, shows well the importance of fallen logs and breaks, Rovina site, May 2022 (I. Bufková)

On streams, lateral erosion and scouring sometimes cause the structure of the fortification to erode and gradually begin to disintegrate. If the straightened stream is shallow, it is advisable to allow the erosion forces to act and the stream to gradually become natural by its own development. Especially in flat or only slightly sloping terrain. The situation is quite

different on slopes with a gradient of 5 % or more, where not only lateral erosion into the banks but also vertical erosion into the bed can intensify after the fortifications have collapsed. In such cases, it is then appropriate to stop or attenuate the process of bottom scouring by suitable natural stabilization of the bed, for example by means of stone riprap.

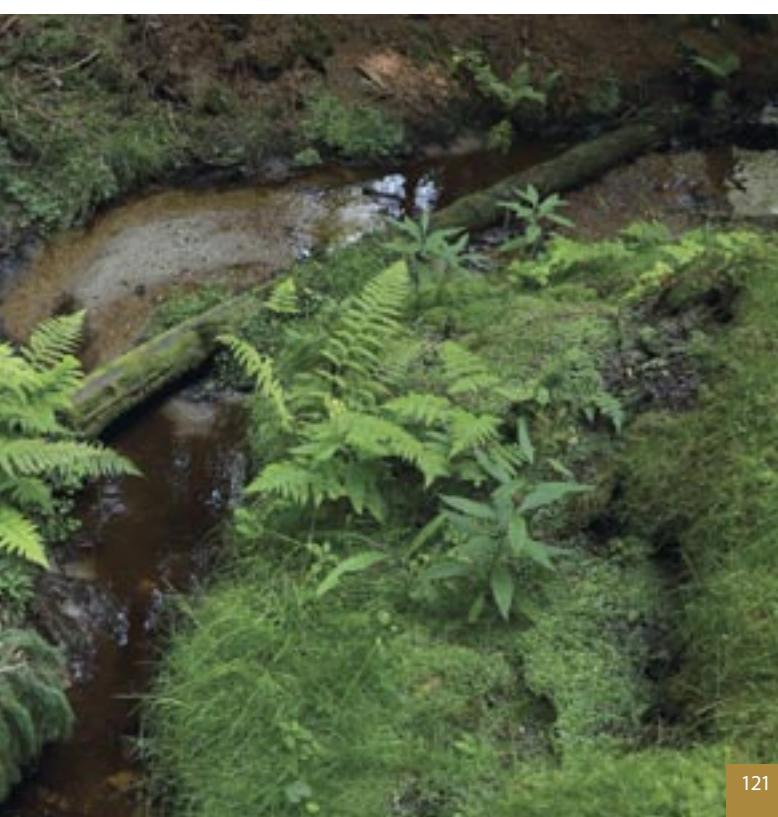
Fig. 174: Even the fall of a relatively small tree can start lateral erosion and re-weaving of a straightened flow, Najmanka, July 2024 (I. Bufková)

Living vegetation also plays a decisive role in spontaneous renaturation. Trees growing on the banks disrupt the fortification of the watercourses, their root systems create hiding places for animals, half-rooted and fallen trees affect the flow and hydraulic patchiness of the watercourse, promote lateral erosion, releasing of the watercourse and the formation of meanders (Fig. 174).

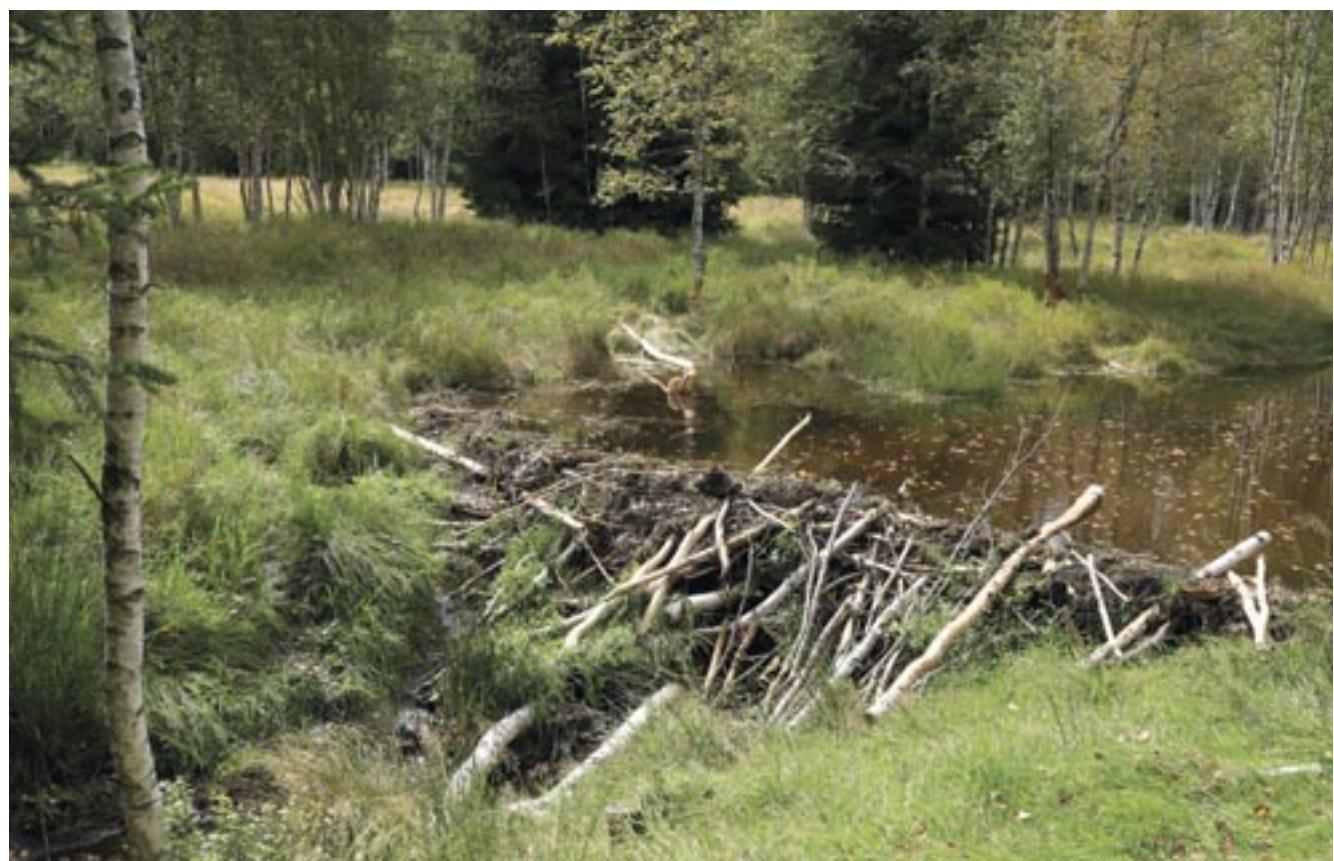
Fig. 175: The beaver dam stands out for its perfection, Vchynice-Tetov site, September 2022 (I. Bufková)

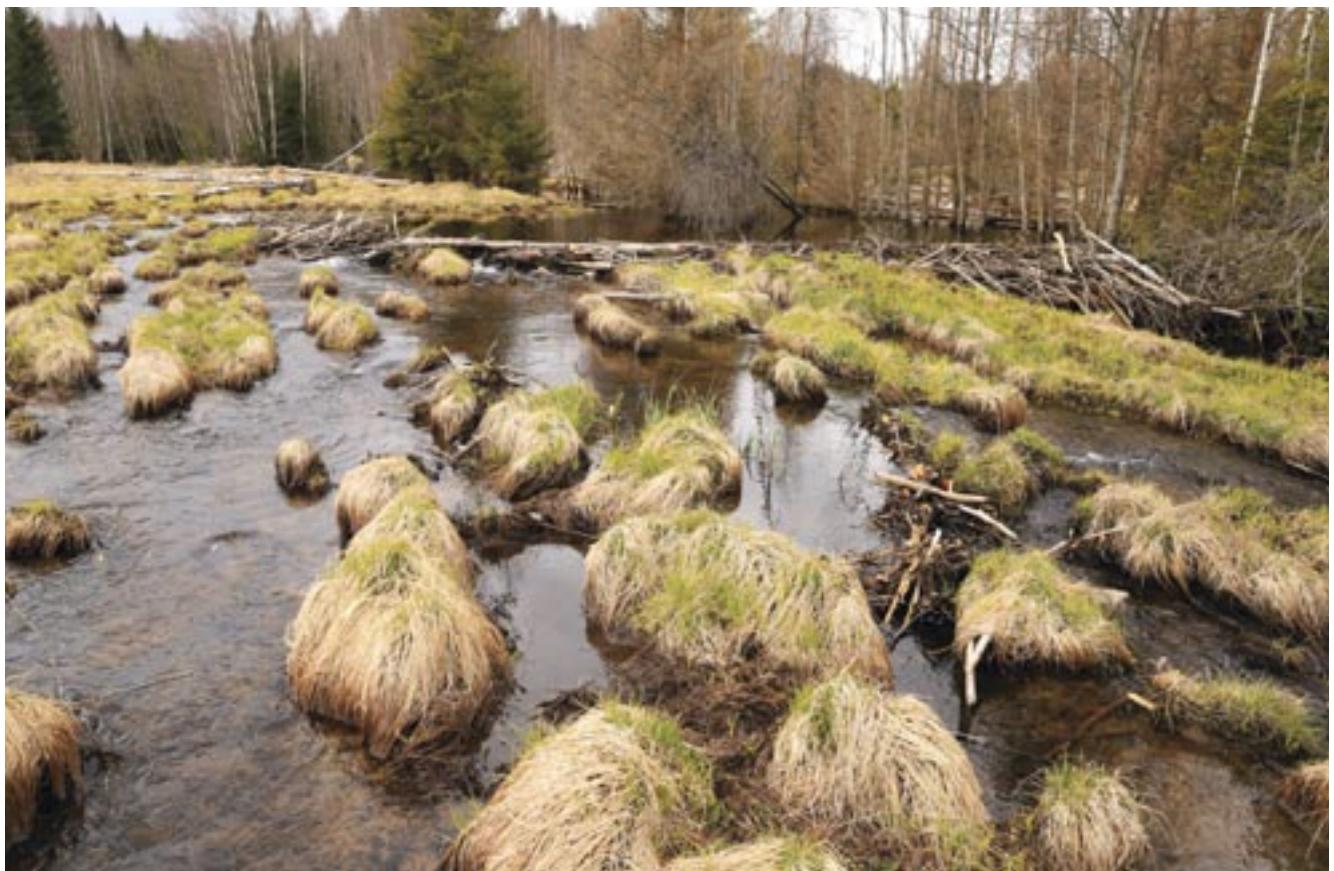
Fig. 176: An example of the restoration of a straightened and modified stream managed by a beaver family, Křemelná site, April 2023 (I. Bufková)

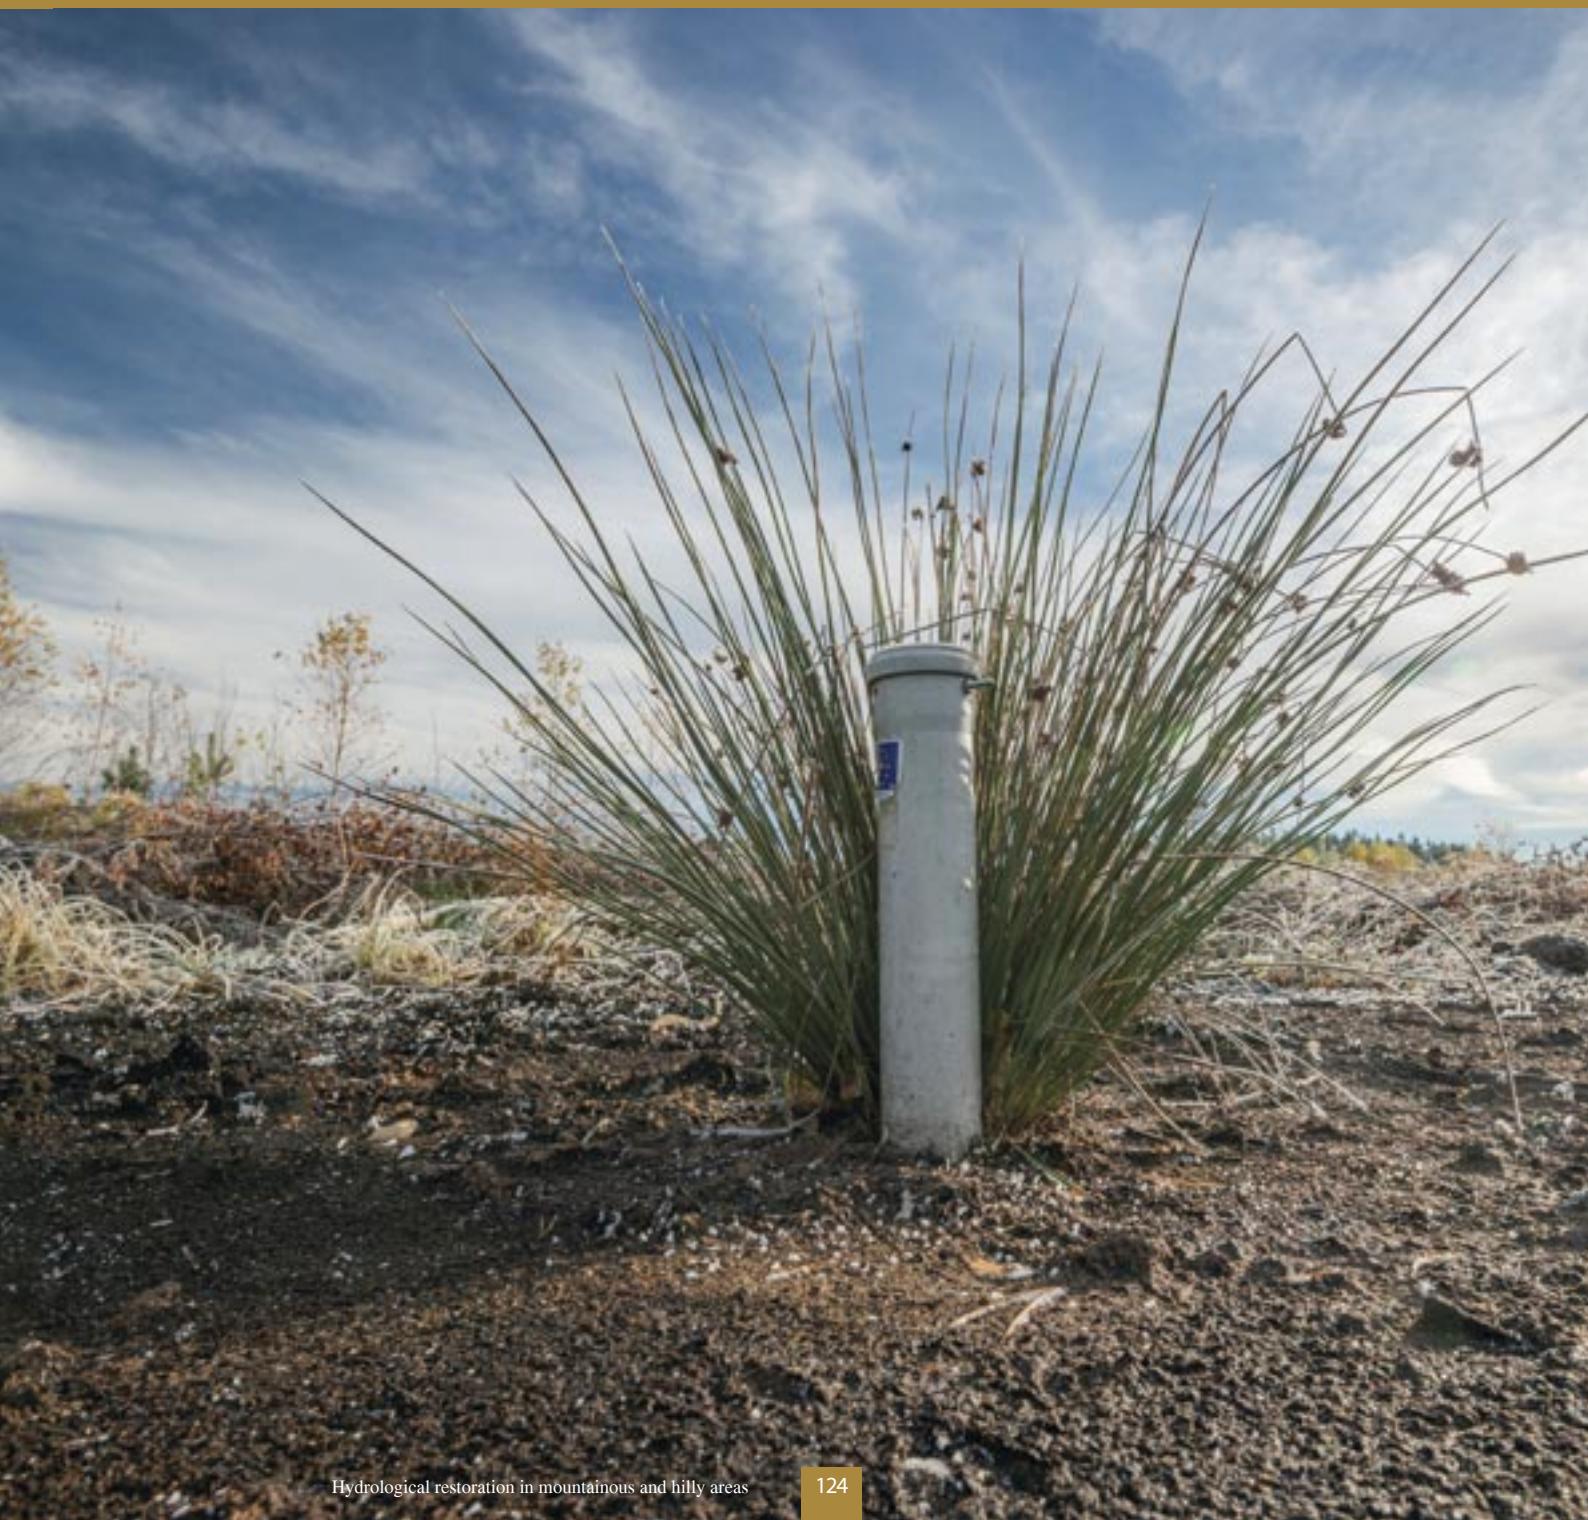
Fig. 178: Installation of a meteorological station with sensors for measuring humidity and temperature of both air and soil, wind speed and solar radiation on the peat bog Záhvozdí, František Stibal (NP Šumava) and Josef Fiedler (FIEDLER AMS Ltd), October 2017 (I. Bufková)

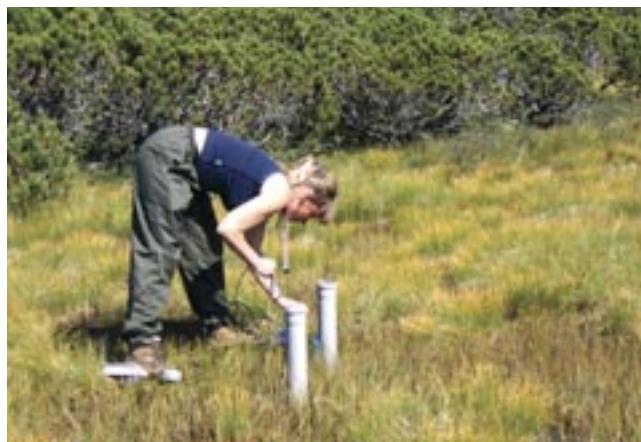
Fig. 181: Manual measurements of water table at the early beginning of mire monitoring in Šumava, Blatenská slatě, August 2005 (P. Hájková)

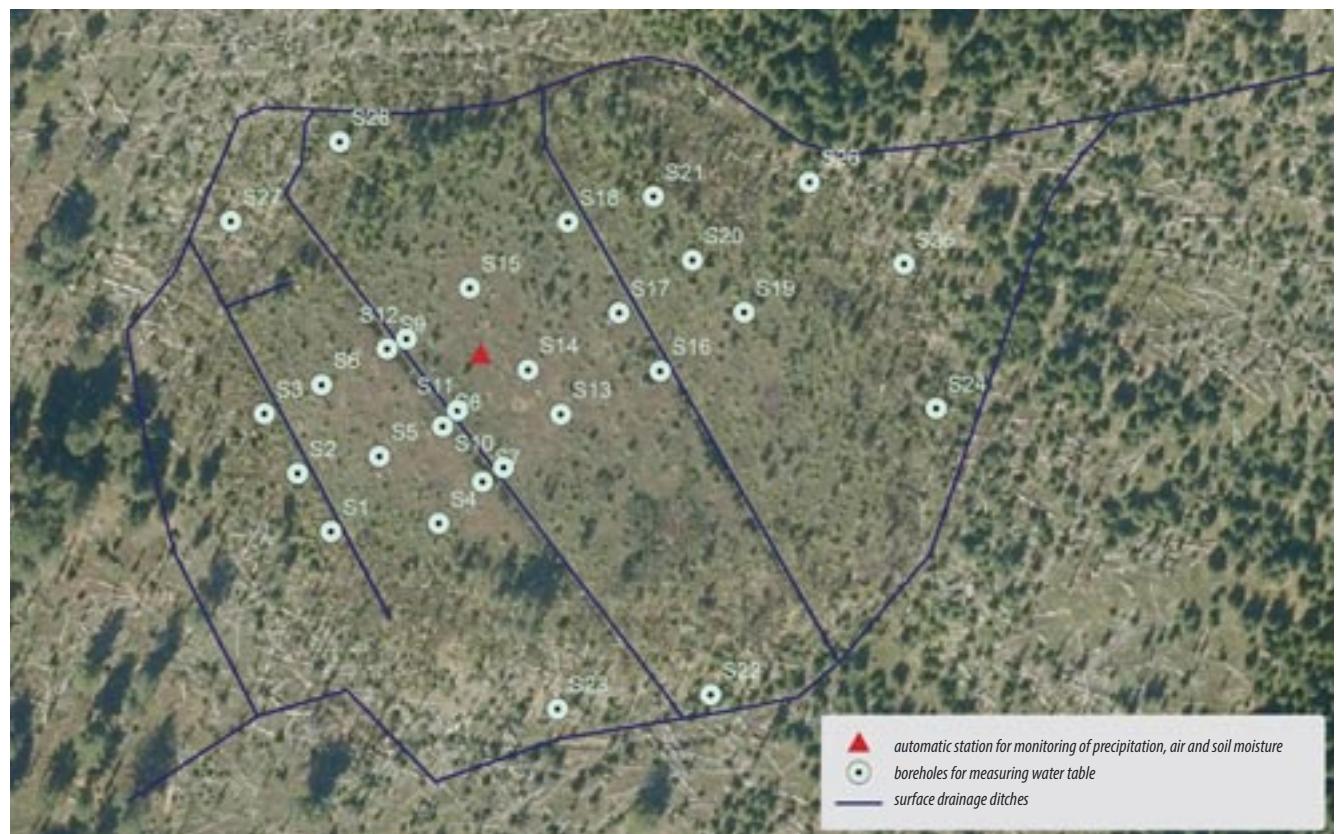
Figure 182: Design of the boreholes placement for measurements of water table on the restored Schachtenfilz peat bog.
