Hydrological restoration

**Summary of experience
with restoration of wetlands,
springs and streams in the Šumava region**

Project "LIFE for MIRES"

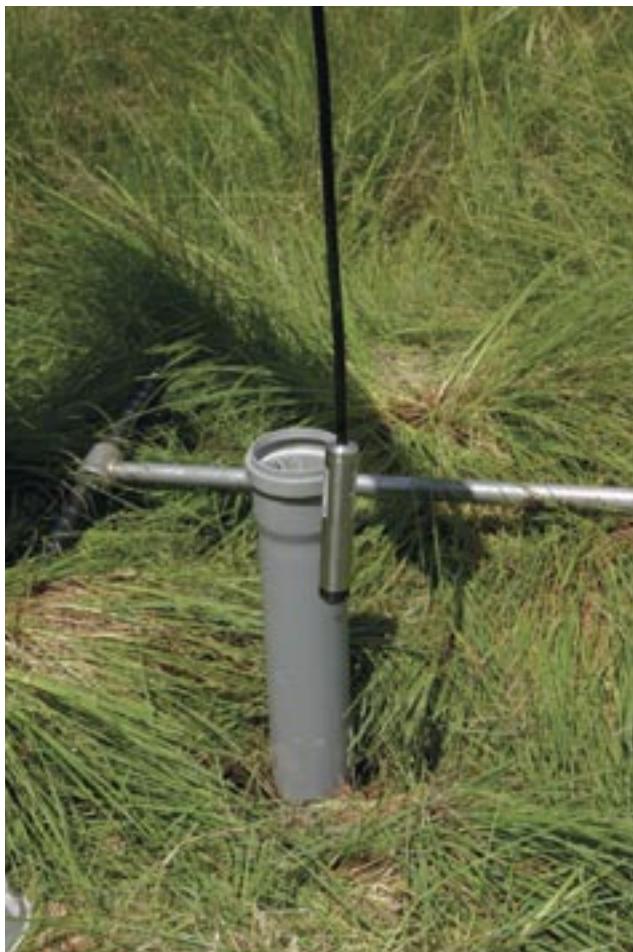
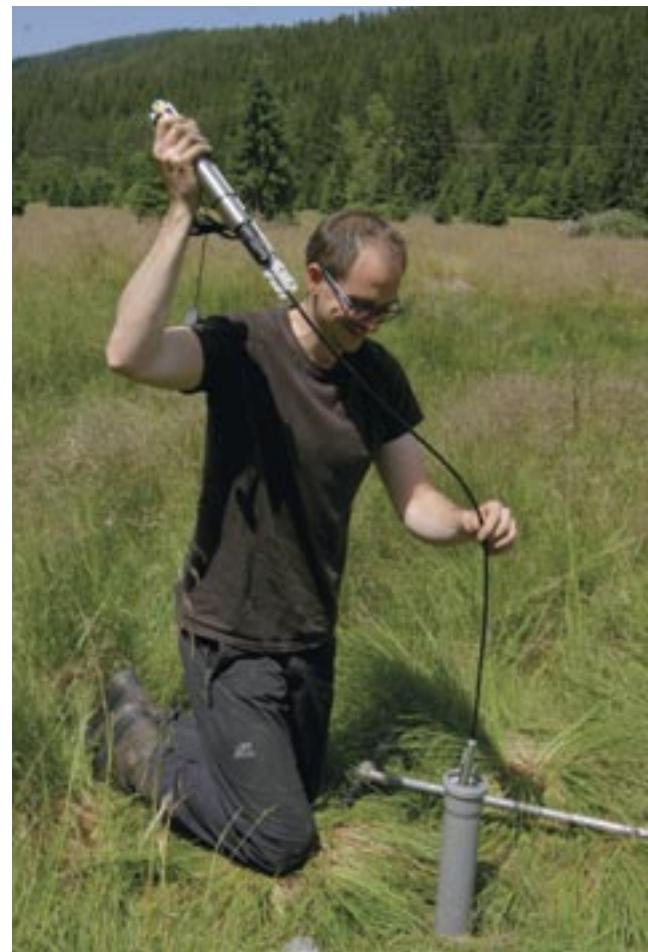
Fig. 183: Pressure sensor for measuring water table TSH22-1-2 (left) and insertion of the sensor connected to the datalogger into a plastic borehole used in Šumava (right), June 2019 (I. Bufkova)

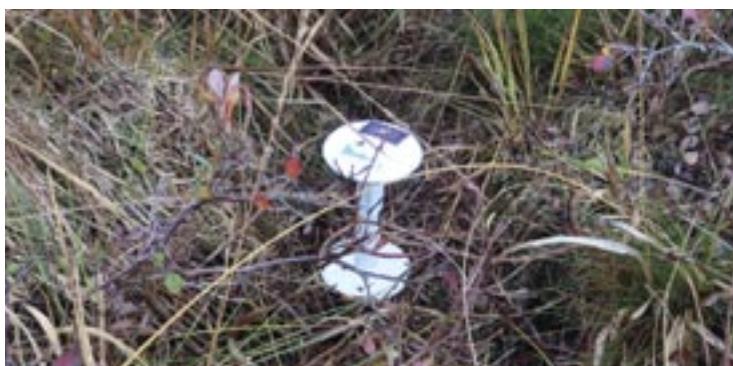
Fig. 186: TMS-4 soil moisture datalogger installed at the Ježová site, October 2019 (T. Doležal)

In the Šumava region, soil moisture was measured using a TMS-4 datalogger, which measures air and soil temperature along with soil moisture, using three temperature sensors (-6, +2 and +15 cm) and one moisture sensor. Soil moisture is recorded in the topsoil in a depth of approx. 15 cm below the surface. TMS-4 datalogger contains a high capacity lithium battery, with a lifetime of approximately 10 years. Combined with a large enough memory (it can record 524,288 measurements), each TMS datalogger is completely self-contained, can be easily installed in the field and requires only minimal maintenance. The disadvantage from the user's perspective is that the data are not online and must be downloaded in the field. Dataloggers are thus not under control and damage often occurs due to wildlife tampering with them and the device is then found lying on the ground, often without protective caps, rendering the data unusable at this time. It is therefore advisable to protect the device in some way, e.g. with a metal cage.

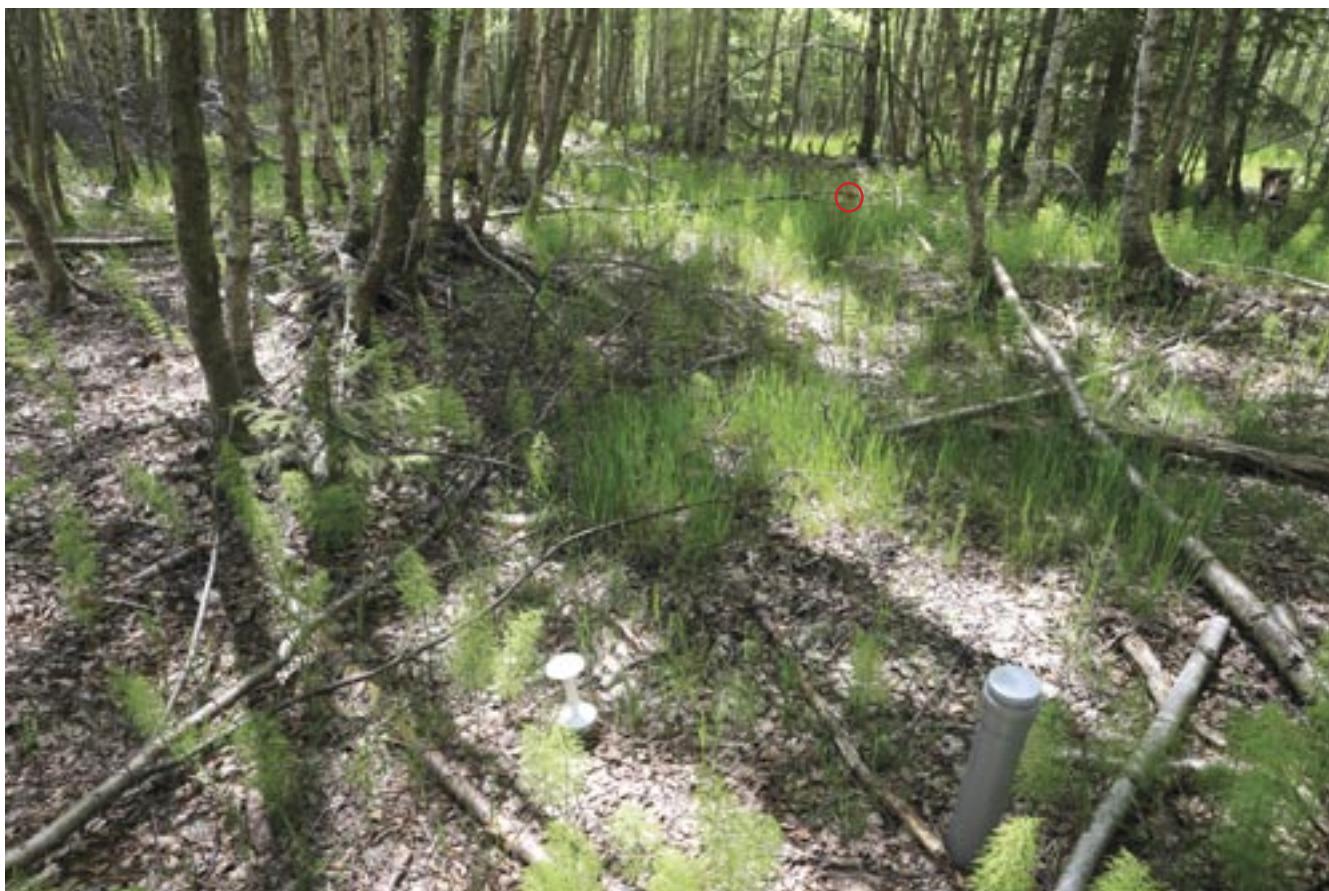
Fig. 187: Example of a monitoring plot in the spring part of the

revitalised Malý Bor site. In the foreground a plastic borehole with installed sensor and datalogger for measuring water table, on the left a TMS-4 datalogger for measuring soil moisture and temperature.

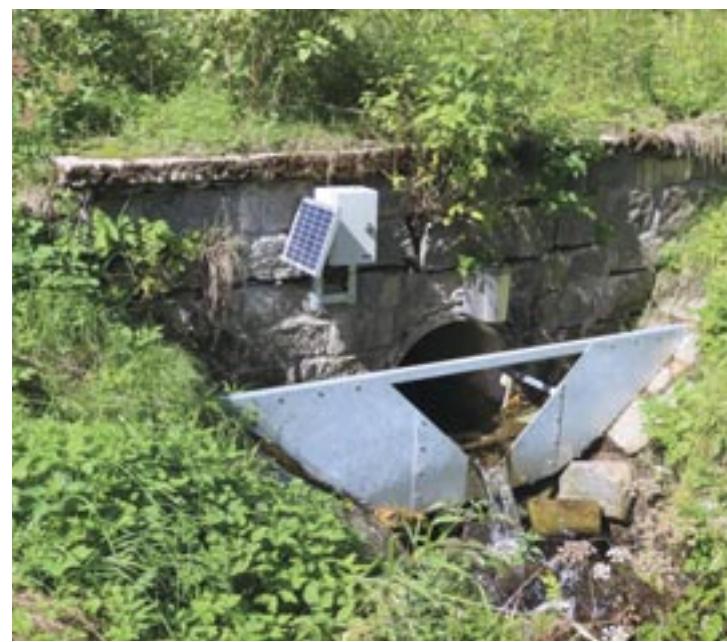
Fig. 191: Thomson spillway and measurement set-up at the final runoff from the Vchynice-Tetov site, September 2019 (T. Doležal)

In the Šumava region, runoff conditions were continuously recorded in the final profile of the monitored micro-catchment where the Thomson spillway was installed (Fig. 191, 192). The amount of runoff water was measured using an ultrasonic or pressure sensor. Data were recorded at ten-minute intervals. Flows from the selected profiles could be monitored on-line on the internet thanks to the built-in GSM system.

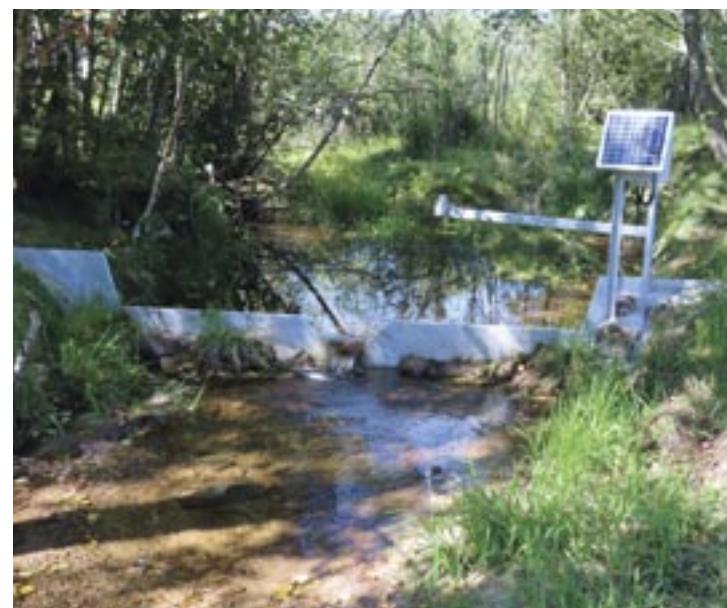
Fig. 192: Composite overflow and measurement set-up at the outflow from the Malý Bor site, September 2019 (T. Doležal)

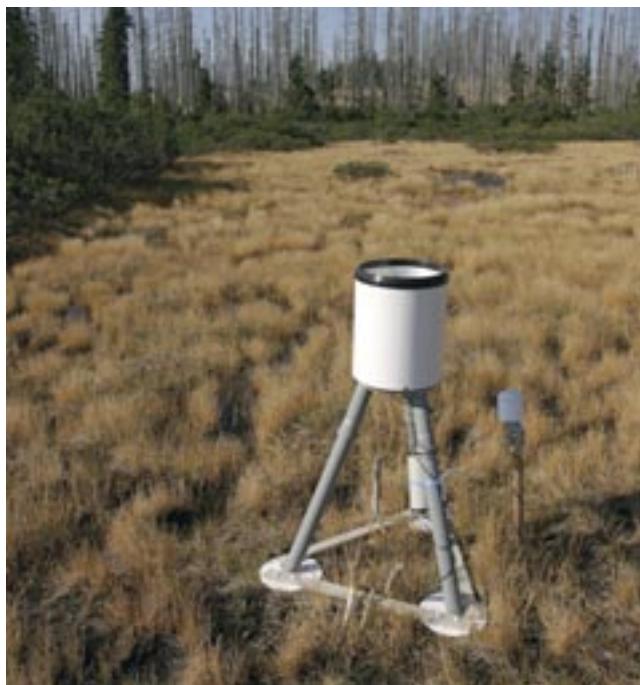
Fig. 194: Rain gauge SR03 500 cm² at Blatenská slatě, October 2005 (I. Bufková)

Precipitation has been recorded in Šumava using standard SR03 rain gauges supplied by FIEDLER AMS Ltd (Fig. 194). The recording area of the rain gauges was 500 cm² and the

pulse output was always 0.1 mm of rainfall. The rain gauges are not heated and therefore only record liquid rainfall. The placement of the rain gauges was done in such a way that they cover different geomorphological parts of Šumava and possible differences between ridge parts and inversion positions in valleys. Furthermore, it was possible to use data from rain gauges installed in the region, which are owned by the Czech Hydrological Institute and other institutions.

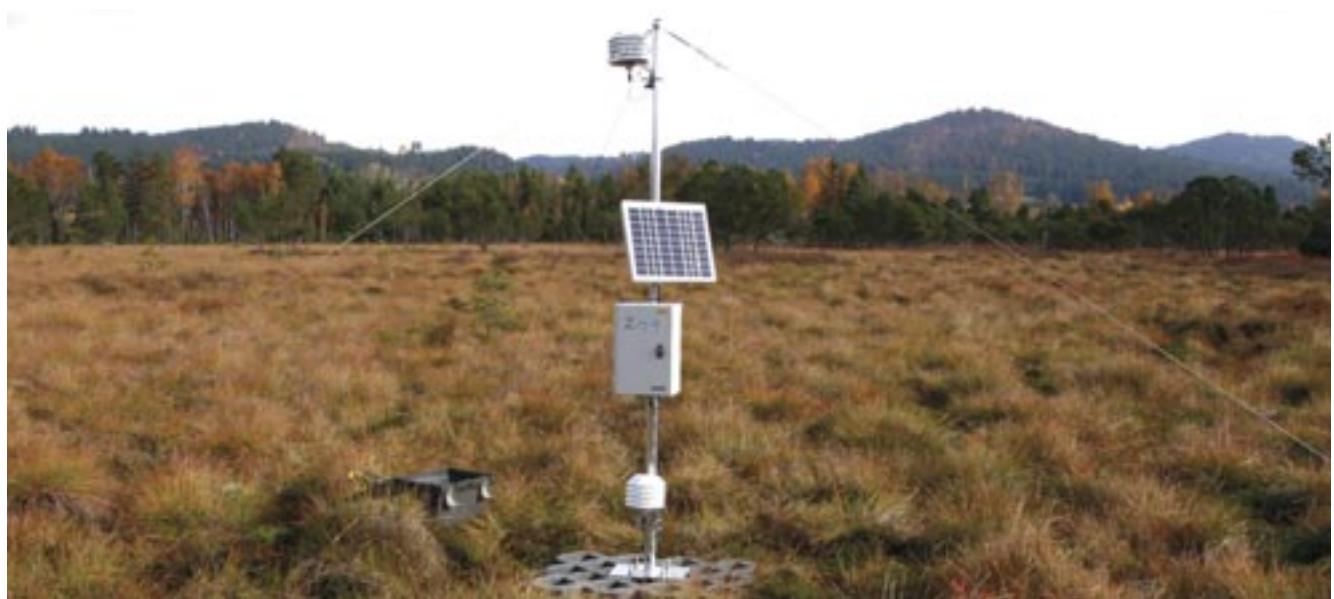
Fig. 195: Automatic station for measuring microclimatic conditions (air temperature, humidity and soil temperature) on the peat bog in the Vltavský luh floodplain near the settlement of Záhvozdi, June 2008 (I. Bufková)

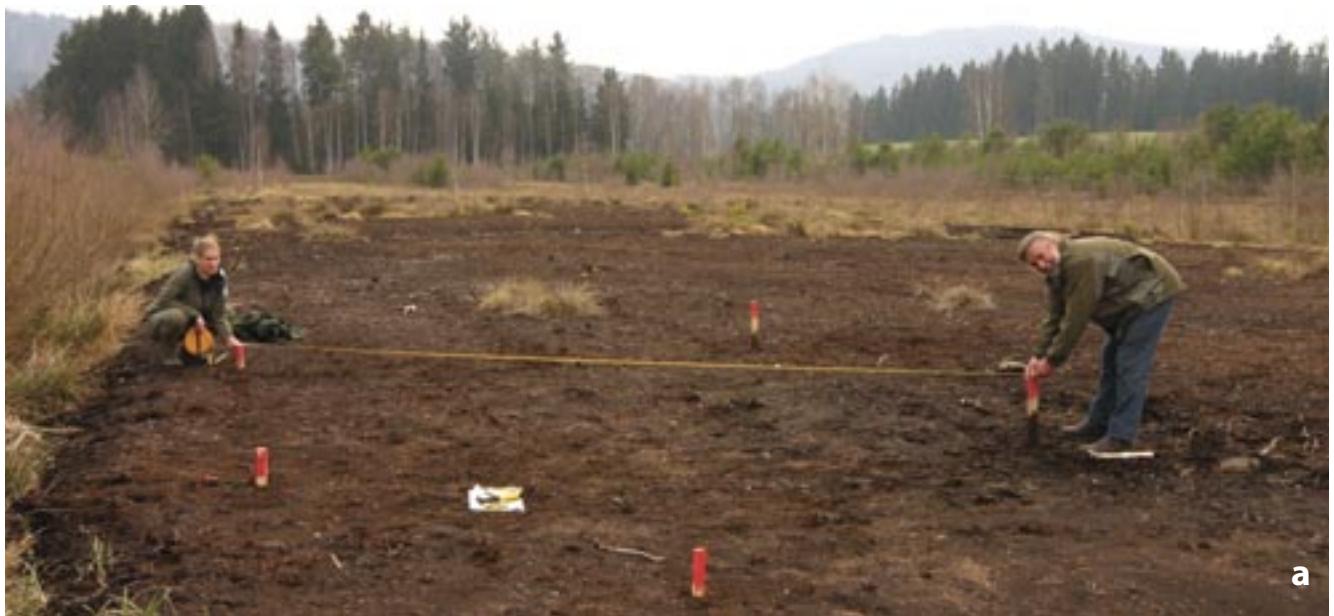
Fig. 196a, b: Vegetation plot of 16 m² on the mined peat bog of Vlčí jámy before restoration in April 2019 (above) and two years after restoration in August 2023 (below) (I. Bufková).

Fig. 262: Inspection of the permanent monitoring plot one year after restoration. The figure shows the same VJ1 plot surface as Fig. 196a, b, October 2022 (L. Linhart)

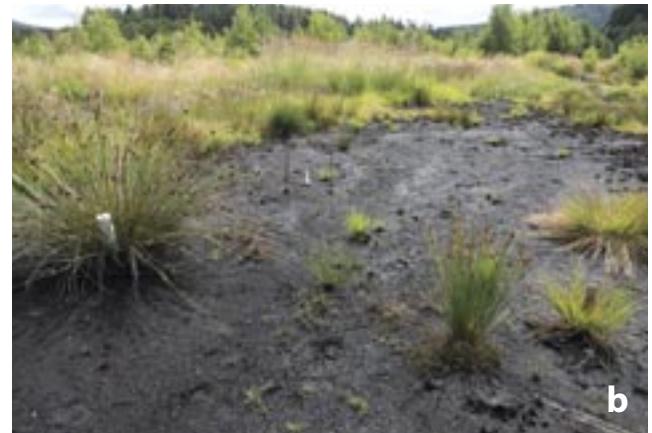
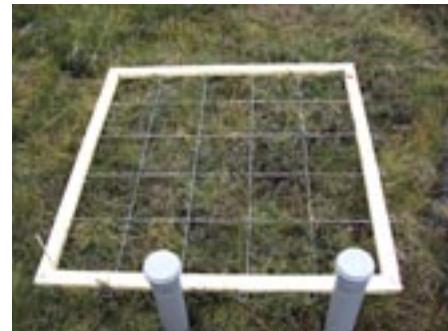
Fig. 197: Example of 1m² of permanent vegetation plot on undisturbed peat bog Blatenská slatě, June 2005 (I. Bufková)

Permanent plots for monitoring changes in vegetation on restored sites have also been established in the Šumava region. Permanent plots from the beginning of the monitoring, which were marked on open peat bogs, had dimensions of 1x1 m due to the patchiness of bog micro-topography (Fig. 197). Later on, plots were established with proven dimensions for collecting phytocenological data: i.e. 4x4 m in open treeless vegetation or possibly 10x10 m in forest stands. The vegetation was recorded in a standard way using phytocenological relevés. The cover of each species was visually determined for each vegetation floor separately and recorded as a percentage. Vegetation records were taken between June and the end of September.

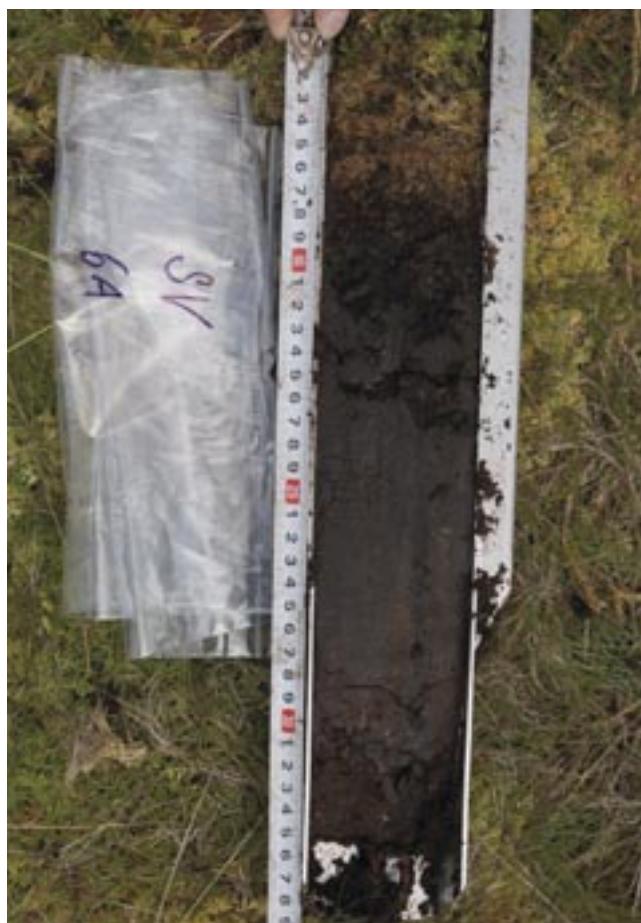
Fig. 199: Box corer with an intact peat sample.

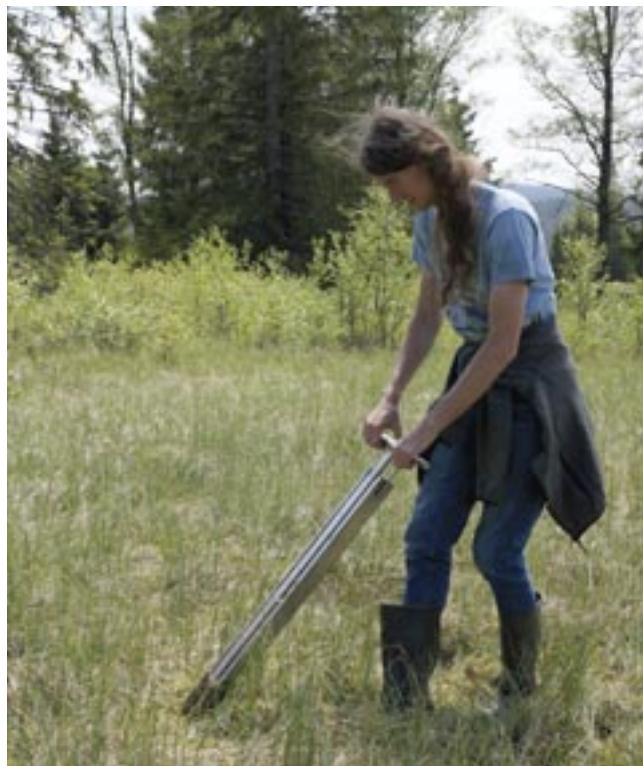
Fig. 198: Soil sampling using specific corer

The basic approach for monitoring soil properties is soil sampling (Fig. 198). Sampling sites should be selected at locations that are both well representative of the condition and type of the wetland and where significant changes are expected following revegetation measures. Because of the large spatial heterogeneity, several samples (3-6) should be collected from each site, and their placement in the field should replicate the permanent vegetation plots and the location of the probes for water table measurements. Experience with wetland monitoring indicates that it is

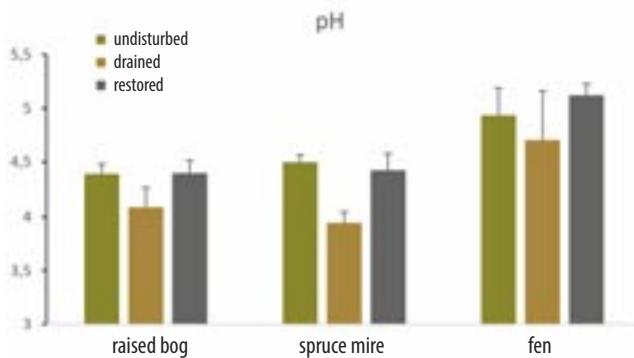
Fig. 200: Changes in peat pH due to drainage and restoration compared to undisturbed control plots

One of the basic chemical parameters is soil pH. It is considered to be one of the main variables that influence many biochemical properties and processes in the soil. It influences nutrient availability, plant growth and microbial activity and thus the rate of decomposition of organic matter. From experience on the Šumava peat bogs, soil pH has proved to be a good indicator of the recovery of natural conditions relatively quickly after restoration (Fig. 200). pH was measured in a soil suspension, i.e. in a soil sample mixed with distilled water in the laboratory (5 g of soil mixed with 25 ml of water). After mixing and settling, pH was measured using an electrode. At the same time as pH, conductivity was measured in the soil suspension.

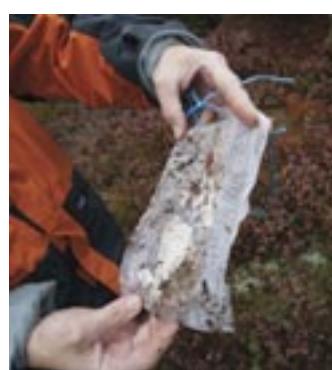
Fig. 201: Cellulose bags used to measure the rate of decomposition processes in soil

A simple method of cellulose bags (Fig. 201), which are installed in the soil for a specific period of time (e.g. growing season), was used to determine **decomposition rates** directly in the field. Cut strips of cellulose (filter paper) are pre-weighed, then placed in prepared mesh bags and put in the soil. After a certain period of time, the bags are removed from

the soil, all impurities are removed by washing in the laboratory, the bags are dried and the undecomposed cellulose residues are weighed, then burnt in an oven at 450 °C and the unburnt residues are weighed again. The values obtained are used to calculate the rate of cellulose decomposition per day.

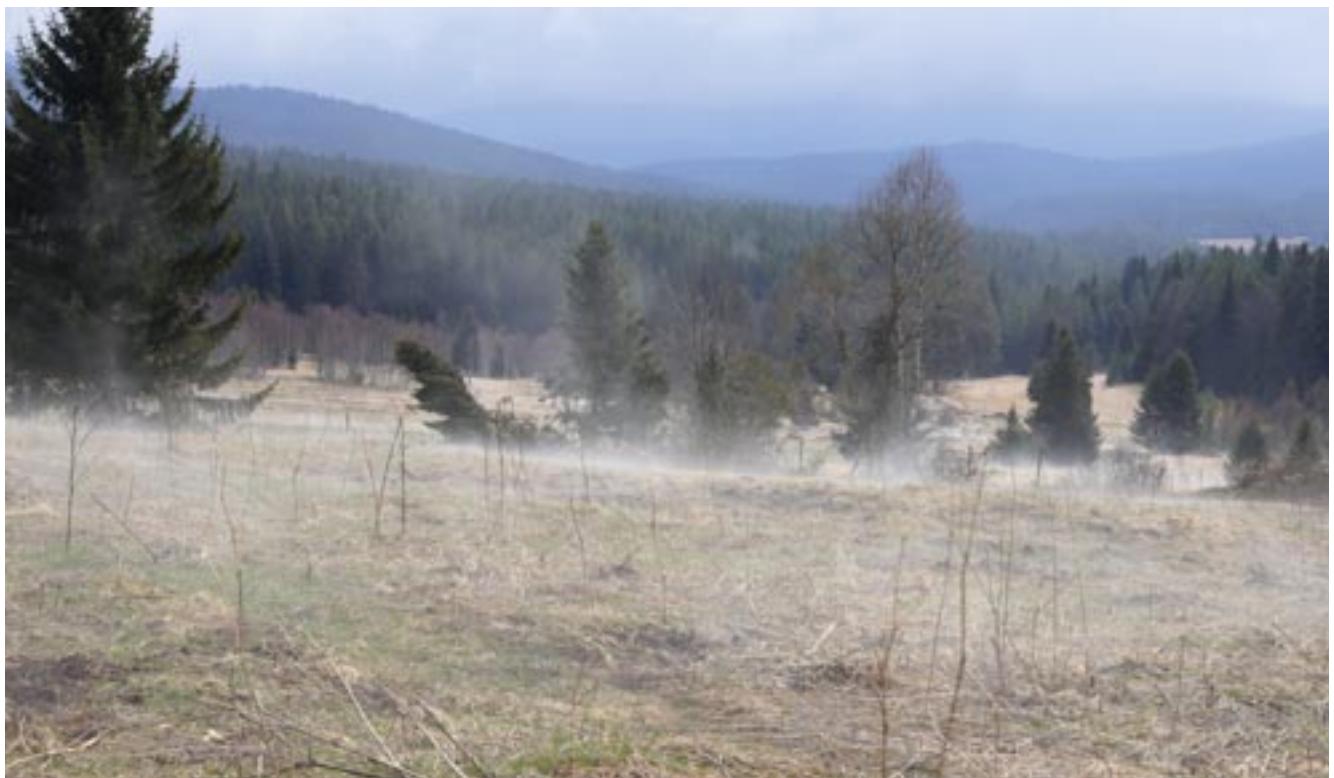
Fig. 204: Water vapor after heavy rain at a restored well re-wetted spring in the Pod Skelnou locality, April 2022 (I. Bufková)

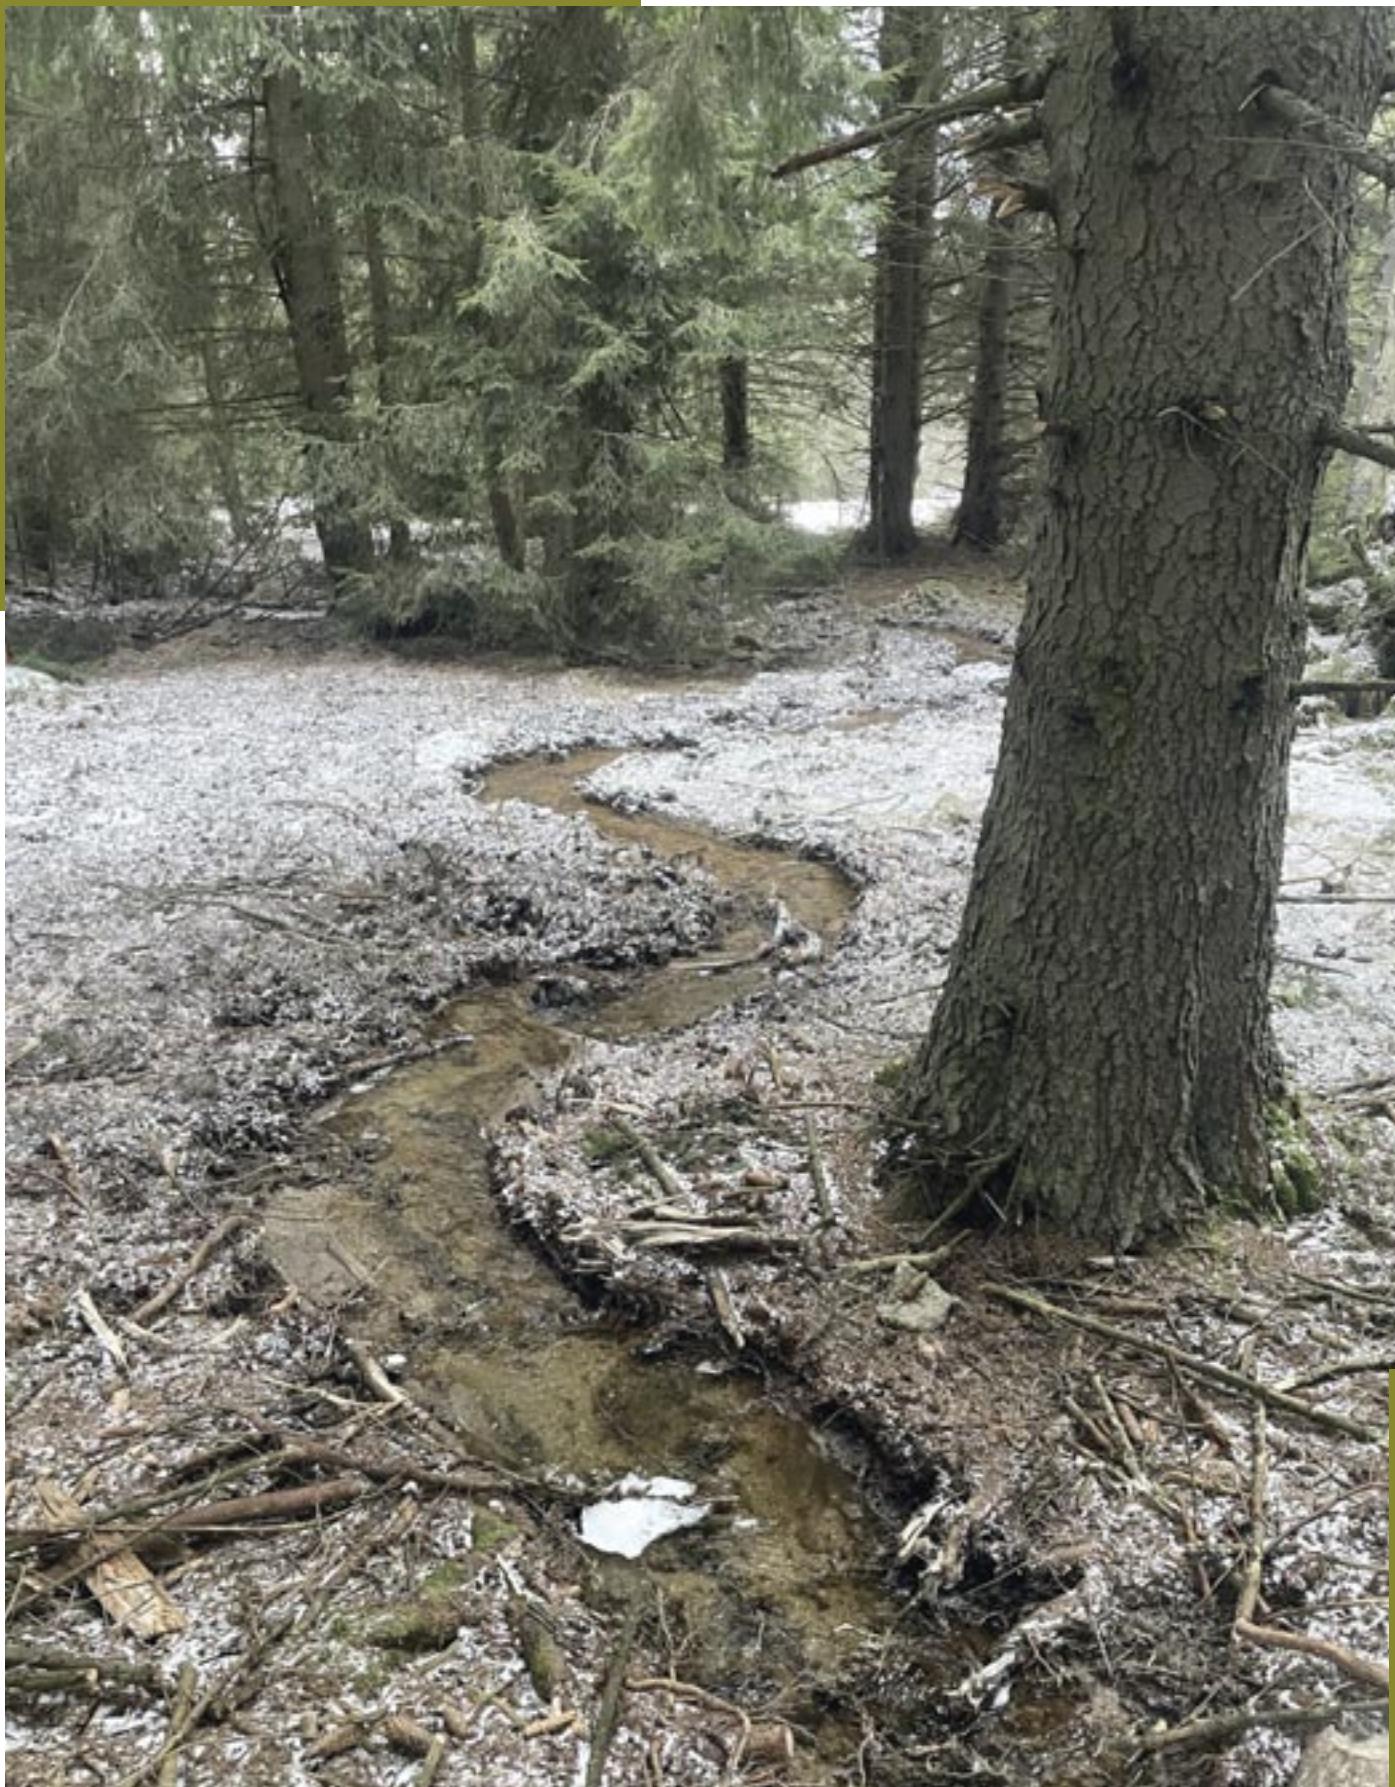
Fig. 205: A small forest stream restored in the Rovina site as part of the LIFE for MIRES project one year after restoration, January 2023 (P. Semerád)

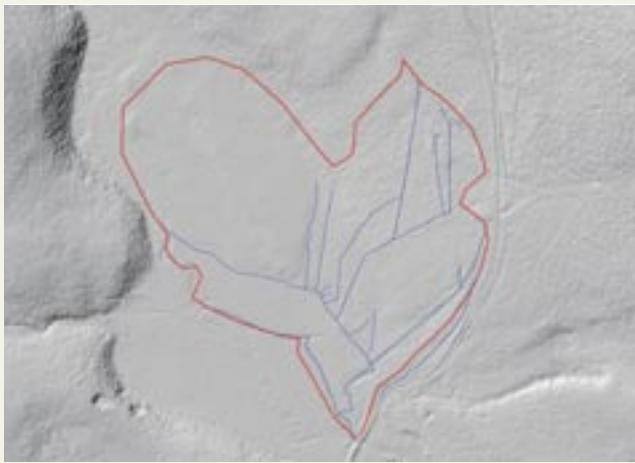
Fig. 207: Scheme of the Malý Bor site drainage based on LiDAR images

The Malý Bor site is a typical example of a non-forest spring area with a strongly altered water regime. The basic surface drainage network was built before the Second World War, as was the millrace that crosses the area at the interface between the slope and the valley floodplain of the Křemelná River. This millrace, which runs along the contour, both drains the edge of the raised bog with bog pine forest and collects water from the two streams flowing down the slope. It also changes their direction and flowing into the river. In

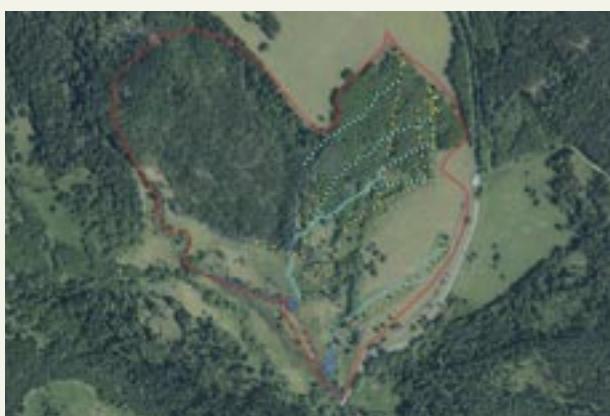
Fig. 208: Aerial image showing the implemented measures at the Malý Bor site

The proposed technology for the restoration of drained springs was tested for the first time on the Malý Bor site. A total of 5 springs (wetland type - helocrene) were restored on the site. A target water level of 0 has been set for blocking the channels at the springs. On a shorter stretch at the eastern edge of the site, due to the high slope of the terrain, the spacing between the dams was increased to about 8 m. The channels in the springs were only 70-80 % filled after the dams were installed. The rest of

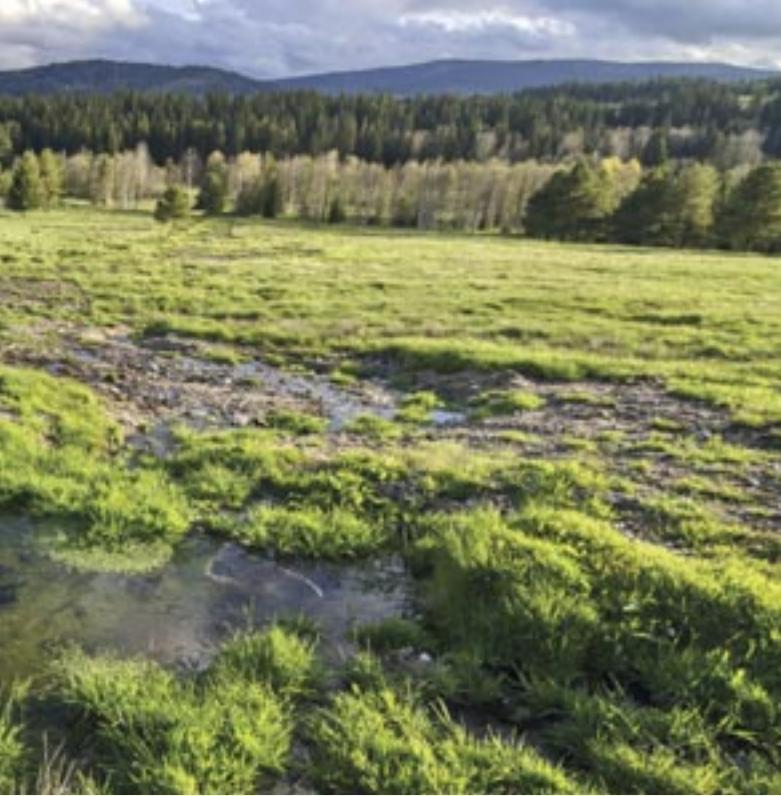
Fig. 209: Restored meadow spring at Malý Bor one year after restoration, May 2021 (P. Semerád)

In the case of streams, due to the small width of the bed, attention was paid mainly to the restoration of their natural route without any morphological shaping of the bed. However, emphasis was placed on the addition of stony substrate to the bottom of the newly created bed, especially in sections with a longitudinal slope of 8% or more. In these sections, stones were spread over the entire streambed with a resulting coverage of about 50 % of the bottom area, in some sections more. Larger stones were placed at critical locations of incipient bottom erosion. They were also placed on the sedimentation bank (point bar) of the meanders to appropriately direct flow and promote lateral erosion. The source of the stones was the surface of the stony soils

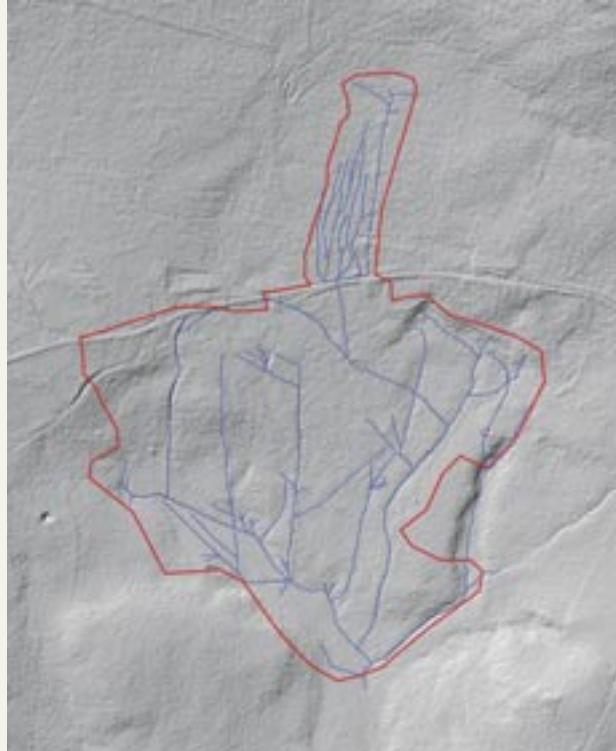
Fig. 212: Map of the hydrological situation and drainage based on LIDAR images

The Pod Skelnou site is a typical example of a spring slope with completely altered hydrology. The site was affected by intensive drainage in the past (Fig. 212). All the springs, together with other wetlands, were drained by deep surface ditches. Without exception, the streams flowing out of the springs have been straightened and deepened and have become part of the drainage network. None of the streams followed their original natural route. The ditches were commonly two metres deep and about 3-5 metres wide (Fig. 132). The channels running directly down the slope, in particular, were gradually enlarged by severe vertical erosion and scouring of the banks. The total length of the drainage channels was 4 km. The minor first-order streams were converted into modified straight channels over a length of 2.4 km, without bank and bed reinforcement.

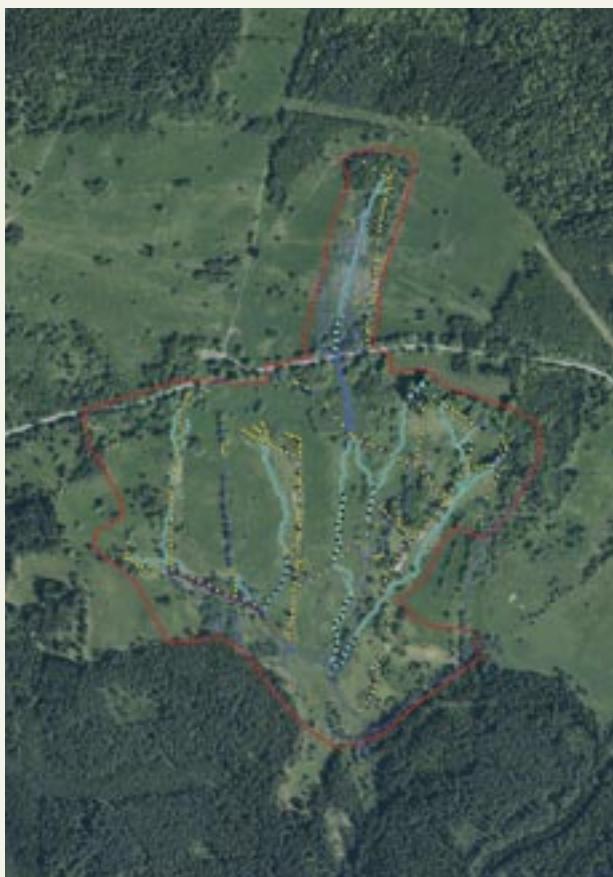
Fig. 213: Aerial image showing the measures implemented

Restoration was carried out in the periods July-December 2020 and July-December 2021. A total of 4052 m of drainage ditches were blocked (Fig. 213). Where the ditches gripped the flow of the stream water, it was first re-directed into restored natural stream routes. The ditches

were blocked using 310 wooden dams, which were always supplemented with soil backfill. Due to the predominance of mineral soils and the rocky bottom of the ditches, all the dams were made of horizontally installed boards with embedded geotextile fabric. Target water table was calculated for mire habitats and springs only. It was set at zero in the springs. For channel sections crossing heavily degraded acidic moss-rich fens and poor sedge fens, the target water table was set at about 15 cm below the surface. However, due to the strong slope of the terrain and the lack of soil for backfilling and filling the channels, the calculated intervals between the dams had to be increased in places. In the erosion gullies in the high surface gradient sections, the main purpose of the woody barriers and subsequent infilling of the channels was to stop erosion and to remove the preferential artificial route for water. Here, the dams were of an explicitly braking nature and were installed at intervals of about 5-7 m apart regardless of the target water table.

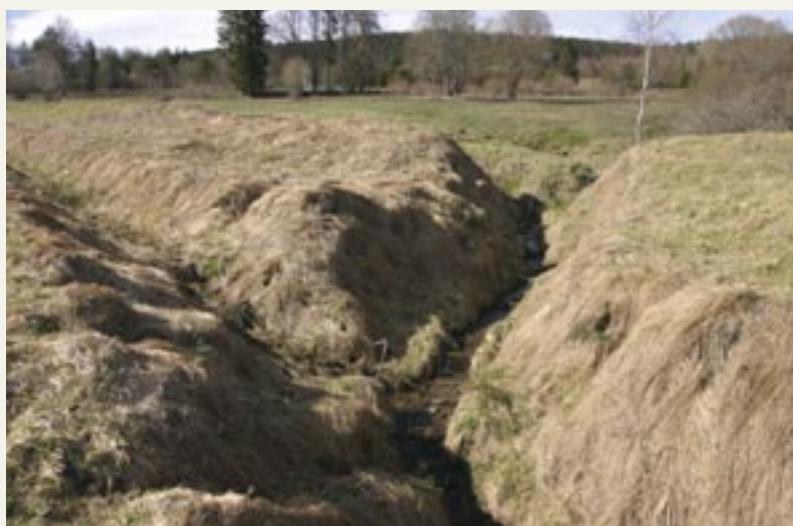
Fig. 214: Large meadow spring at Pod Skelnou site one year before revitalisation (top) and two years after (bottom), April 2019 (I. Bufková) and May 2022 (L. Linhart)

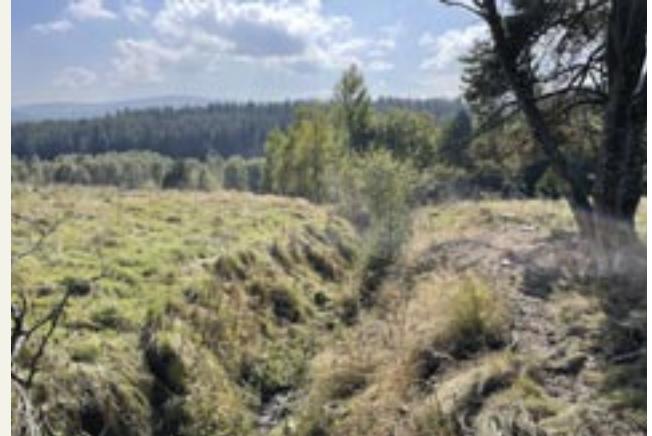
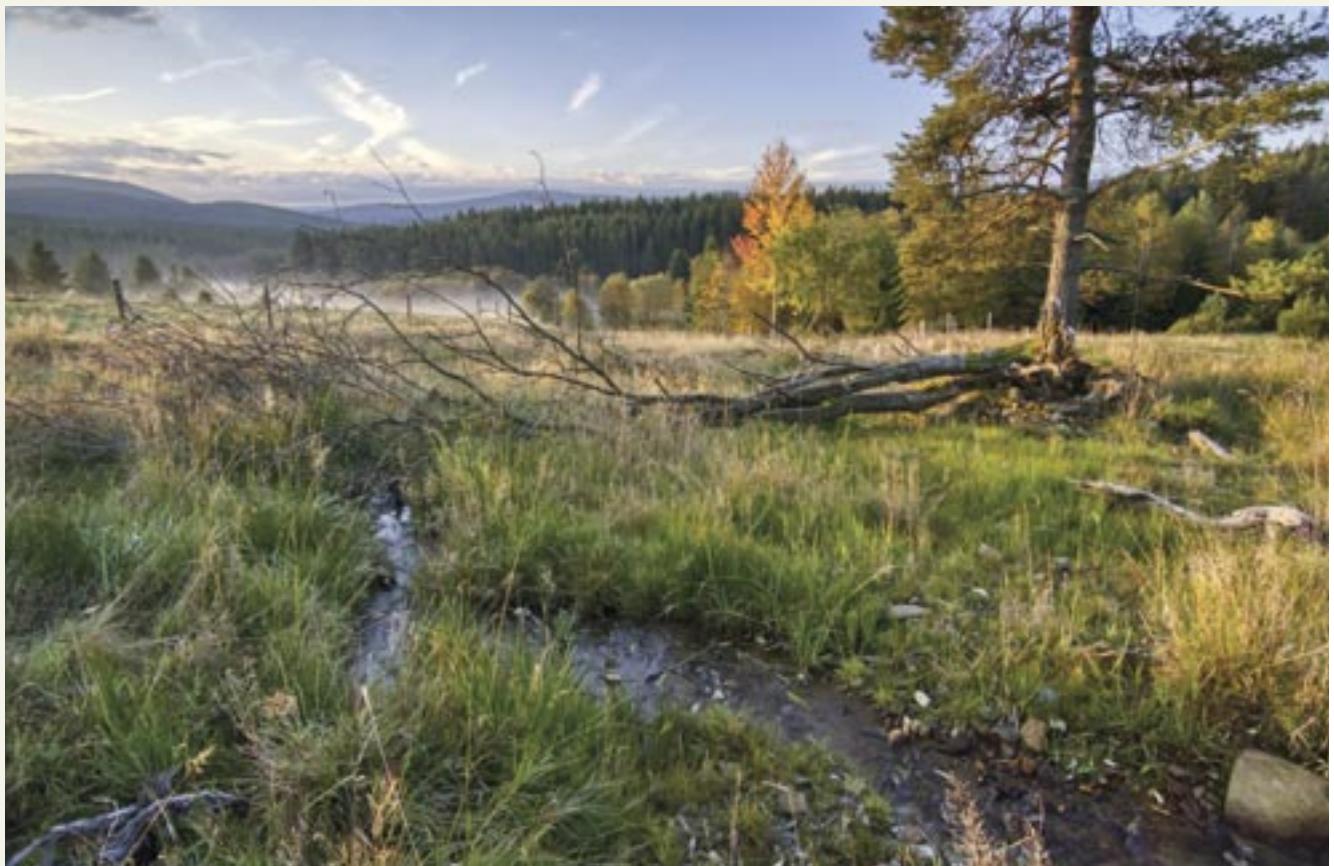
Fig. 215: Small stream on the slope in the western part of the Pod Skelnou site one month before restoration (top) and one year after restoration (bottom), November 2021 (T. Doležal) and October 2022 (P. Semerád).

A total of 2.4 km of original stream beds have been restored on the site. Due to a great number of the very small streams, attention was mainly paid to restoring their natural route and adding rocky substrate to their newly re-constructed beds. The average width of the restored stream beds was around 40

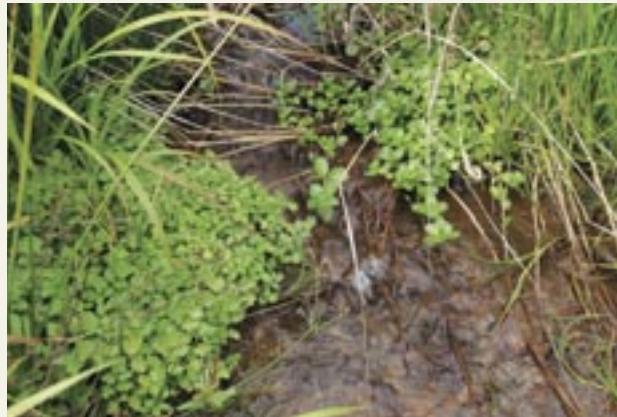
Fig. 216: Detailed view of the restored spring at the Pod Skelnou site two years after revitalisation, October 2022. Well regenerating spring vegetation can be seen, however, a year later it was completely overgrown by the spreading common rush (*Juncus effusus*) (I. Bufková)

In total, 8 springs were restored on the site. All of the springs were helocrene (wetland flat spring). A target water table of zero was set for blocking the channels at the springs. The channels at the springs were completely filled and covered with soil (100 %) after the dams were installed. At the outflow of three springs, the effort was to create a reverse delta of small flows that merged into a single brook after about 10 meters.

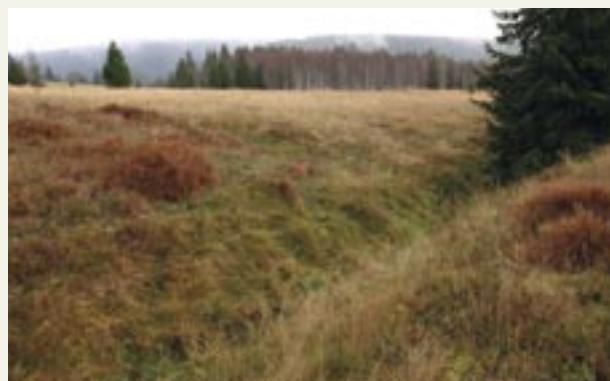
Fig. 217: The deep drainage ditch in the upper part of the Vchynice-Tetov site is in fact a straightened stream, November 2019 (I. Bufková)

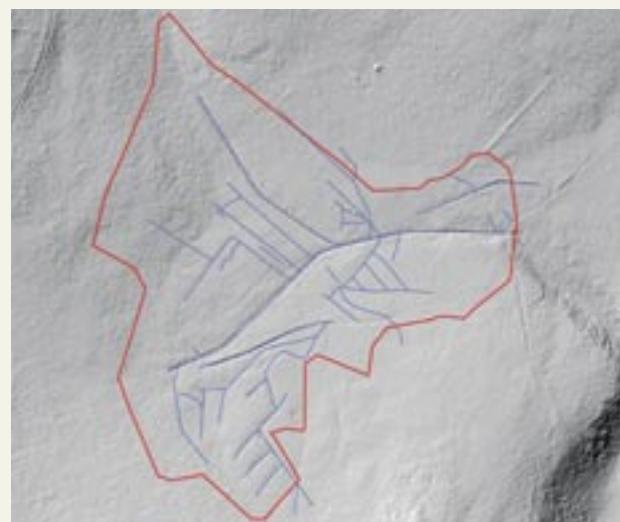
Fig. 218: Scheme of the drainage system at the Vchynice-Tetov site based on LIDAR images

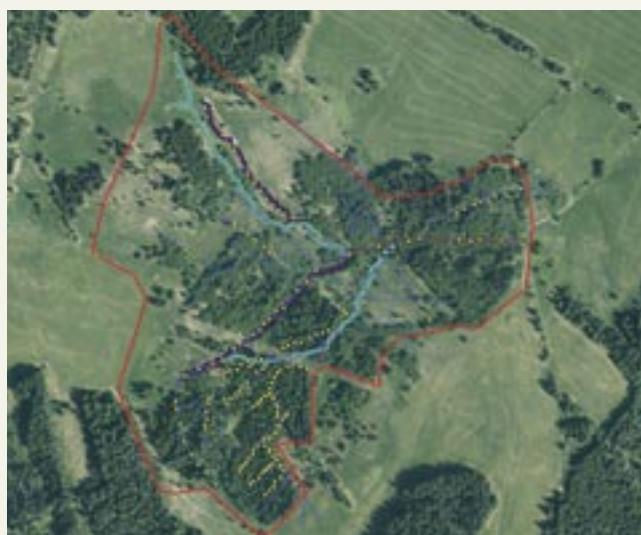
Fig. 219: Aerial image showing the implemented measures in Vchynice-Tetov site (prepared by Geovision Ltd)

The new bed was shaped with an excavator, due to the sloping surface (10 %) the width of the stream line was around 5 m and the diameter of the meanders was about 7 m. Due to the size of the stream, only a flat shallow bed was created with a depth of up to 25 cm. The diversified morphology of the bed was not shaped in any way, the bed was only covered with coarse gravel and stones. These were obtained on-site from where soil was removed for the backfilling of the channels. The channelized streambed was dammed using the standard method with wooden dams made of horizontally installed planks and completely backfilled with soil obtained from the surrounding area. However, the areas around the upper part of the channel still generated a large amount of seepage water, which subsequently generated spontaneous surface runoff. Therefore, a shallow valley with an undulating cunette was created in the route of the completely filled channel to provide the other runoff with similar parameters to the newly created parallel stream. Approximately halfway

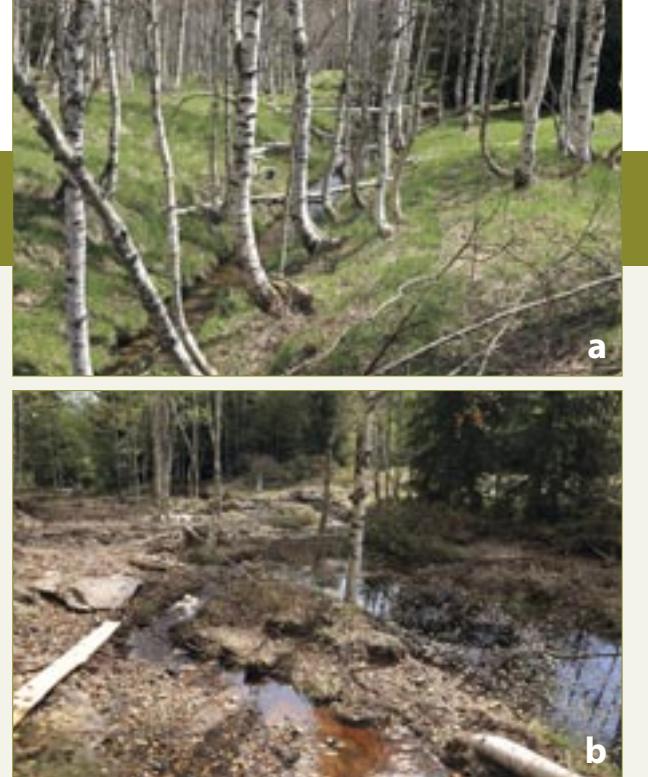
Fig. 220a, b: One of the modified streams at the Vchynice-Tetov site in May 2022 before restoration (a) and in September 2022 immediately after (b) (I. Bufková)

along the route, the two branches of the stream subsequently merged into a single bed (see Fig. 220b).

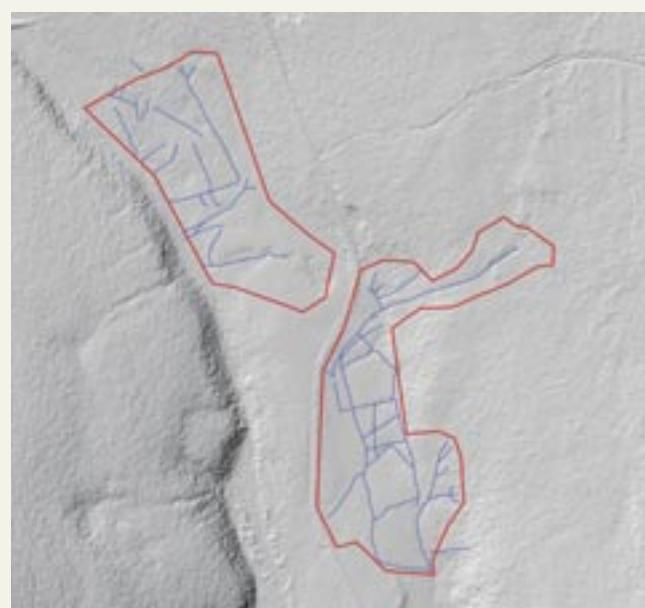
Fig. 222: Scheme of drainage system based on LIDAR images, U Tremlů site

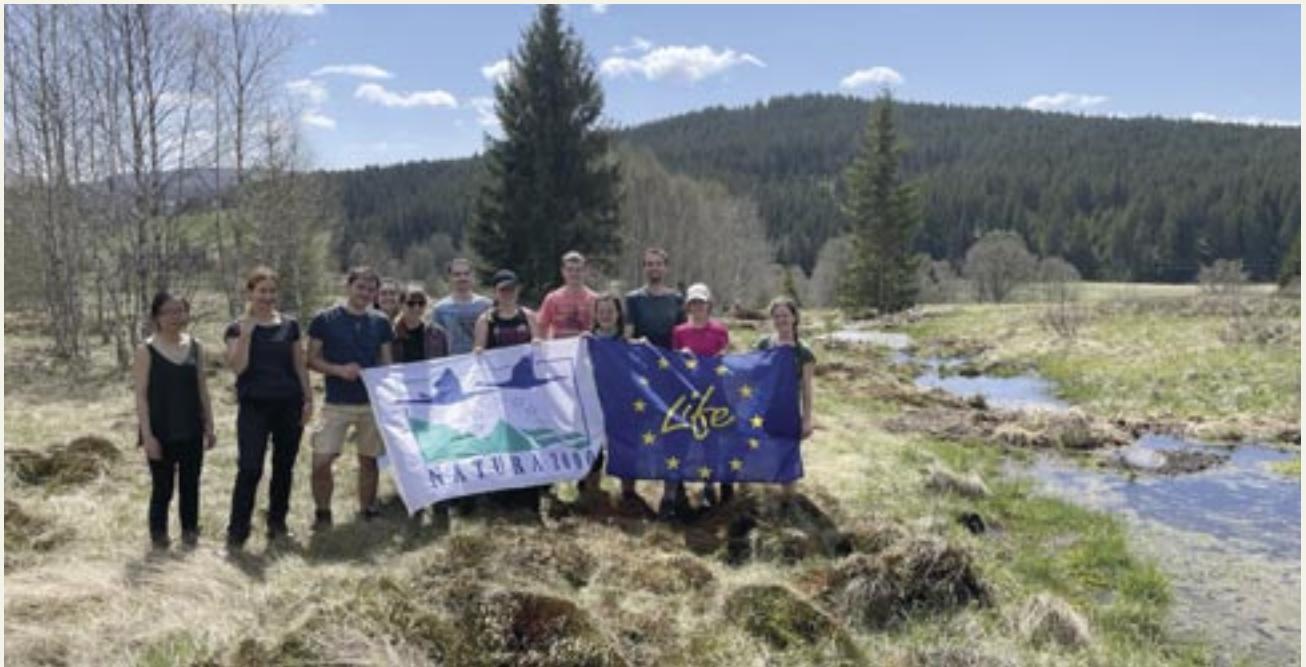
Fig. 223: Much of the credit for the successful restoration of the U Tremlů site goes to the volunteers who manually moved peat from the former dam of the now defunct pond into the blocked drainage channel in the peat bog, May 2022 (L. Linhart)

The lack of material for filling in the channel was solved by dismantling a nearby peat dam from a defunct small pond. Due to the limited movement of machinery (only one-way movement of a small tracked excavator to build the dams), the entire section of the channel was infilled with peat manually with the help of volunteers. Groups of people moved along a temporary walkway while transporting the soil. The infilling of the channel was carried out in stages over two years.

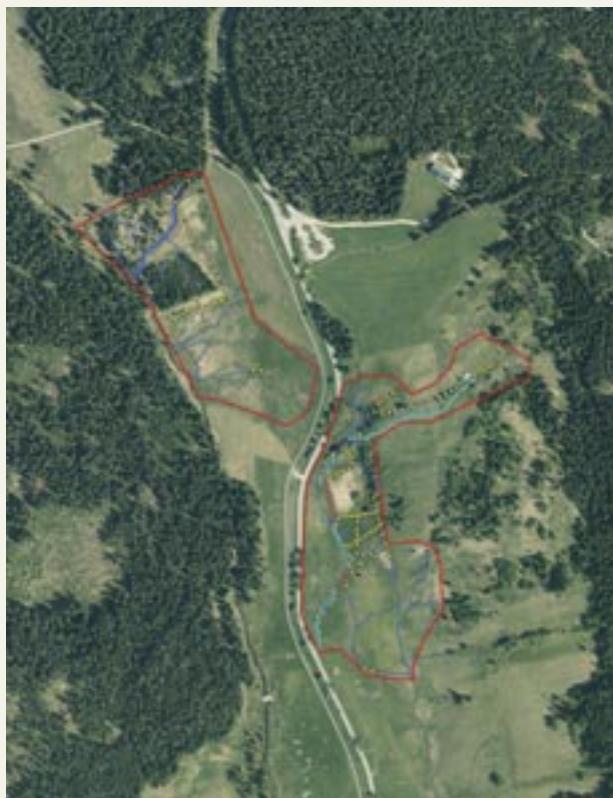
Fig. 224: The drainage scheme of the U Tremlů site and the measures taken on the basis of the aerial image. From the technical documentation (prepared by Geovision Ltd. 2021).

The site was restored in the period August-October 2021. The most technically challenging part was blocking a deep ditch in the spring part of the stream above the road. Wooden dams with backfill were installed and the rest of the channel was filled with peat and sod. The ditch effectively drained the transitional mire, which was heavily saturated with groundwater, so that once it was blocked a strong surface runoff quickly developed.
