Hydrological restoration

**Summary of experience
with restoration of wetlands,
springs and streams in the Šumava region**

Project "LIFE for MIRES"

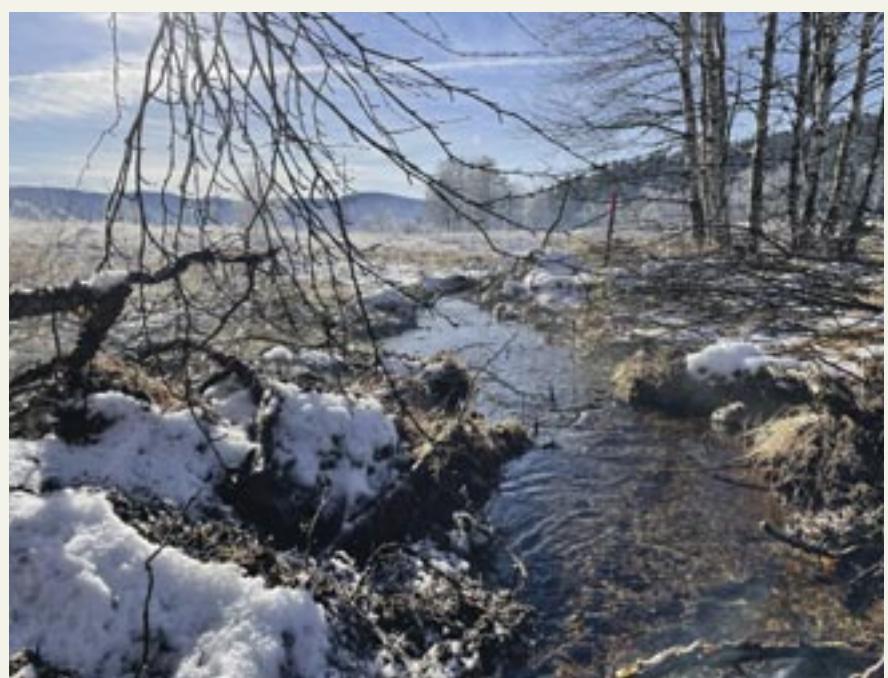
Fig. 225: The nameless left-side tributary of the Kvildský brook has been re-weaved in its original route, November 2021 (L. Linhart)

In the lower downstream section, the brook was only re-weaved in the route of the straightened channel that ran directly through the floor of the valley (Fig. 225). In its lower section before the road culvert, the stream crossed a building lot. The interesting feature of the U Tremlů site is the fact, that during the preliminary phase of the project, the land was exchanged and instead of constructing buildings, the stream and wetlands were restored.

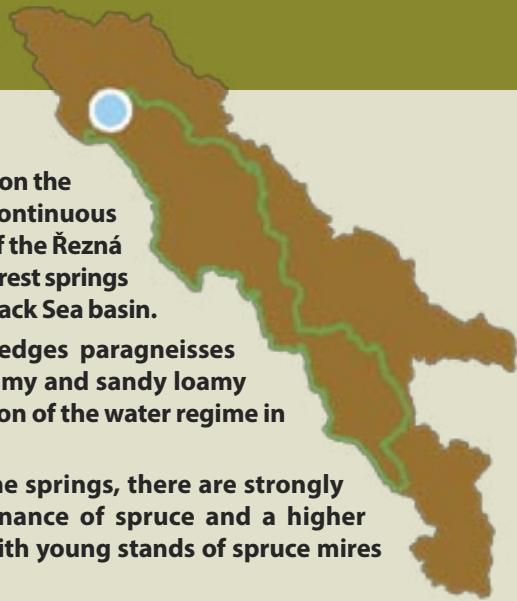
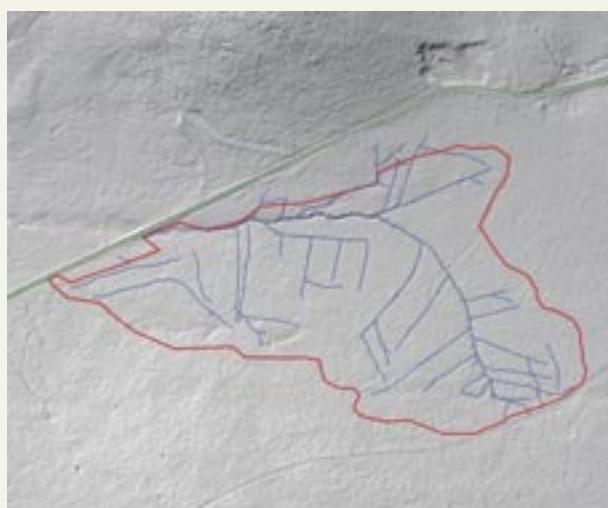
Fig. 226: Scheme of drainage based on LIDAR images, Gerlova Hut' site

The entire area was affected by wind breaks in the 1990s. After their removal, the waterlogged slope was intensively drained by surface channels (Fig. 226).

Side ditches running along the contour were directed into a single drainage channel that represents the lowest cunette in a narrow valley, probably following the route of the original stream. Due to the high longitudinal gradient, there was a strong gully erosion in the line of the main ditch, which was of a progressive character. The depth of the incised runoff reached 3 metres in places. Only in the lowermost, less sloping section, about 100 metres above the road culvert, the stream is already shallow and undulating and there is an accumulation of sediment.

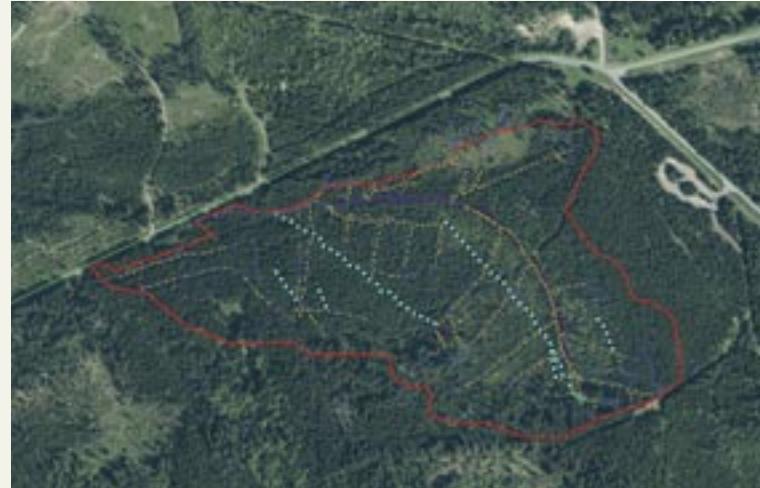
Fig. 227: Aerial image showing the implemented measures, Gerlova Hut' site

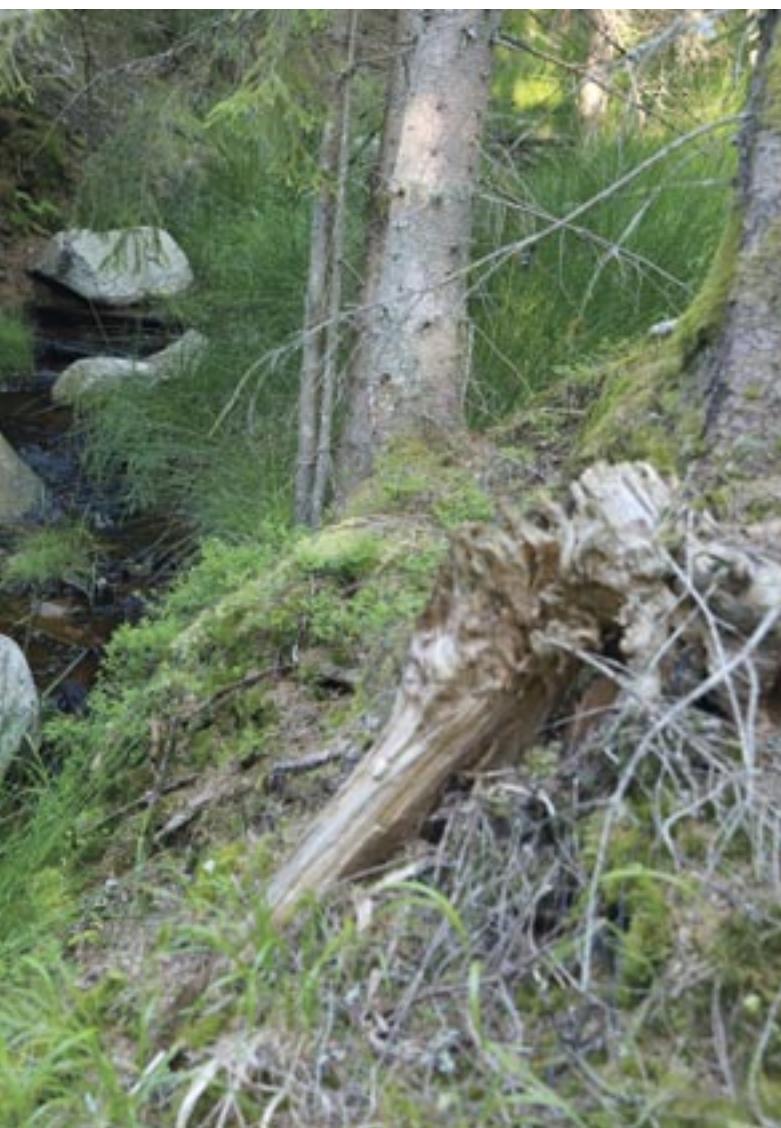
Fig. 229: Transformation of a deep erosion gully into a natural stream at the Gerlova Hut' site two years after restoration. Stabilization dams are hidden in the raised bed of the re-weaved stream, June 2024 (I. Bufková)

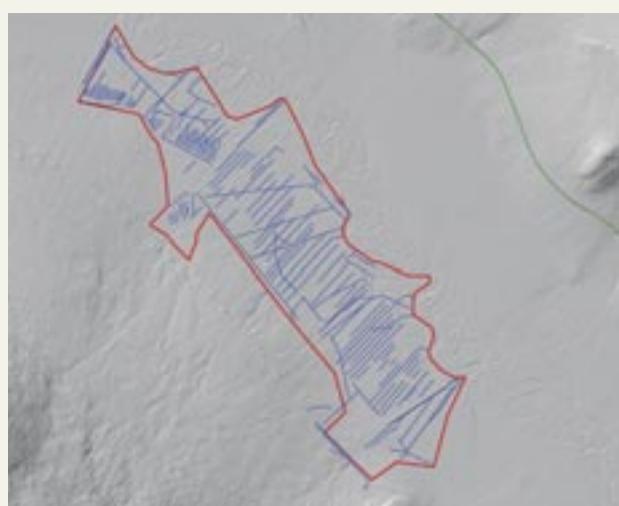
Fig. 231: Scheme of the drainage based on LIDAR images, Dobrovodské louky site

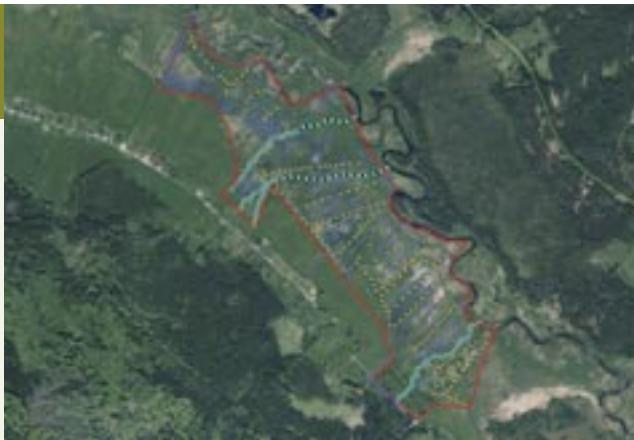
Fig. 232: Aerial image showing the measures implemented, Dobrovodské louky site

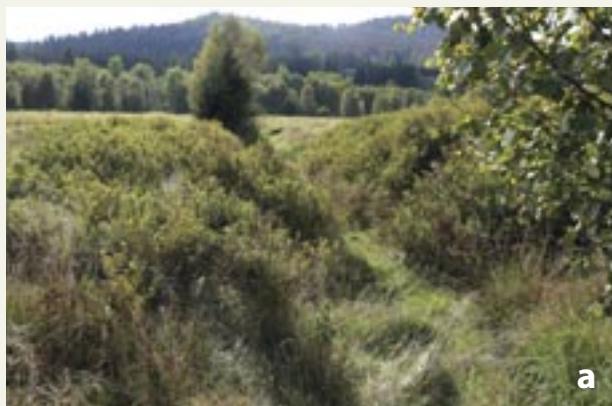
Fig. 233a, b: Drainage channel at the Dobrovodské louky site in September 2021 before blockage (a) and in May 2022, almost a year after restoration (b) (I. Bufková).

Hydrological restoration was carried out between 2021 and 2022. A large number of drainage channels (8.5 km in total) were removed on the site. All channels were blocked with wooden dams with backfill and almost everywhere completely filled with soil from local sources. Due to the flat terrain with minimal longitudinal slope, the water table was not calculated. However, the distance between the dams does not exceed 15-20 metres. In the filled area between the dams of the large channels, this rather short distance between dams prevents excessive pressure of the waterlogged mud on the backfilled dams and thus prevents their scouring. The soil for filling the channels was obtained from the bank mounds, which were

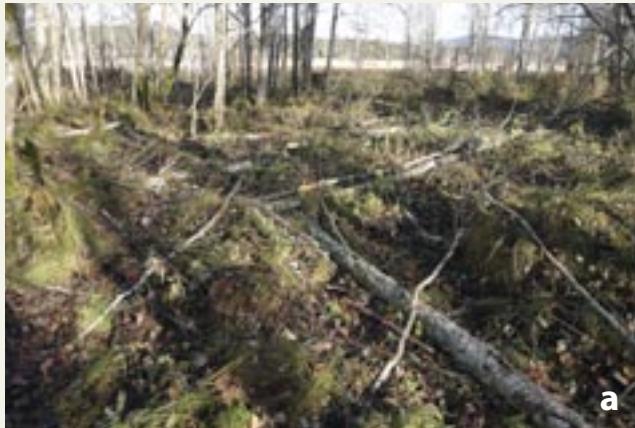
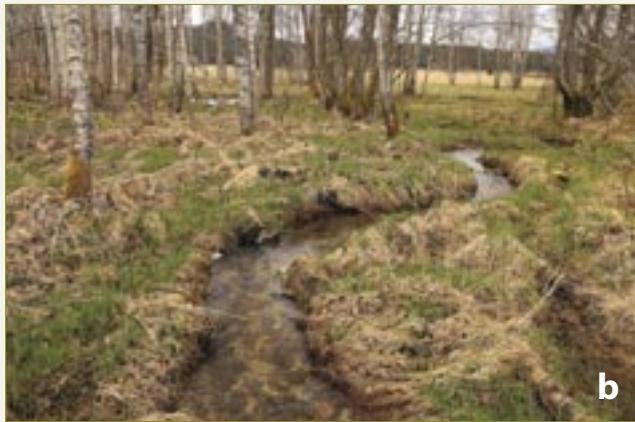
Fig. 234a, b: The stream in the alder woodland in the piped state in November 2021 (a) and two years after restoration in April 2023 (b), Dobrovodské louky meadows site (I. Bufkova)

Three of the four streams were diverted from underground pipes on the slope above the floodplain to the surface into a new bed shaped by an excavator. The stream bed was 0.6 - 0.8 m wide and up to 25 cm deep. In the case of the two restored streams, their lowermost sections were freely released through the floodplain to their original route. The piped drainage was repeatedly interrupted by excavating into approximately 5-10 m long sections of concrete pipes. Both ends of the pipes were covered with a wooden dam with an overlap and backfilled. Locally shallow pools were created at the pipe removal points with shallow depressions for directing water runoff into the wetland area. A large quantity of older, probably pre-war drainage was also found in the area, consisting of narrow pipes ca 0.25 m in diameter, for which no documentation was available. This, too, was interrupted in many places by the removal of short sections of pipes (up to 3m) and back-filling the area with compacted soil.

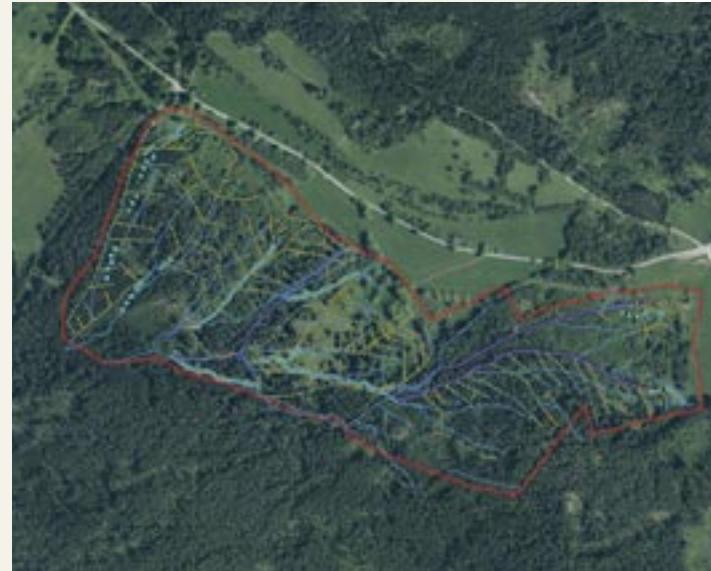
Fig. 238: Aerial image showing the measures implemented, Rovina site

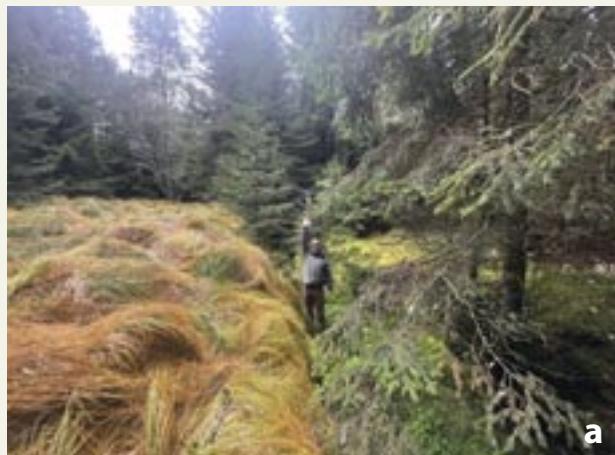
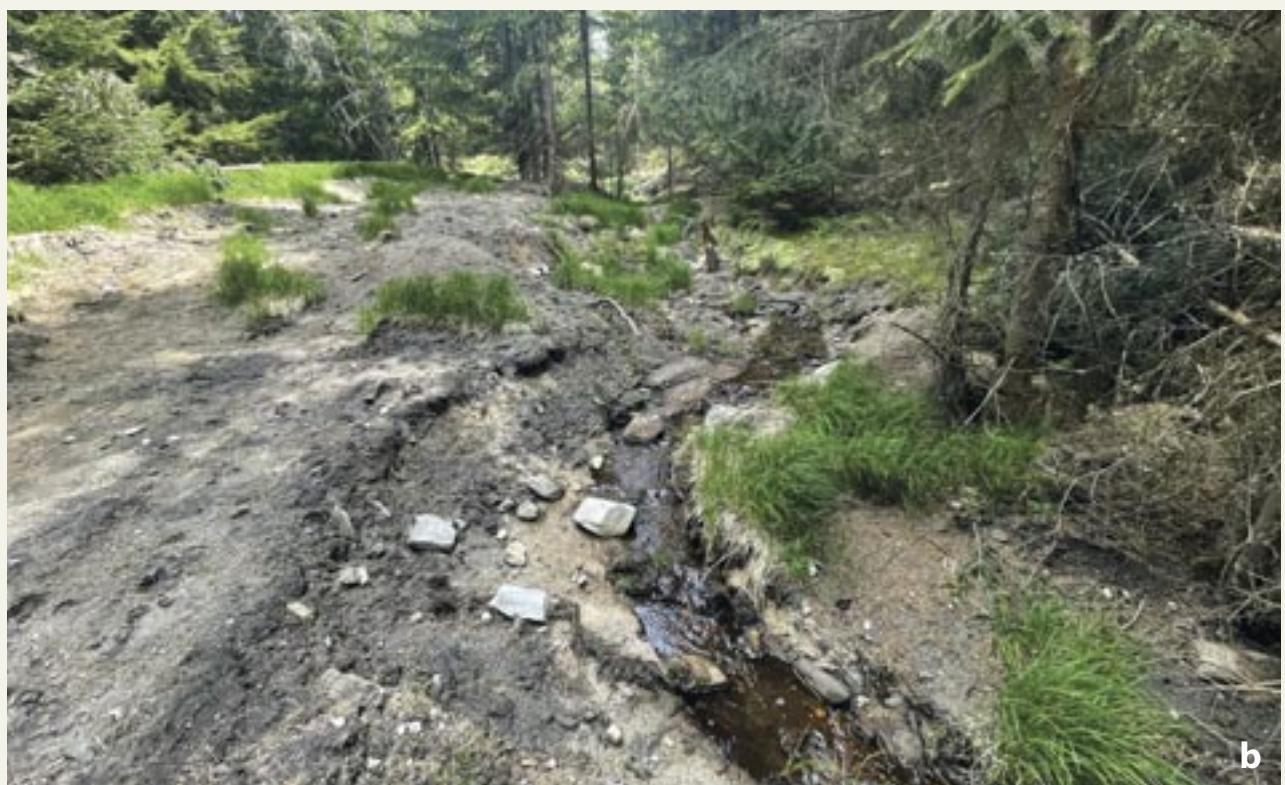
Fig. 240a, b: Deeply incised and straightened stream at the Rovina site just before restoration in October 2022 (a) one year after its return to natural state (June 2023) (b) (L. Linhart)

The blocked main channels, which prior to the restoration led straightened streams, are of about 85 % well retaining water, stable and without signs of scouring. The rest of the sections are experiencing incipient scouring of the backfilled dams, which needs to be urgently addressed by diverting flows to the wetland area and repairing the dam backfilling.

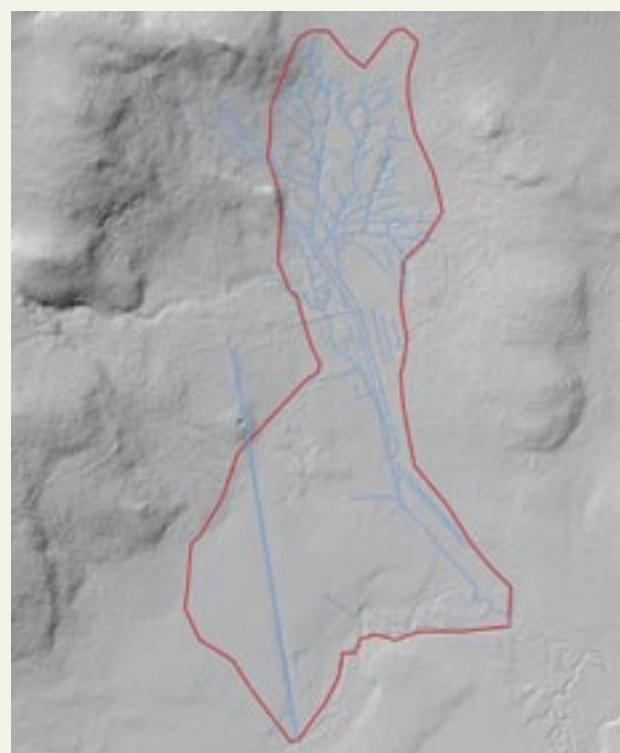
Fig. 241: Scheme of the drainage based on LIDAR images, Nové Údolí

a network of surface channels (Fig. 241). Similarly, the source streams of the unnamed left-side tributary of the Studená Vltava River were impounded and diverted into the drainage system. The channels with diverted watercourses on the slope were subject to severe erosion and deepened to a depth of up to two metres. The stream was also regulated downstream a paved road that crosses the slope approximately halfway down. Part of its flow was directed into a parallel millrace. The stream originally flowed into a cut meander of the Studená Vltava River, which was developed in the past due to the straightening of the Vltava River. The surface ditches also drained the raised bog at the foot of the slope.

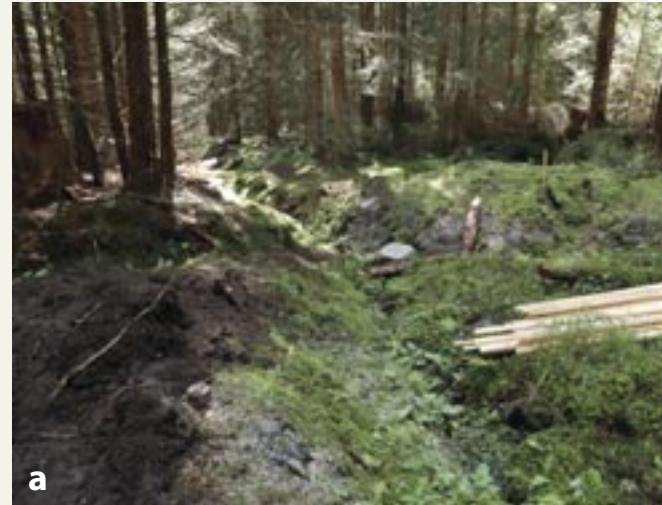
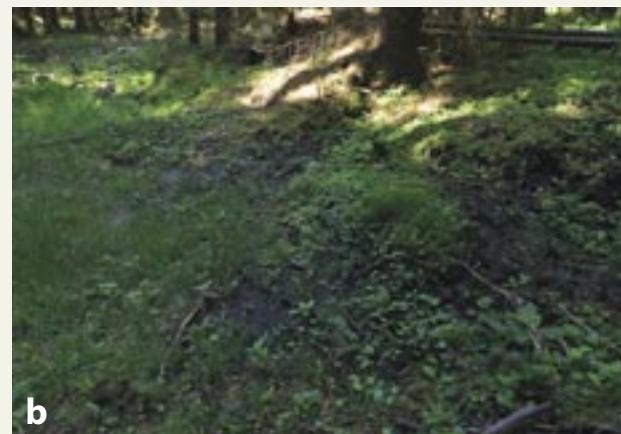
Fig. 243a, b: Drained forest spring at the Nové Údolí site in August 2020 just before the ditches were closed (a) and after they were blocked with wooden dams (b) (I. Bufková)

Monitoring of the sites after the restoration showed good regeneration capacity of the springs. After the blocking of the channels, they were very quickly rewatered and natural routes of the small flows were restored. The vegetation responded quickly to these changes by increasing the proportion of spring and wetland species. Among the most successful species were especially the water-starwort (*Callitrichne sp.*), as well as the bog stitchwort (*Stellaria alsine*) and the large bitter-cress (*Cardamine amara*).

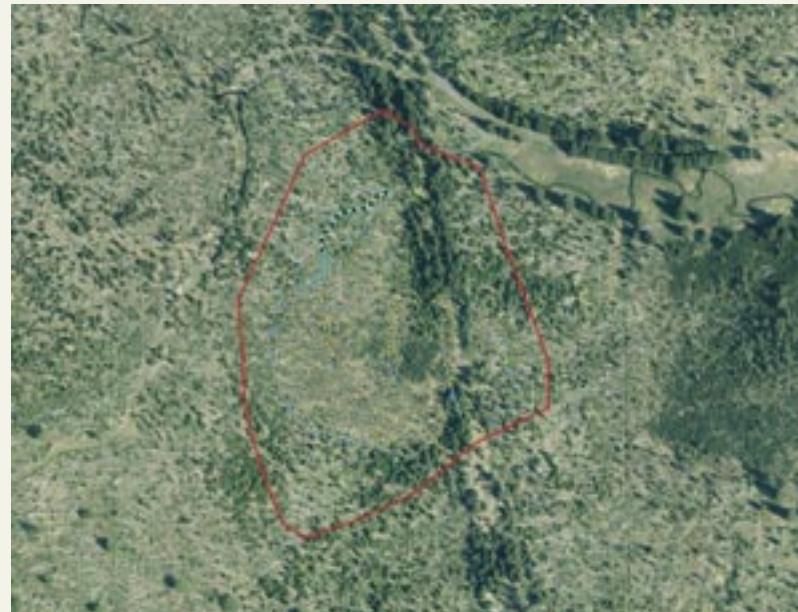
Fig. 245: Aerial image showing the measures implemented, Střelecký průsmyk

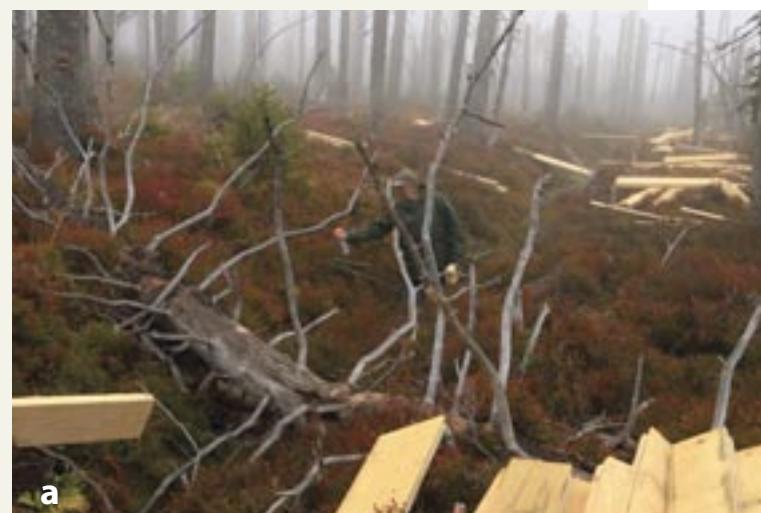
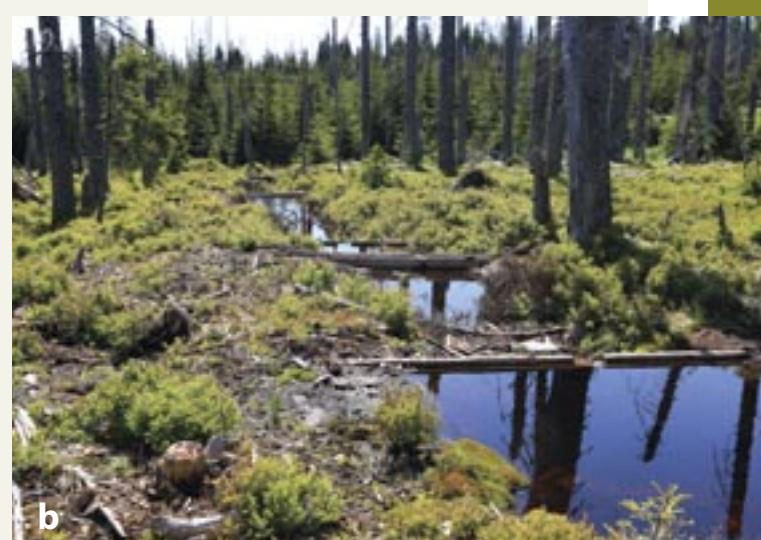
Fig. 247a, b: Drainage channel in spruce mire in the decay phase after the bark beetle expansion in October 2020 just before restoration (a) and after blocking with wooden dams in June 2023, two years after restoration (b) (Střelecký průsmyk) (I. Bufková)

The blocked drainage channels were filled with water the following year after the restoration. The soil profile in their vicinity became significantly waterlogged. The northern outflow follows the newly created route, but continues to operate periodically. Approximately halfway through the section, it is completely lost by soakage into the soil. Due to the short post-restoration phase, changes in vegetation have not yet been evaluated.

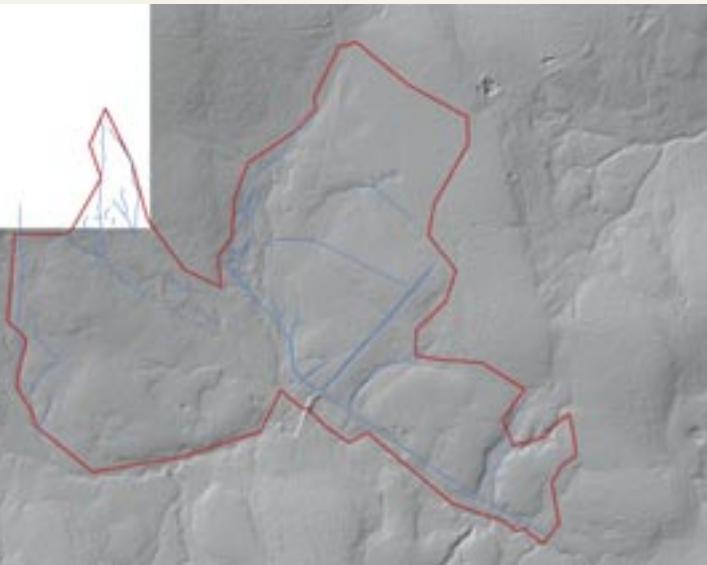
Fig. 248: Scheme of the drainage based on LIDAR images, Rokytecké slatě

Mires in the Rokytecké slatě area were affected by several different interventions into site hydrology in the past. In particular, the raised bogs in the north-eastern and eastern parts of the site were drained by a set of deep channels. Serious damage both to the water regime and the integrity of the peat bodies was also caused by the construction of a paved road in this part of the site. The road is lined with deep ditches and also contains a limestone deposit which, through its chemistry, damages the oligotrophic and acidic environment that is important for the existence of the raised bog.

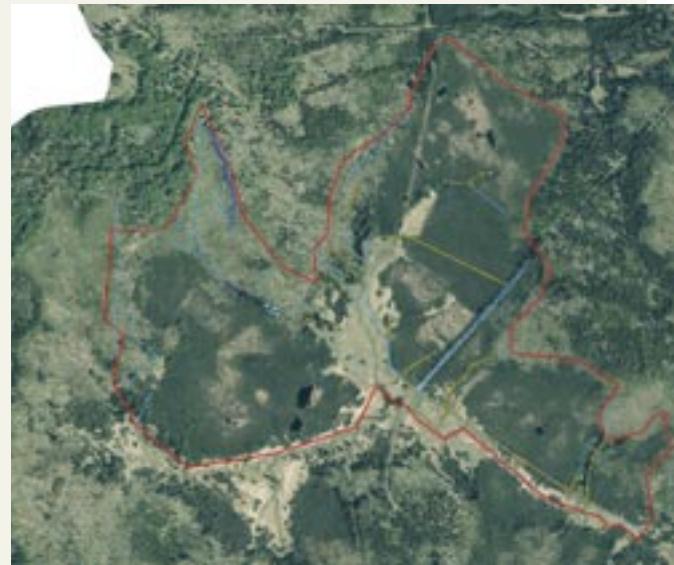
Fig. 249: Aerial image showing the measures implemented, Rokytecké slatě

The hydrological restorations within the LIFE for MIRES project mainly focused on the removal of the drainage system. The removal of the limestone path is a task for the next restoration stages. The work was carried out between August and November 2022. A year earlier, access roads for machinery were cut. Drainage channels on the raised bogs were blocked using vertically hammered plank dams with backfill. The target water table on the raised bog was set at -5 cm. Due to the significant surface gradient (especially at the outer edge of the raised bog), the dams would be installed only 1 m apart in some sections according to this value. The distance between the dams was therefore extended to a minimum of 4-5 m. A light crawler excavator weighing up to 3 t was used to install the dams for approximately 1/3 of the total length of the channels.

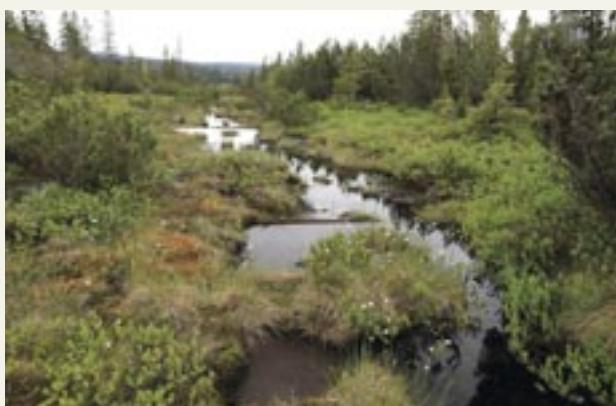
Fig. 250: A rapidly deepening surface erosion gully on the old line of the Iron Curtain in the locality of Rokytecké slatě was closed with the generous help of volunteers. (I. Bufková)

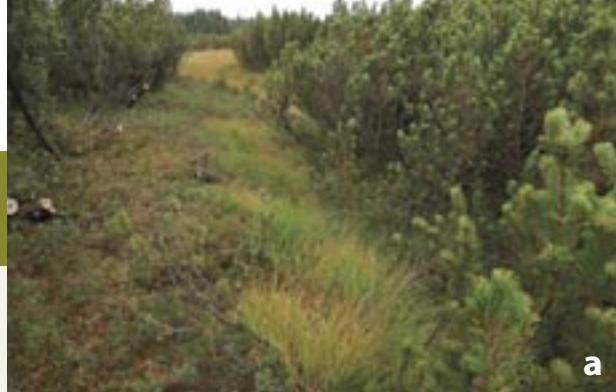
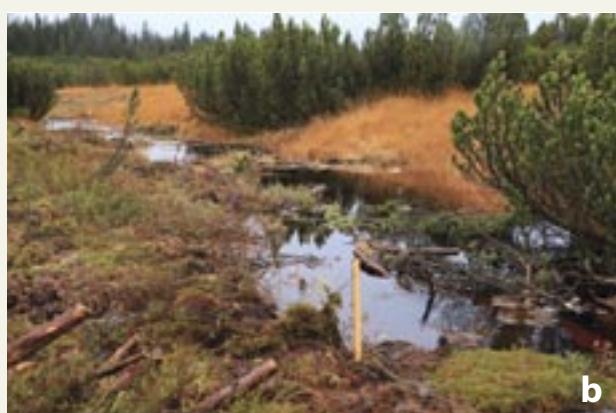
Fig. 251a, b: Deep drainage ditch on the raised bog in the Rokytecké slatě mire complex just before restoration in August 2022 (a) and soon after blocking with wooden dams and infilling in September 2022 (b) (I. Bufková)

Due to the lack of peat to fill the channels, the spaces between the dam backfills were filled mainly with branches from cut dwarf mountain pine. Shallow pools were also excavated at several locations along the channel to obtain peat for the backfill. In the coming season, clumps of bog mosses have to be introduced into the blocked channels to accelerate the terrestrialization of the small pools.

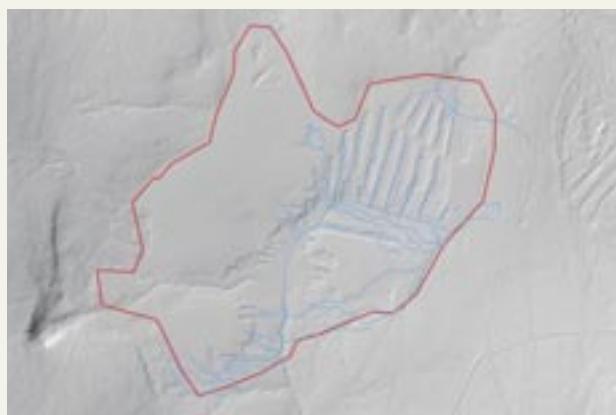
Fig. 253: Scheme of the drainage based on LIDAR images, Jezerní slat'

The large raised bog has been completely transformed by block-cutting of peat and drainage. The original arched shape of the bog dome was replaced in large areas (approx. 50 % of the area) by post-mining features with a typical strip structure. It alternates between mined out waterlogged lowlands ("baths") and retained elevated zones ("logs"). The raised bog is centrally drained by a wide channel, the bottom of which is significantly deepened in relation to the surrounding area, creating a gradient that draws water from the adjacent bog domes.

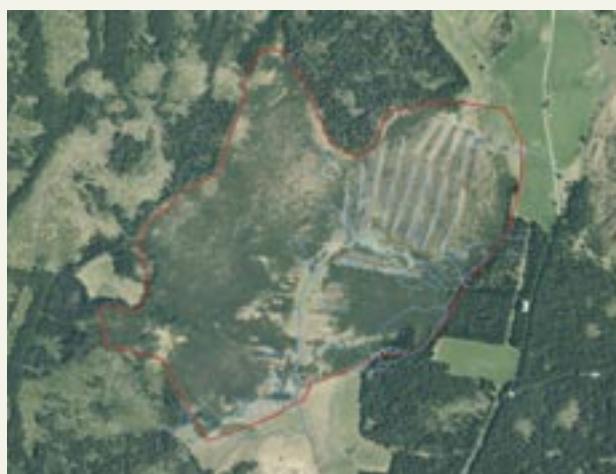
Fig. 254: Aerial image showing the measures implemented, Jezerní slat'

In total, just over 1 km of drainage channels were removed from the site. The central channel on the raised bog was blocked by a cascade of vertical plank dams with proper backfilling. The target level was around 5-10 cm. In some sections, the dams were spaced further apart due to limited machinery movement and with respect to the very wet channel banks. In the downstream part of the central channel, a reinforced dam made of two plank walls (Fig. 256) with peat compacted between them was used. The channels were subsequently filled with peat at approx. 50% of the volume. The peat was obtained by tearing down the channel banks and

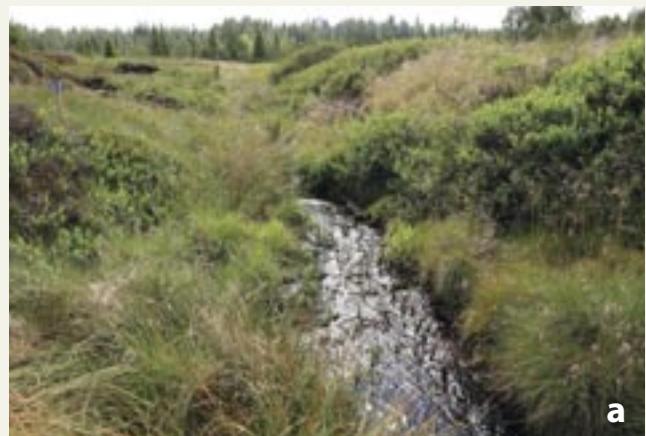
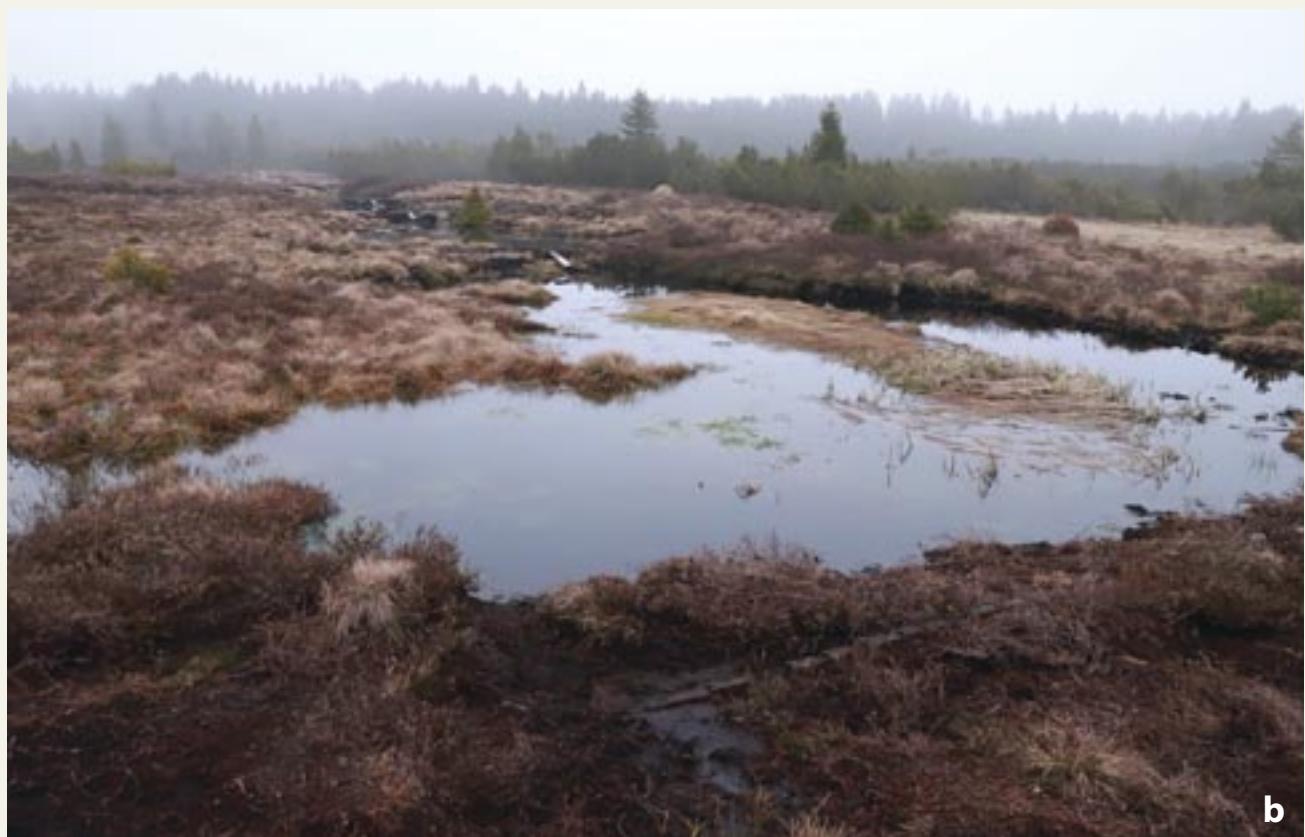
Fig. 255a, b: The central drainage ditch on the Jezerní slat' site in June 2022 just before restoration (a) and two years after it, in February 2024 (b) (I. Bufková)

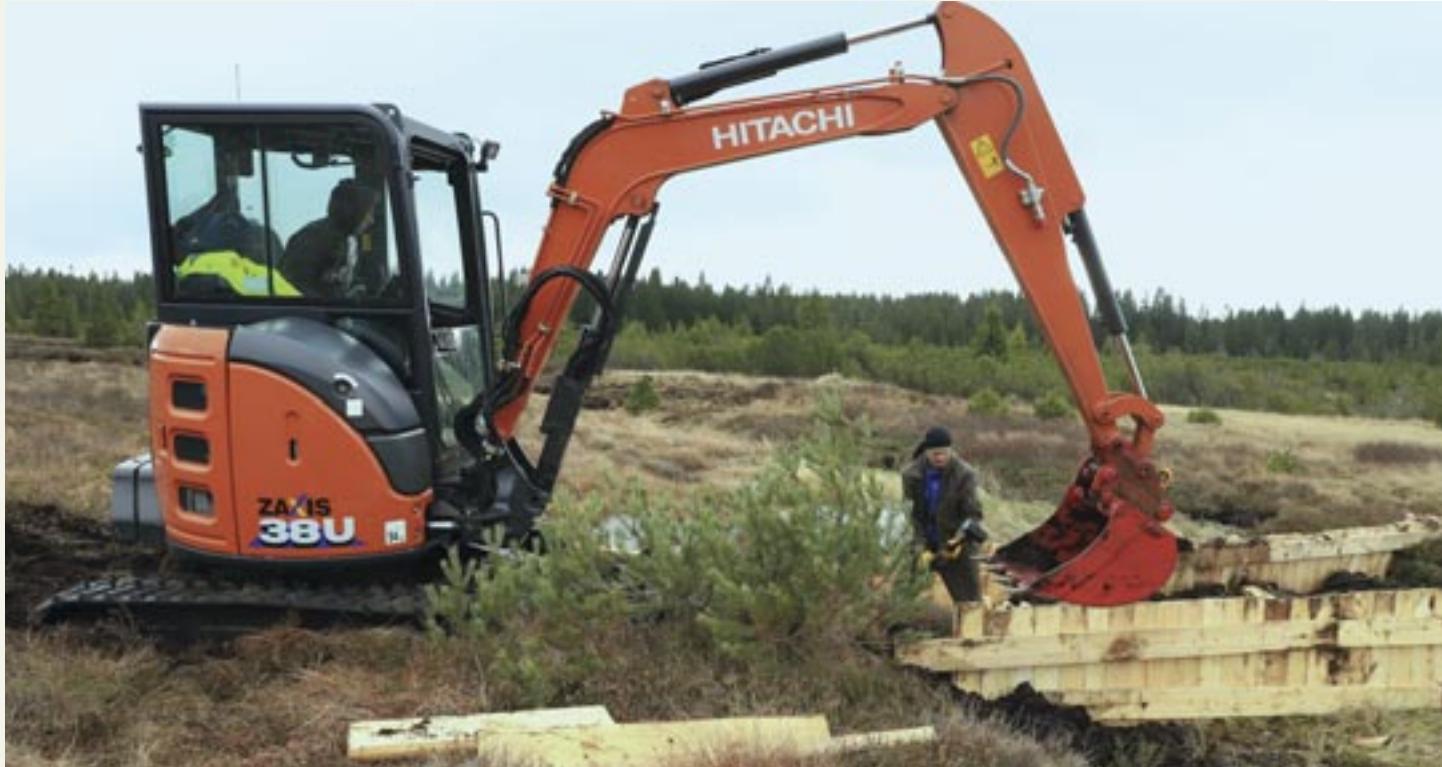
Fig. 256: Construction of dams made of hammered planks at the Jezerní slat' site, November 2022 (I. Bufková)

breaking the bank mounds in the line of the former tracks. The ends of the raised "strips" were also partly used as a source of material. A small excavator weighing 3.5 t assisted in the installation and filling of the channel. Several dams also enclosed the artificial outflow from the bog pool in the preserved part of the raised bog. Small channels draining the area at the interface between the excavated "baths and strips" were also blocked. In at least 8 places, culverts were created to divert excess water from the channel back into the peat bog.

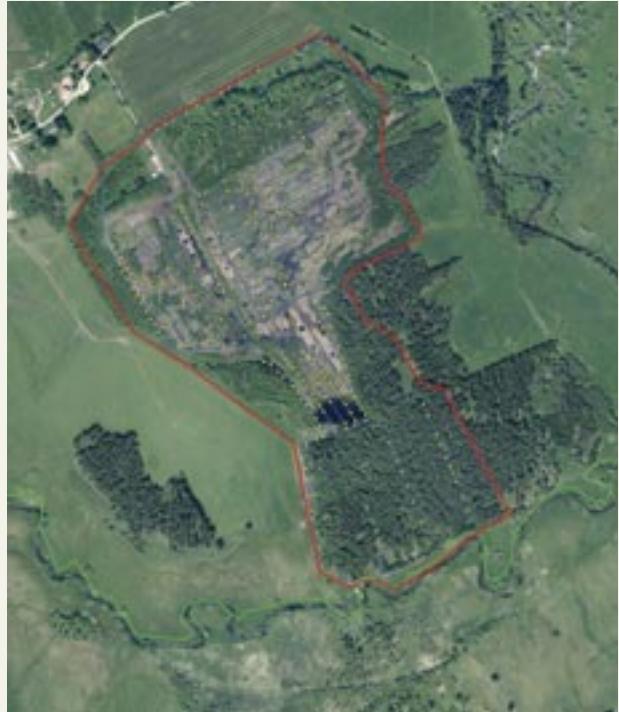
Fig. 260: Aerial image showing the measures implemented, Vlčí Jámy

In the southern part of the mined area, the side ditches lead to surface channels. At the western edge, the underground drainage flows into a 4 m deep pit measuring 10 x 10 m. They continue as deep surface channels. At the lower edge of the drained part of the peat bog, they mouth into a 2 m deep and 4 m wide main collecting channel, which drains water along the edge of the forest cover into the Rásnice River. A system of shallow drainage ditches was also

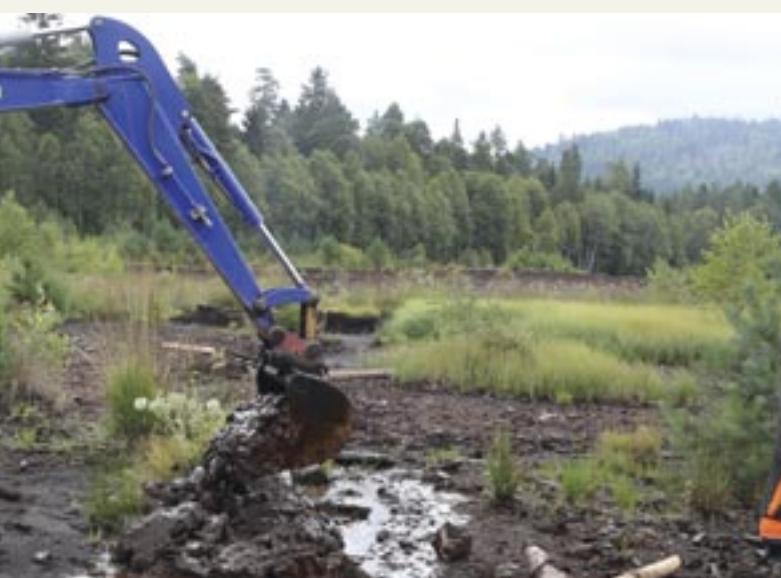
Fig. 258: Earth works during surface modifications at the restored Vlčí Jámy site, September 2021 (I. Bufková)

Selected post-mining depressions were closed with a wide peat bunding. The material for the bunds was obtained by shaping the bottom of the terrain depression as well as by partial removal of degraded top peat layer from the elevated "strips" (from above).

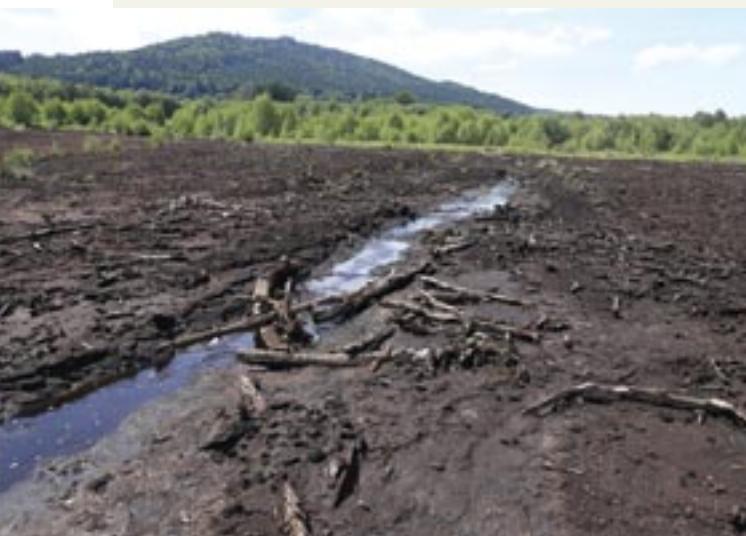
Fig. 261: Rapidly deepening erosion rills were easily formed on the bare surface of the peat. Situation just before restoration, Vlčí jámy bog, June 2021 (L. Linhart)

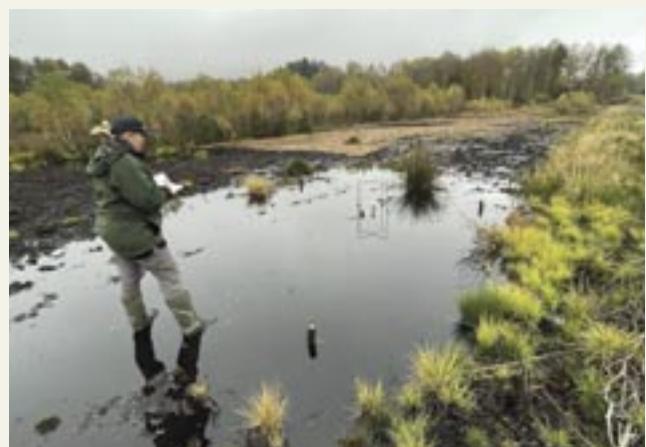
Fig. 262: Inspection of the permanent monitoring plot one year after restoration. The figure shows the same VJ1 plot surface as Fig. 196a, b, October 2022 (L. Linhart)

Fig. 196a, b: Vegetation plot of 16 m² on the mined peat bog of Vlčí jámy before restoration in April 2019 (above) and two years after restoration in August 2023 (below) (I. Bufková).

Vegetation on the site was monitored at three monitoring plots located near the TWT and soil moisture probes. In the permanent plots at the mining site section (plots VJ1-2), common rush (*Juncus effusus*) appears to be a successful coloniser of the bare peat two years after the restoration. Both monitored areas tend to flood briefly during high water levels. The rapid onset of vegetation has occurred particularly in the area of the lower mining site VJ2, which is also affected by water flowing from the blocked underground drainage during high water levels and is probably enriched with nutrients. Herbaceous cover in this area has increased from 0 %

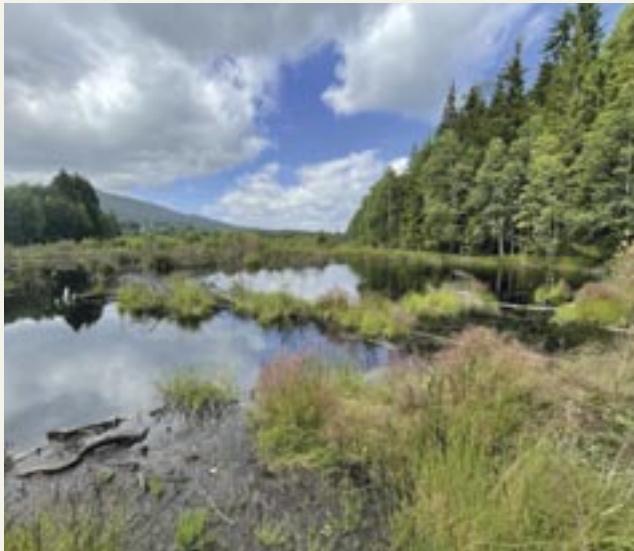
Fig. 263: A large lake formed spontaneously in the lower part of the Vlčí jámy bog after the drainage channels were blocked, situation one year after restoration in July 2023 (L. Linhart)

After the restoration, most of the areas were significantly re-watered. In the lowest part of the site at the southern edge, a large shallow pool of 0.3 ha spontaneously formed. A similar pool was created in the central part of the mining site at the site of a blocked underground drainage crossing. However, the hydrological response of the bog in terms of water table level position is rather patchy. The boreholes in both the upper and lower mining sites (VJ1-2) show an

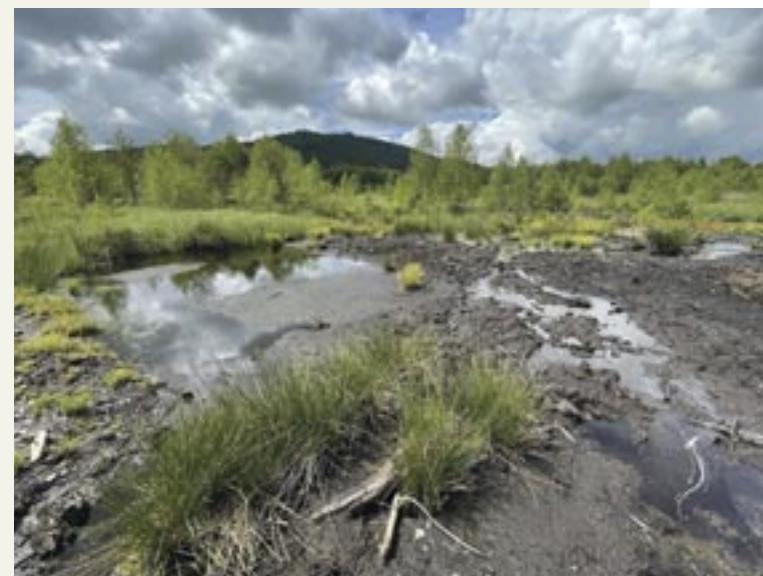
Fig. 264: General view of Vlčí Jámy bog in June 2023, one year after restoration (L. Linhart)

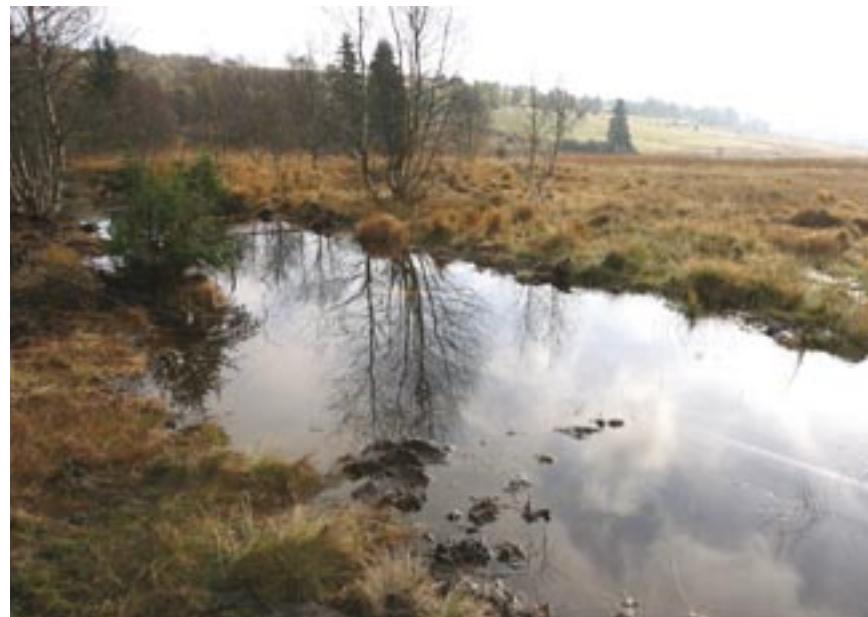
Fig. 266: Drainage channel blocked during Phase II of restoration at the Zhůří site, situation immediately after implemented measures, October 2014 (I. Bufková)

perfectly at first, but over time many of them were leaking at the bottom or sides due to water pressure and erosion. Unsufficient transfer of water into the wetland area outside the actual blocked channel certainly played a part.

In addition, plain unfilled dams on slopes, where water levels in the dammed channels often fluctuate, were more susceptible to rot and gradual decay due to air access. This problem mainly affected horizontally installed board dams, which were used on forest and meadow minerotrophic mires or in non-peat wetlands. Most of the massive dams from planks that were vertically hammered into the peat on the raised bogs did not have similar problems and are still in use today. Yet even with these, it is clear after several decades that the absence of backfill reduces their overall durability. However, the regenerative capacity of the rewetted mires compensates for the shortcomings of the uncovered dams in many cases, and the ditches are able to become overgrown with mire vegetation, become terrestrialized and stabilized before the woody dams collapse. At some sites, backfilling of dams and channel filling were carried out retrospectively. Since 2013, backfilled woody dams and channel filling have been an integral part of the implemented measures.

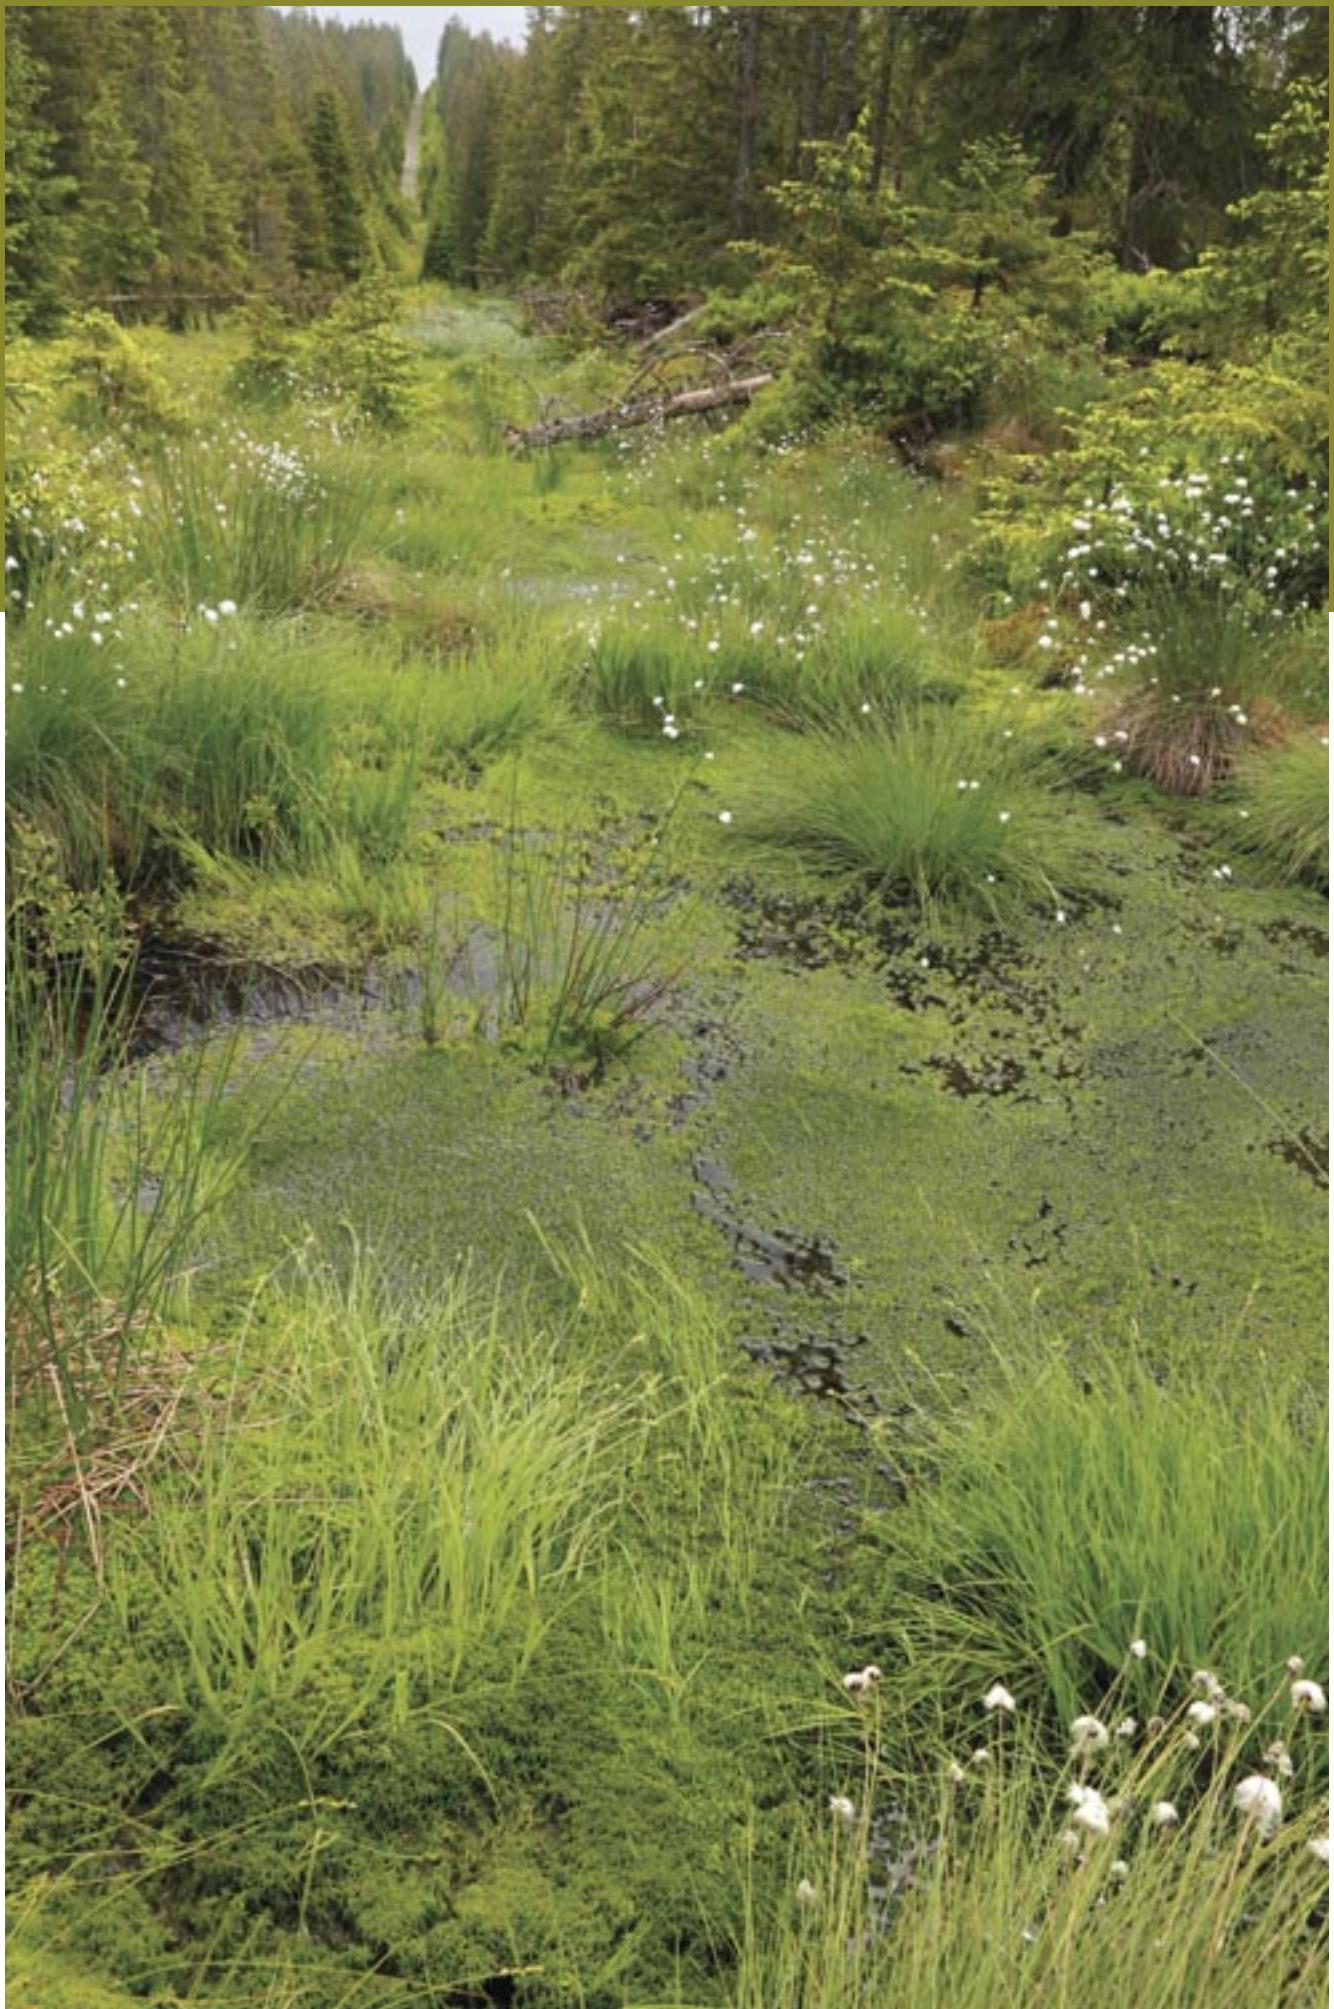
Fig. 267: The deep erosion gully under the Černá Mt. is already a matter of the past. View of a completely terrestrialized and stabilized channel overgrown with mire vegetation. Situation 10 years after the restoration, July 2024. The same section is shown as in Fig. 278.
