Hydrological restoration

**Summary of experience
with restoration of wetlands,
springs and streams in the Šumava region**

Project "LIFE for MIRES"

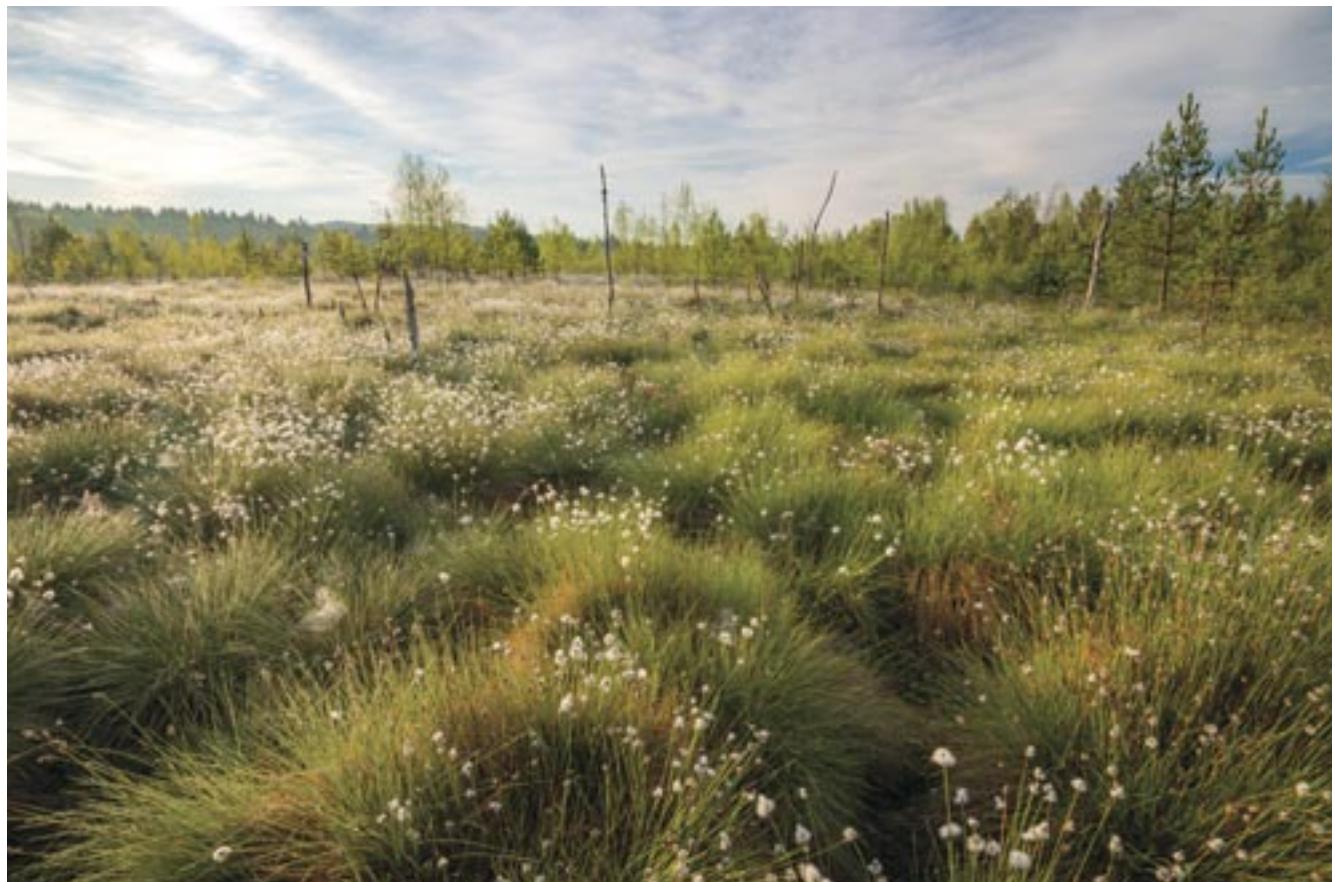
Fig. 268: Restored industrially mined bog Soumarský Most, June 2021 (J. Albrecht)

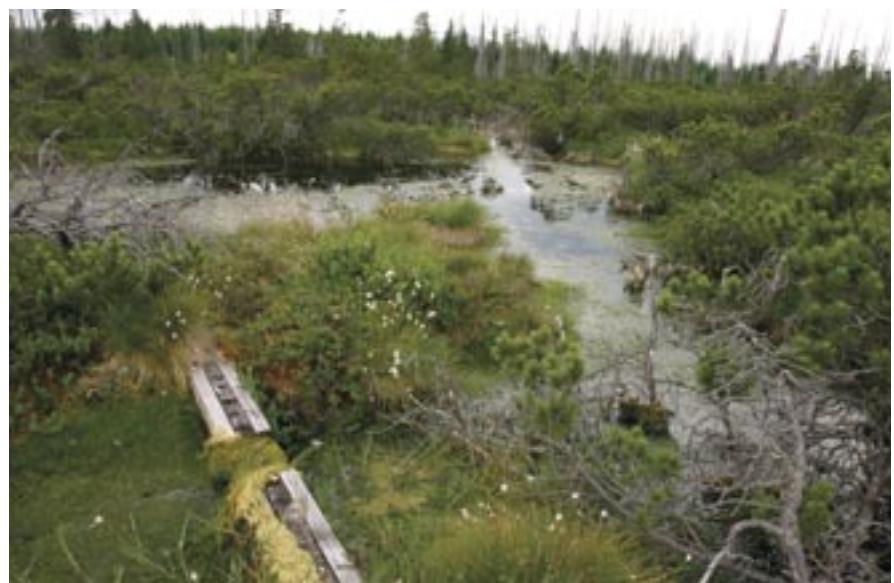
Fig. 269: Cancelled surface drainage on the unique raised bog area of the Novohuťské močály site, nine years after restoration, July 2013 (I. Buřková)

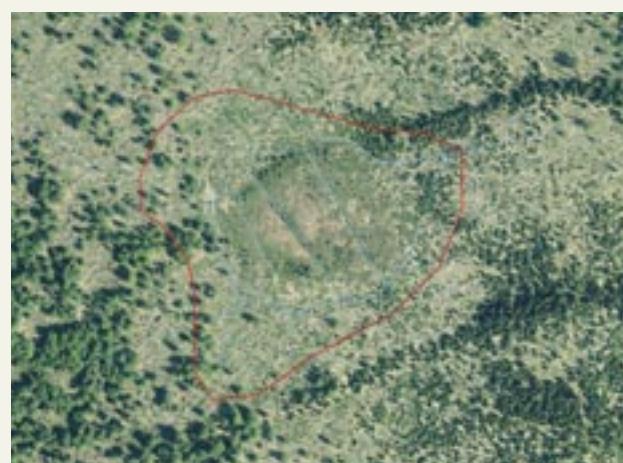
Fig. 271: Aerial image of the restored area, Schachtenfilz bog

Drainage gullies were over 1 m deep and over 4 m wide in some places due to erosion and washout of material from the banks of the channels. In the raised bog areas all the drainage ditches were only cut in the peat profile and none of them reached the mineral bedrock in their bottom. The entire peat complex, including the raised bog, is situated on a very gentle slope with an eastern orientation. The slope thus determines the flow and water runoff from the site and largely influences the effect of past drainage.

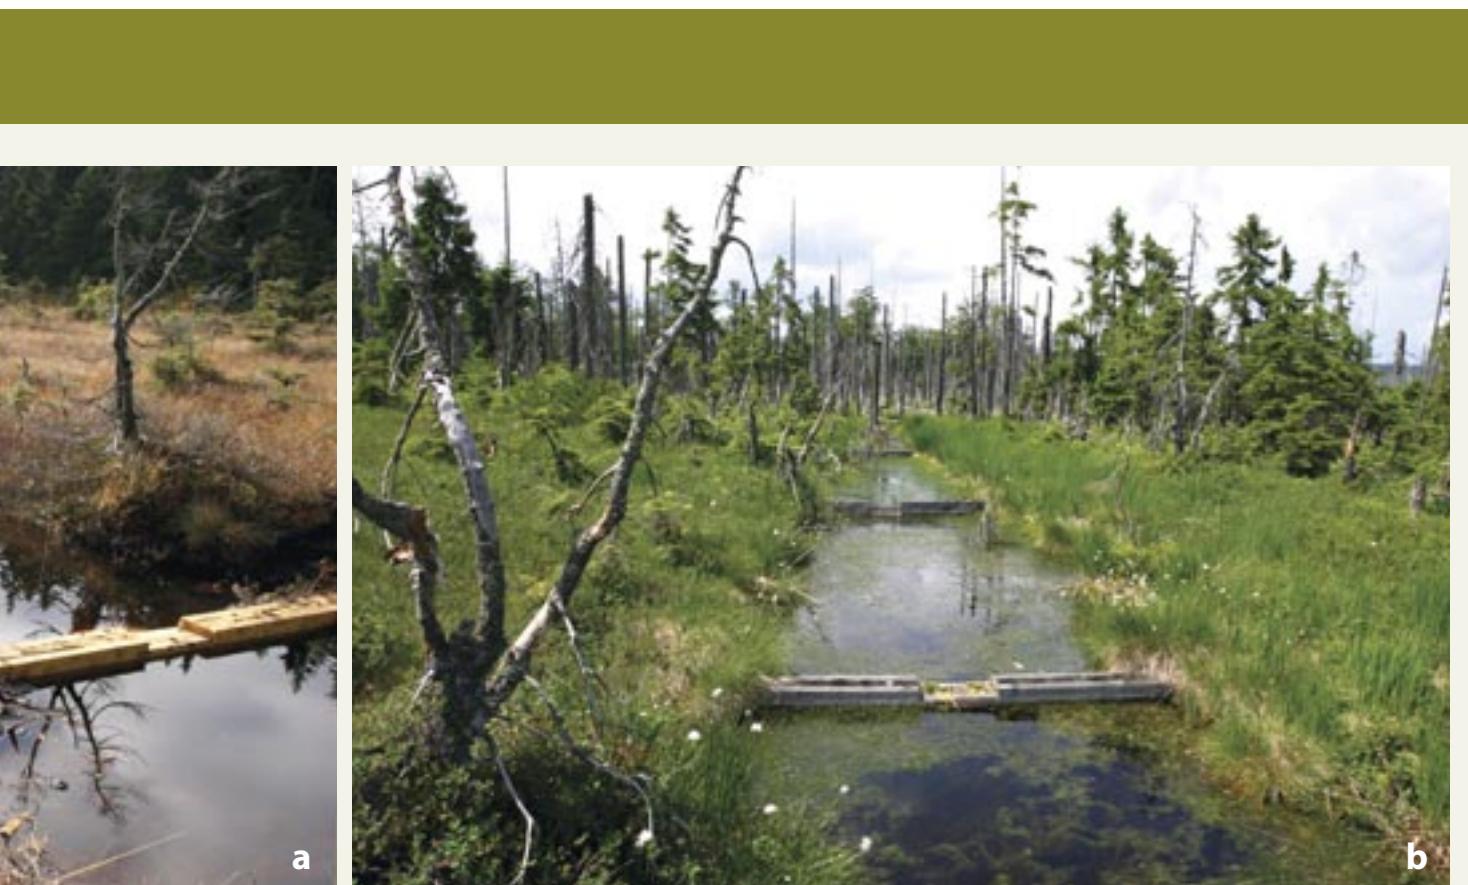
Fig. 273: The drainage channels at the Schachtenfilz site were manually dammed using woody dams without backfilling. Condition of the dams in October 2008 immediately after restoration (a) and ten years later in June 2018 (b) (I. Bufková)

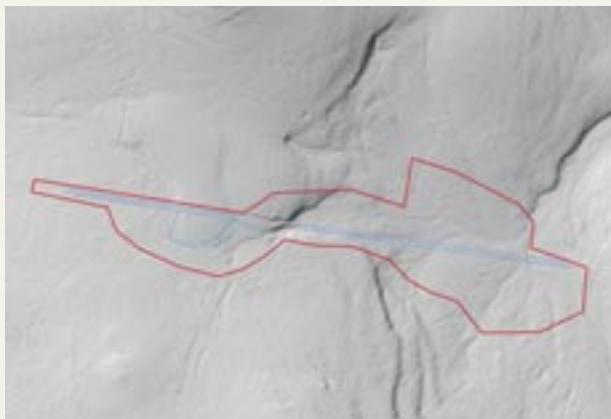
Fig. 274: Scheme of drainage based on LIDAR images, Černohorský močál I and II

The area was historically drained by surface forest channels, many of which were probably created in the 19th century and subsequently deepened in the second half of the 20th century. However, the most serious intervention in the water regime is the 'Iron Curtain' line, which was secured on both sides by thorough drainage along its entire length. The surface channels along this line were over two metres deep and around 5 metres wide.

On the slopes to the Vltava River, the runoffs from several springs under Černá Mt. were diverted into these channels. The large longitudinal terrain slope and the force of the concentrated runoff of the three streams turned one of the drainage channels into a deep gully. Strong erosion caused a large amount of peat to be washed out into the Vltava River. The erosion was still active in the period before the restoration started. The deep channel created a significant

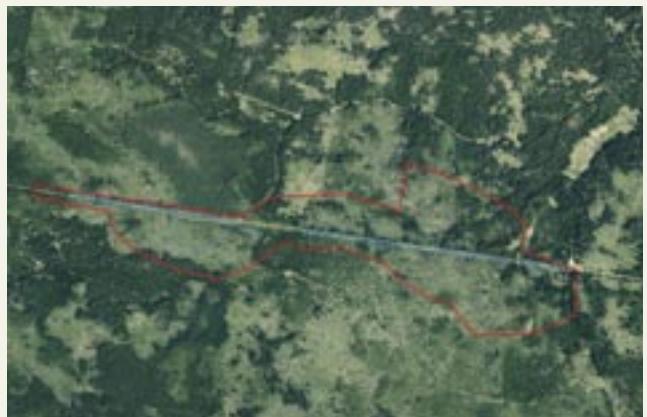
Fig. 275: Aerial image showing the measures implemented, Černohorský močál I and II

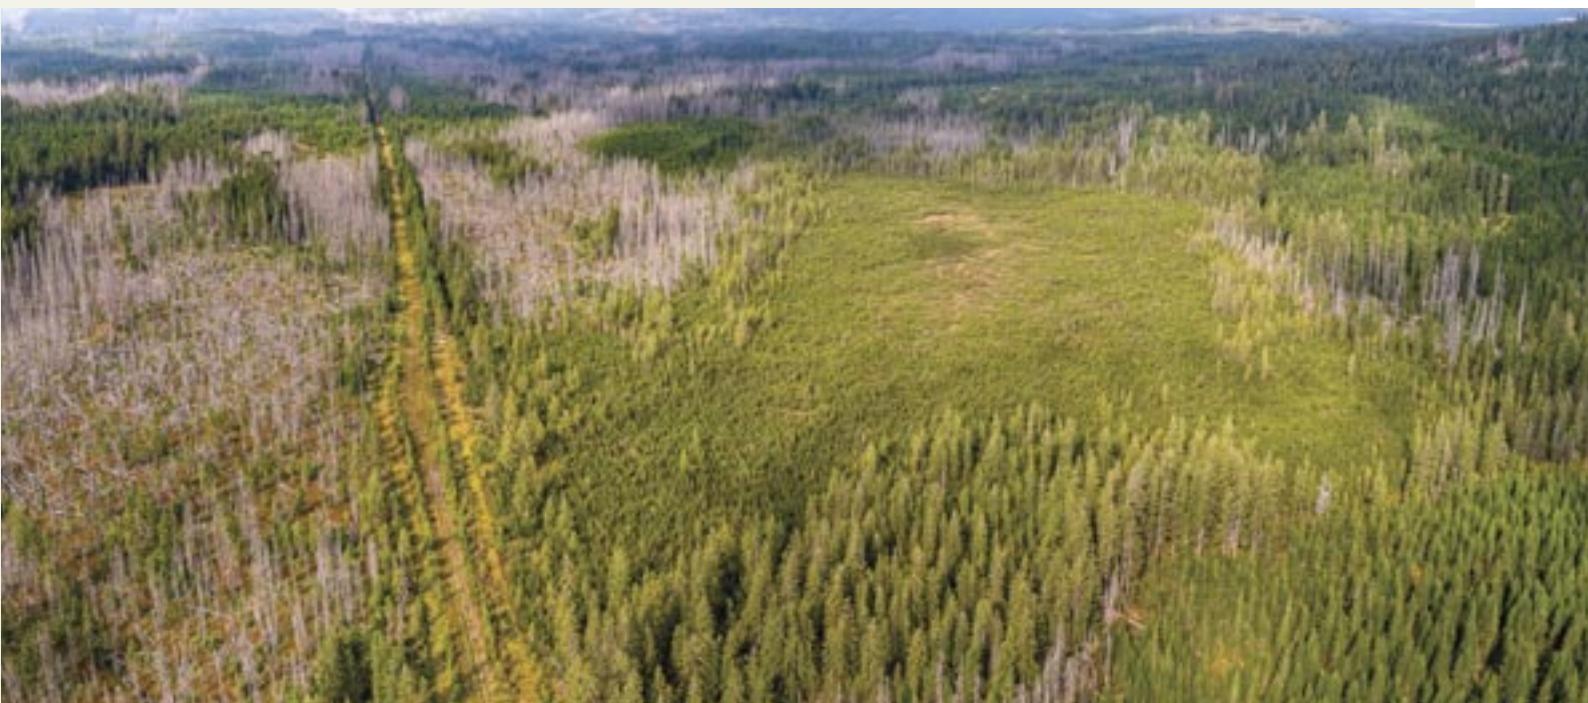
Fig. 276: Bird's-eye view of the upper part of the site with the Černohorský močál peat bog. The deep channels along the "Iron Curtain" have already been eliminated. Status 17 years after restoration, October 2023 (R. Plíhal)

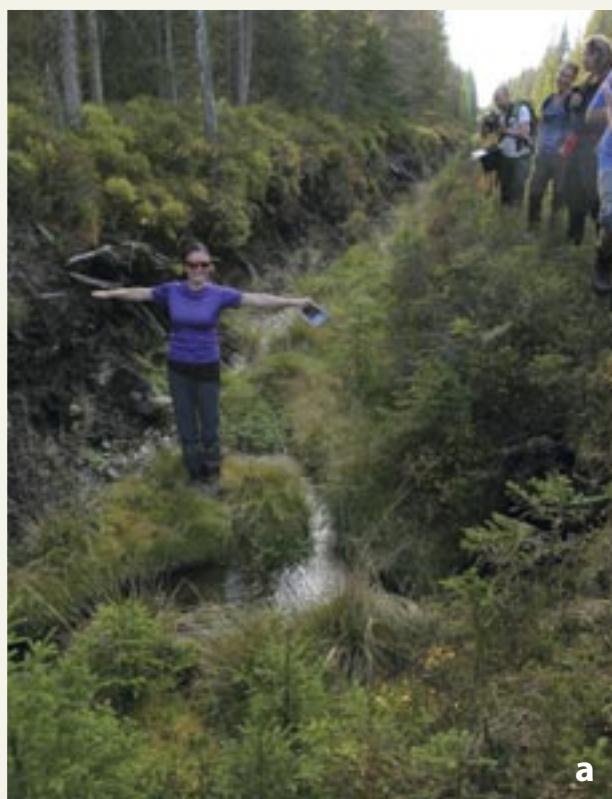
Fig. 277a, b: Deep erosion gully along the former "Iron Curtain" on the eastern slope above the Vltava River before restoration in October 2014 (a) and after by channel damming and backfilling in July 2024 (b). The canals are well stabilised by spreading mire and wetland vegetation (I. Bušková).

From a technical point of view, the blocking of the channels was successful despite the difficult conditions on the site (Fig. 277b). Only in some places did the water pressure and waterlogged mud volumes cause the dams to sag; the timely backfilling of the channels preferentially in the risk areas and successful development of wetland vegetation solved the problem. The elimination of the channels and the returning

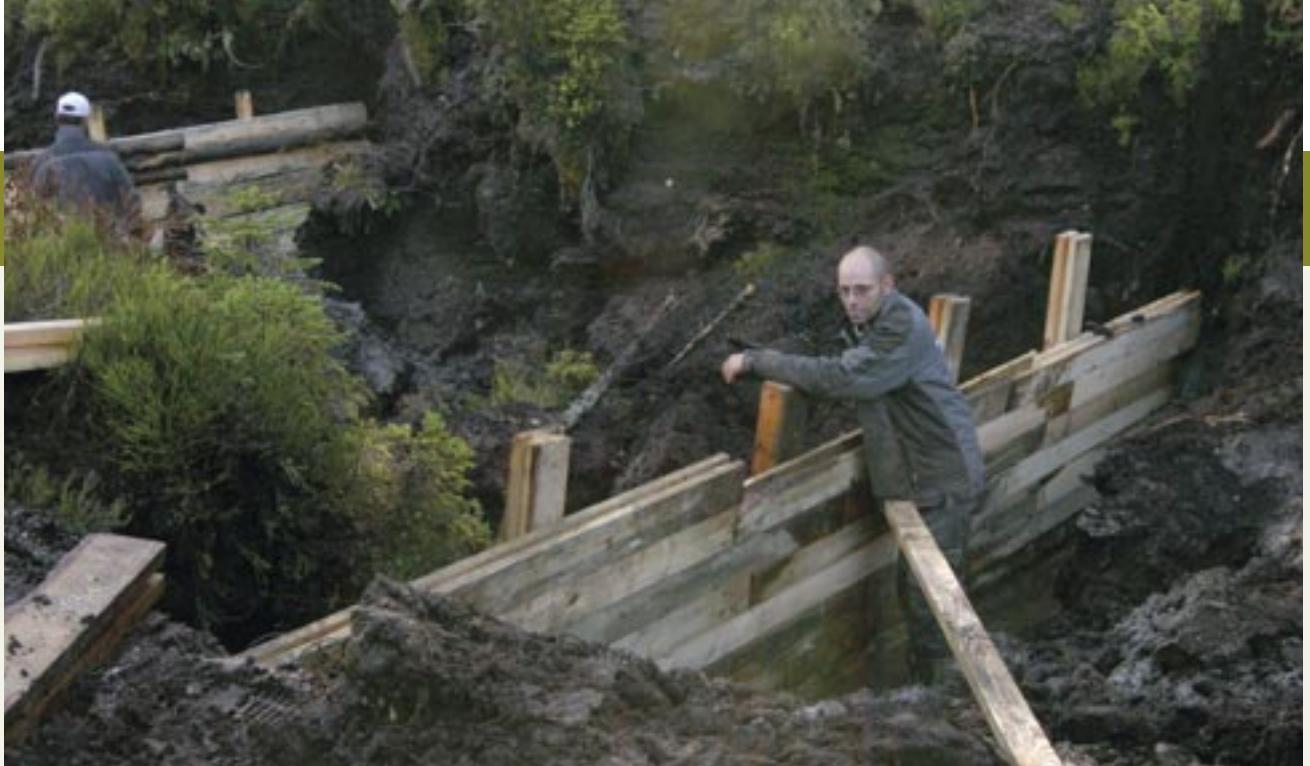
Fig. 278: Installation of the board walls in the erosion gully on the slopes above the Vltava River below Černohorský močál bog was technically very demanding, October 2014 (I. Bufková)

Fig. 267: The deep erosion gully under the Černá Mt. is already a matter of the past. View of a completely terrestrialized and stabilized channel overgrown with mire vegetation. Situation 10 years after the restoration, July 2024. The same section is shown as in Fig. 278.

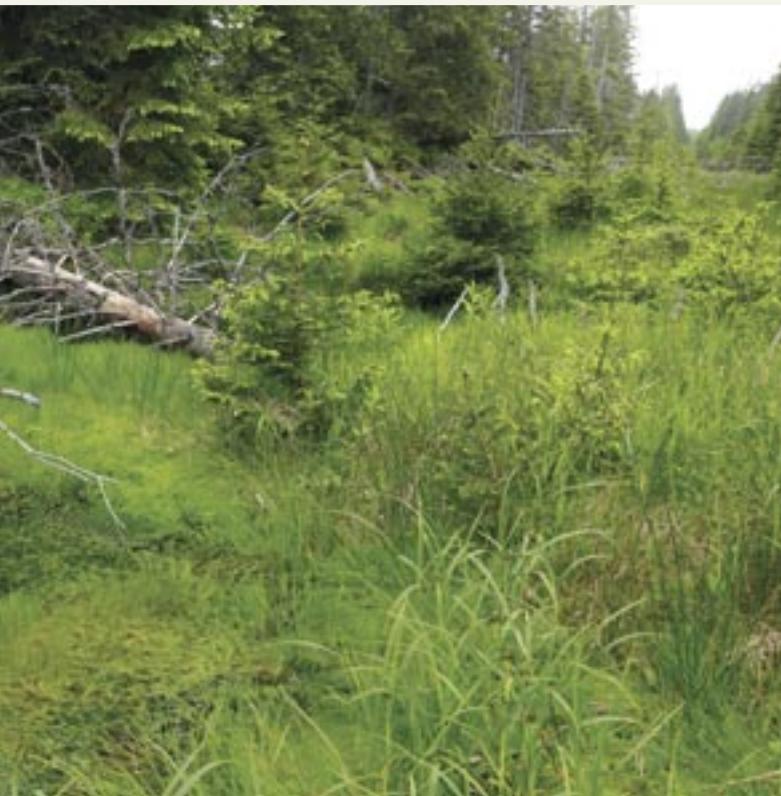
Fig. 279: Conversion of the stream over the "Iron Curtain" line to the original bed at Černohorský močál site, October 2014 (I. Bufková).

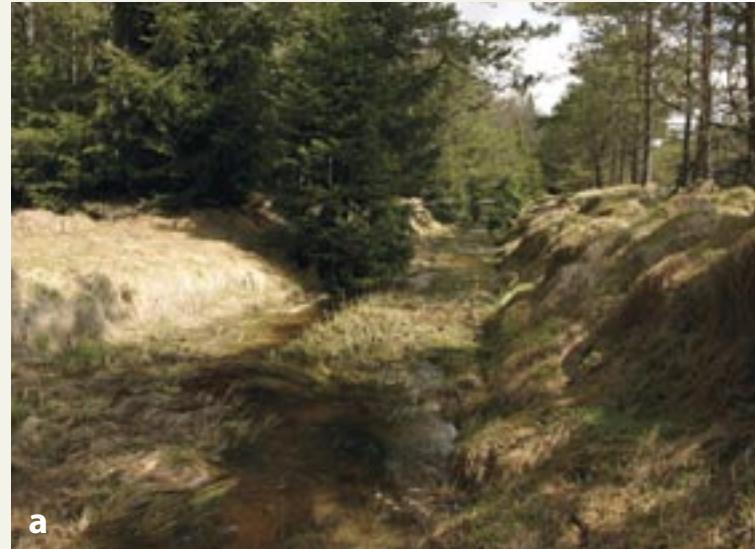
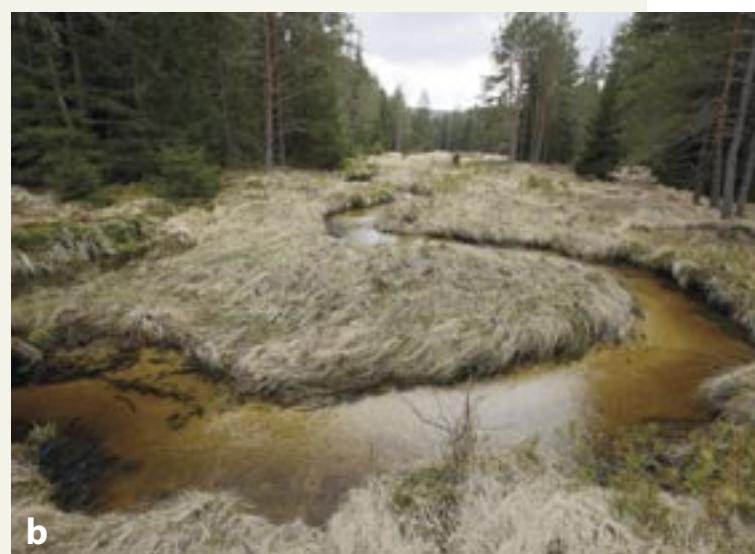
Fig. 281a, b: Hučina River before restoration in April 2006 (a) (I. Bufková) and ten years after restoration in May 2023 (b) (M. Mejstřík)

The second restoration stage of the water regime in the area was the restoration of the regulated lower section of the Hučina River. A total of approximately 1.2 km of stream was restored. By returning it to its original riverbed, its length increased by almost 0.5 km to a total of 1,672 m. After several years of subsequent natural riverbed-forming forces (bank scouring and enlargement of meander loops/stream bends), the target riverbed length is assumed to be approx. 1850 m.

During the restoration, the majority of the flow from both channels was directed into the original riverbed of the Hučina River by means of a technical modification at the point of diversion of the original natural riverbed. A new natural bed was reconstructed in the upper forested section of the original stream route, which meandered through the old, completely terrestrialized drainage channel. The

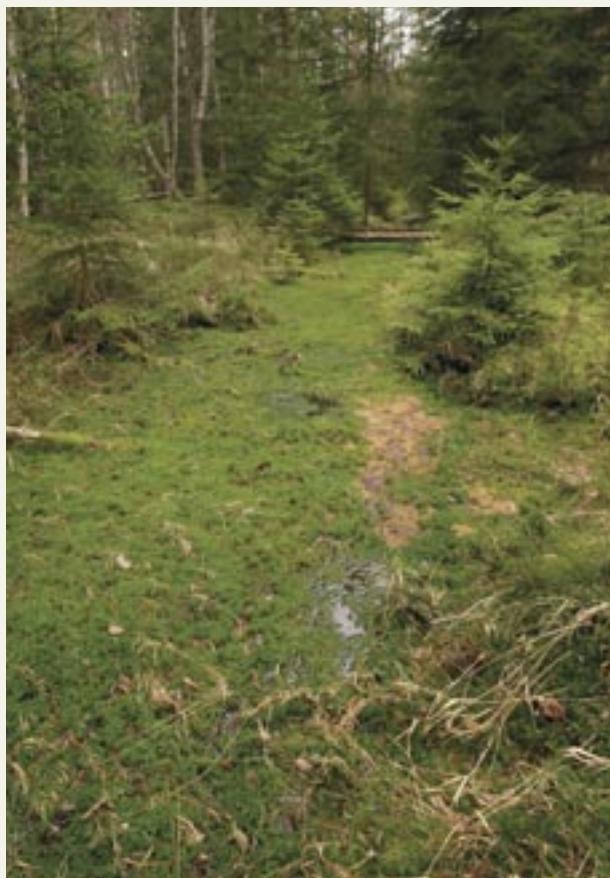
Fig. 283: Blocked and well overgrown drainage channels in the forest part of the Hučina site 4 years after restoration in May 2010 (I. Bufková)

The blocking of most surface channels (approx. 85 %) in the forest stands was successful despite the inadequate implementation of the dam backfilling. Within 10 years the channels have spontaneously overgrown with peat vegetation dominated by bog mosses and some of them are no longer recognizable in the field. This is certainly due to the minimal slope of the terrain and therefore the low risk of erosion leading to the unfilled dams being washed away. Locally, however, the dams have also been damaged by

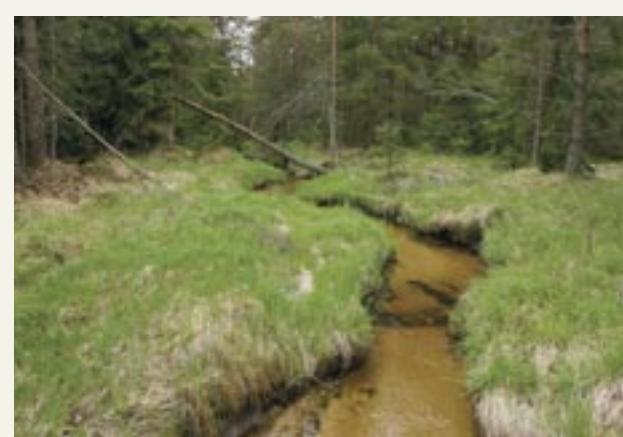
Fig. 285: A section of the Hučina stream restored by simple releasing the banks and their re-weaving three years after the restoration in May 2016 (I. Bufková)

The bed of the restored section of the Hučina River became covered with natural sediments within three years after restoration, including sections where the riverbed had been reshaped and the bottom consisted only of clay deposits. During the 10 years following the restoration, the bank lines, pools and point bars have been spontaneously re-shaped and the stream appears to be dynamically stable. However, in the upper part of the section there has been a slight deepening of the bed compared to the restoration level.

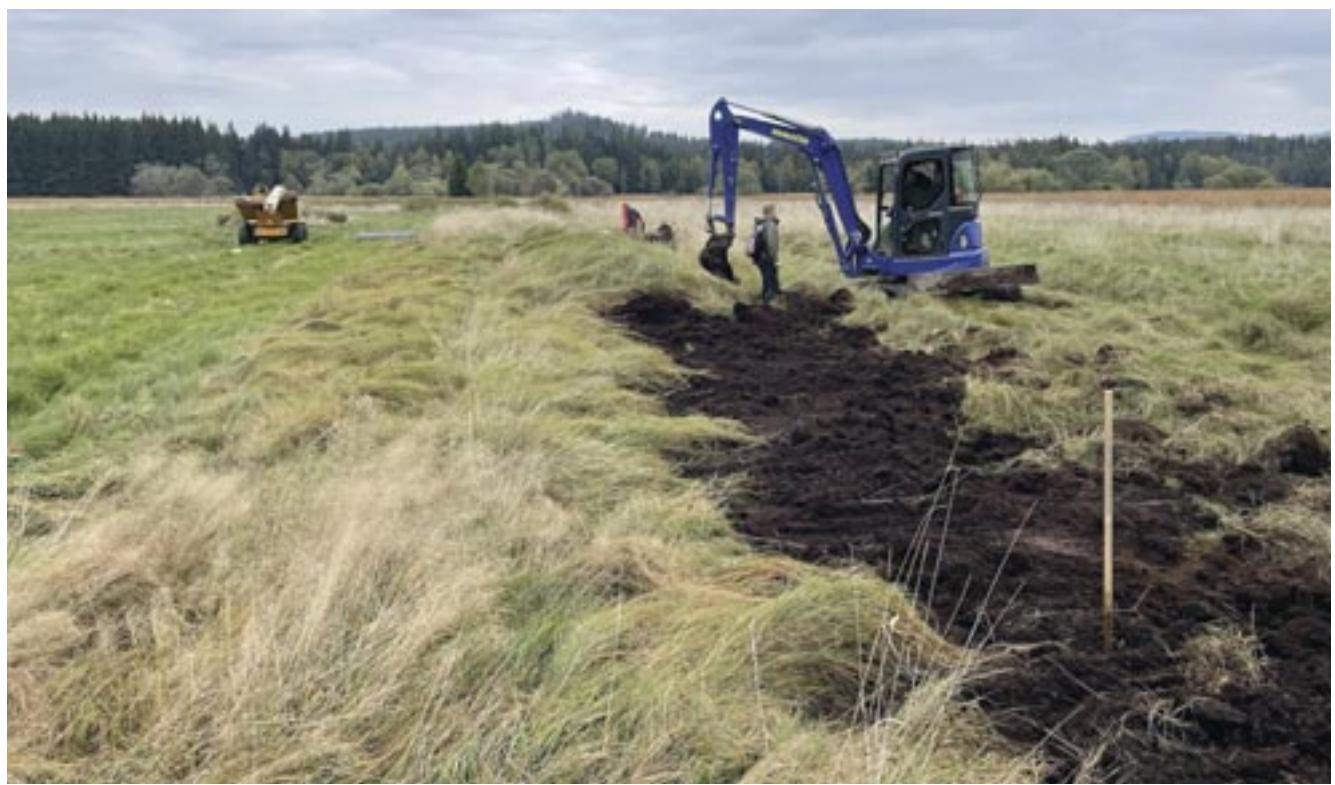
Fig. 286: Frequent inspections of the construction site and good communication with the contractor are a must for restoration projects. Disposal of the drainage channel in the Vltava floodplain at the Dobrovodské louky site, September 2021 (L. Linhart)

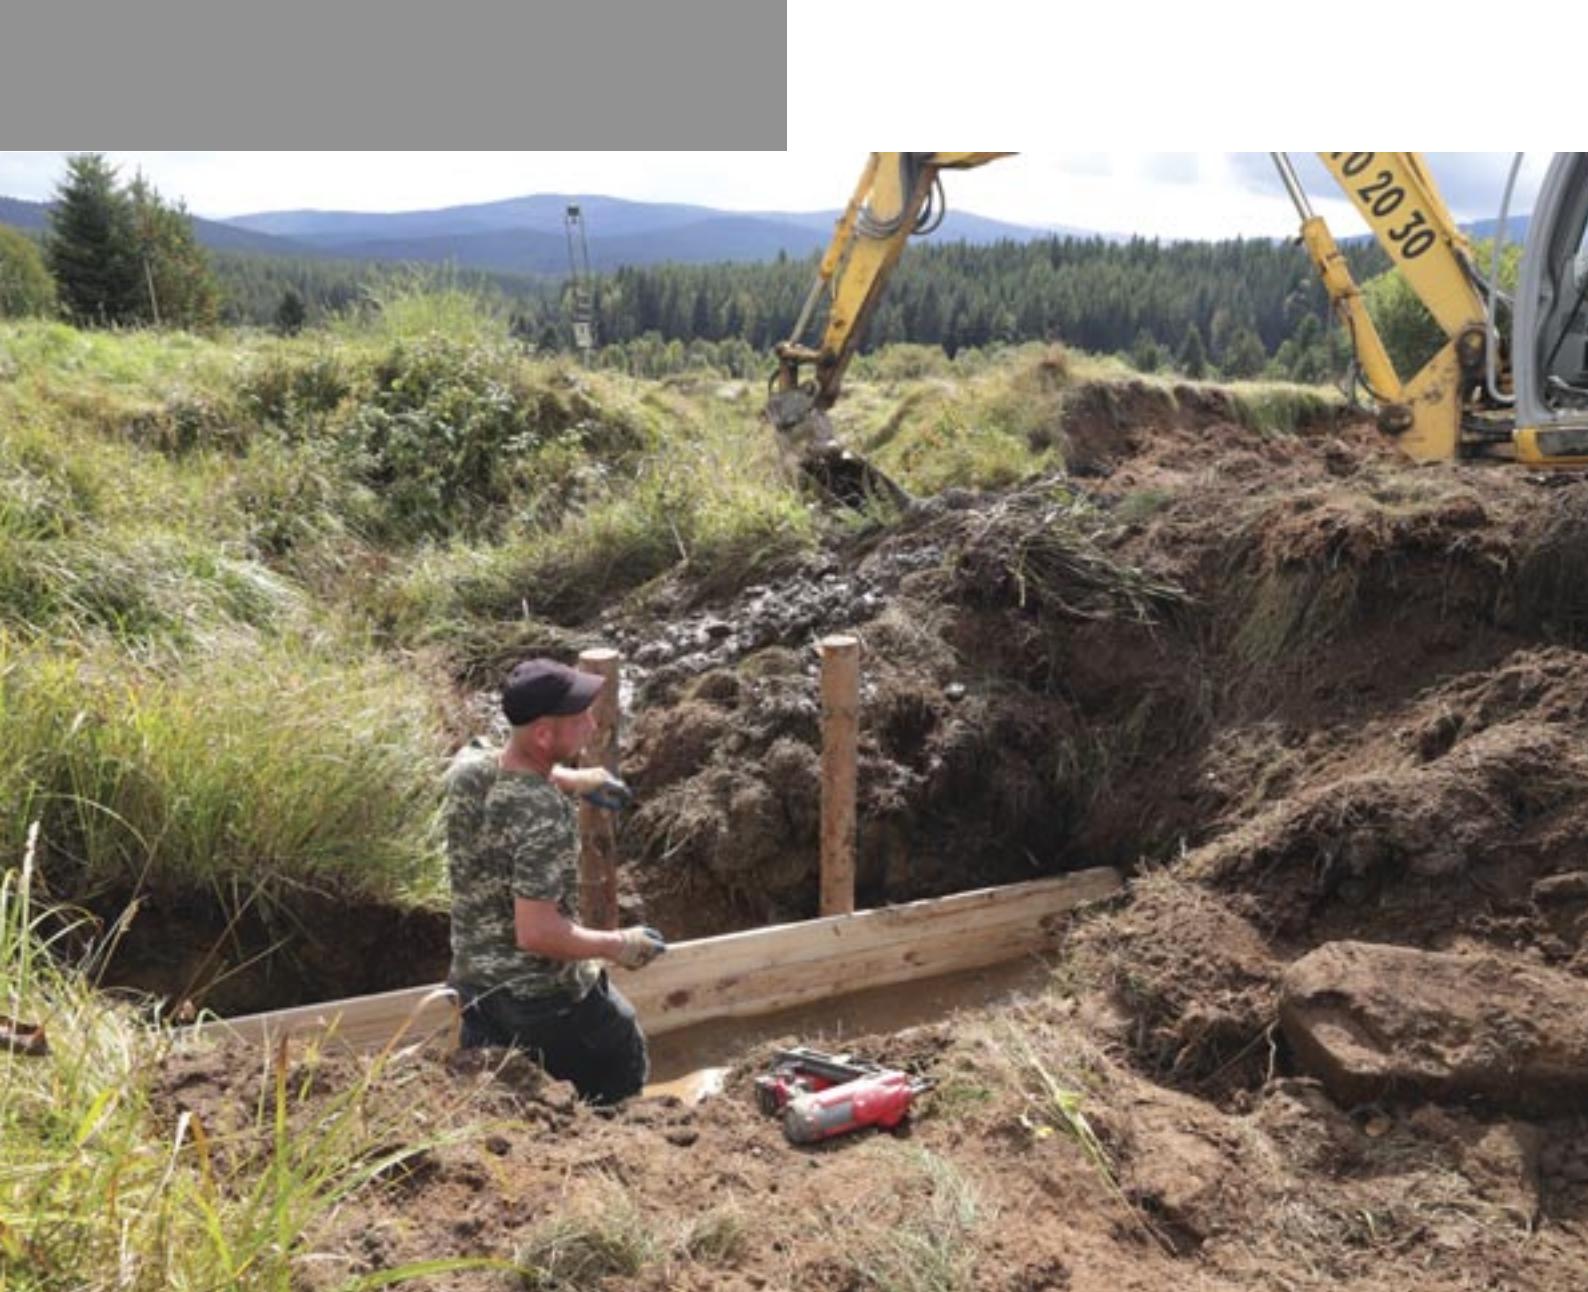
Fig. 287: Complete blocking of the drainage ditch before it is filled by soil at the Pod Skelnou site, September 2021 (I. Bufková)

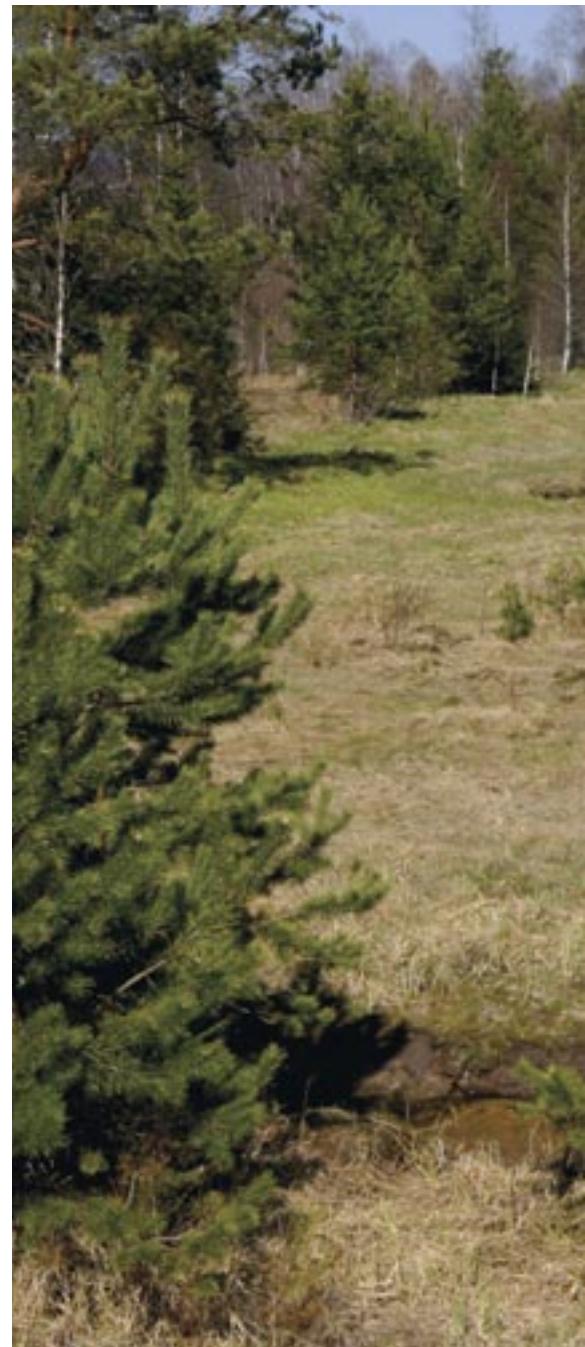
Fig. 288: Restored Hučina stream two years after restoration, April 2015
(I. Bufková)
