## Character and dynamics of the floodplain of the Losenice stream, Bohemian Forest

### Abstract

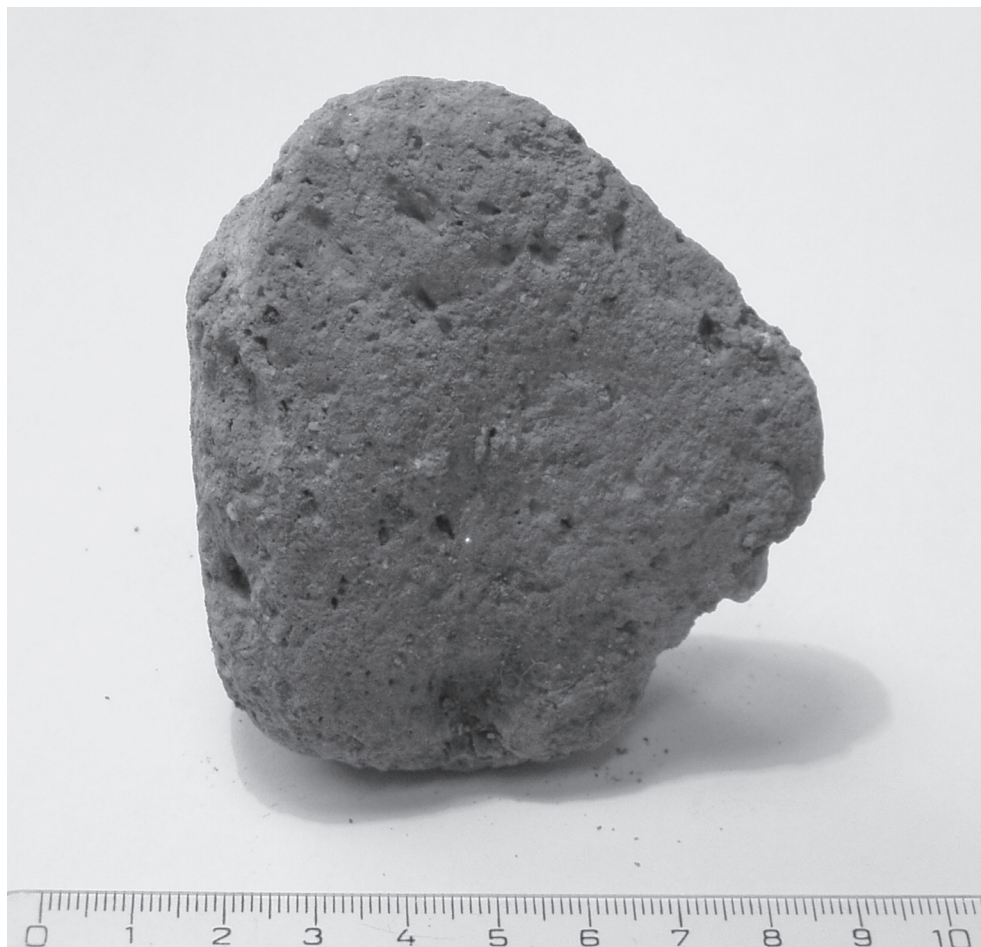
**Fig. 11.** A photo of the biggest piece of brick, found in a dug probe 80 cm deep. Notice the almost perfect roundness after merely 600 m transport.

Anticipated lake sediments have not yet been found, there are, however, other interesting findings. In dug probe No. 2, almost 110 cm deep, measuring  $150\times 120\text{ cm}$ , under various flood events sandy sediments and some fluviodeluvial gravels (only slightly rounded blocks up to 40 cm in the longest axis) at a depth of almost 80 cm, several well-rounded, water transported pieces of brick (Fig. 11) were found.

There is only one possible source of the brick – the village of Popelná, nowadays only consisting of two hotels and a few cottages, but at the beginning of the 20<sup>th</sup> century a blooming village with over 30 houses, a church, and a school (Vinická, pers. comm.). The oldest constructions in the village originated approximately 300 years ago, thus pinpointing the oldest possible period of the said sedimentation. Hence the 80 cm of sediments in the probe,

which is located some 25 m from the channel, i.e. rather far in the floodplain, must have accumulated within last three centuries.
